British Gliding Association Aircraft Inspection

Number:
042/07/2004

Subject: Structural inspections

Applicability: Schleicher Ka 1, Ka 2, Ka 2B, Ka 3, Rhönlercher II (Ka 4), Ka 6 series, K7, K7 conversions, K8 series, K10, ASK 13 series, ASK 14, ASK 16, ASK 18 series and all variants of each type.
(This inspection is strongly recommended for the motor glider types listed above)

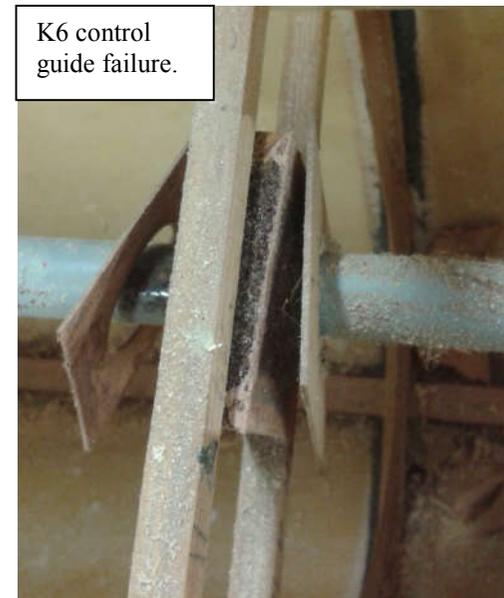
Try and establish the glue type used. We are most concerned about the longevity of Kaurit glue. It is usually pink in colour (see figure 4) but has been known to be other colours if a filling agent has been used. You might have to remove some paint to determine the glue used in each critical component. On all control guides carefully check the felts are adequately retained. (see pic of K6 control guide for example of failure.

K6 control
guide failure.

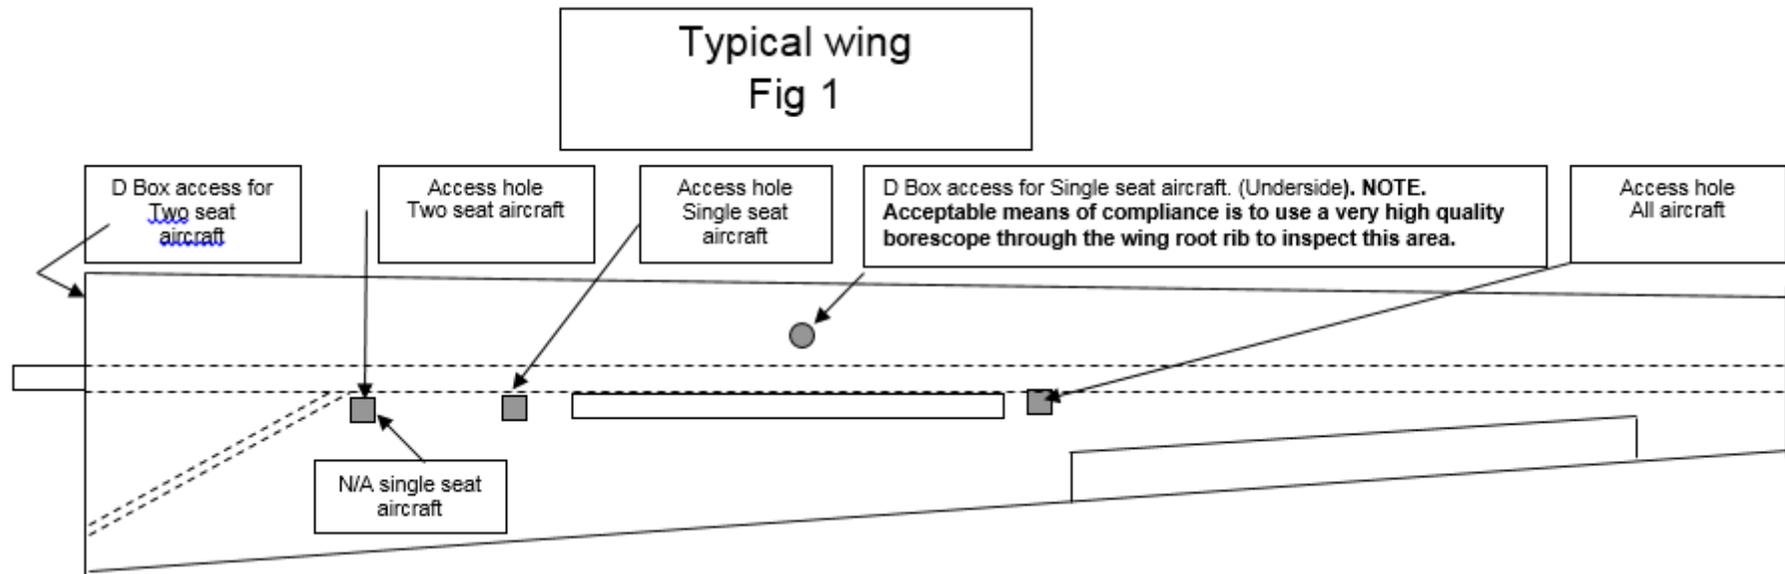
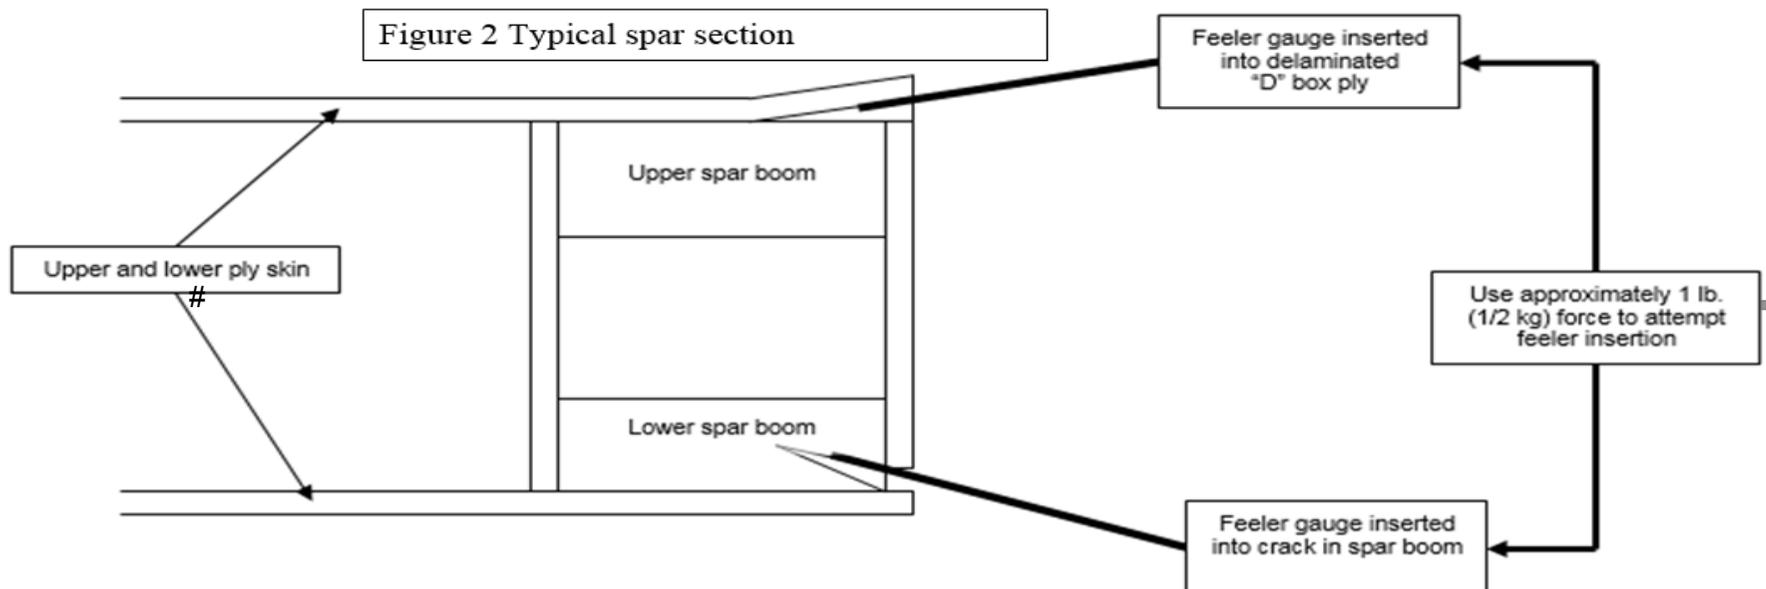
Single seat aircraft: Adjacent to the rear face of the main spar immediately inboard and outboard of the airbrake box. See fig 1.

Two seat aircraft: Adjacent to the rear face of the main spar immediately outboard of the airbrake box and at the drag spar intersection with the main spar. See fig 1.

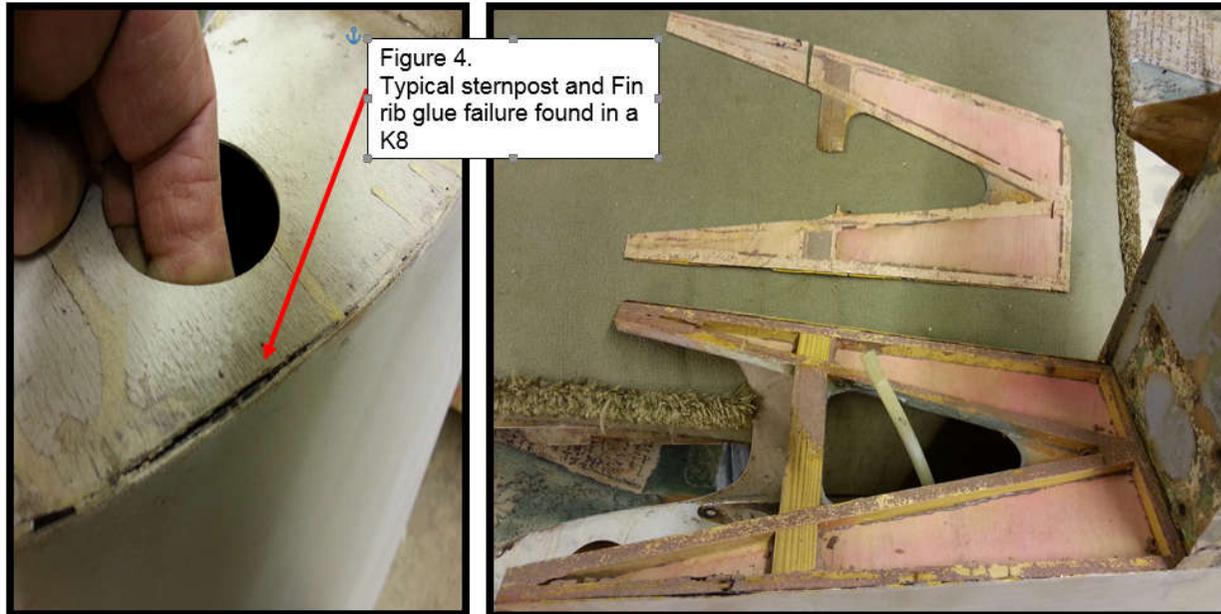
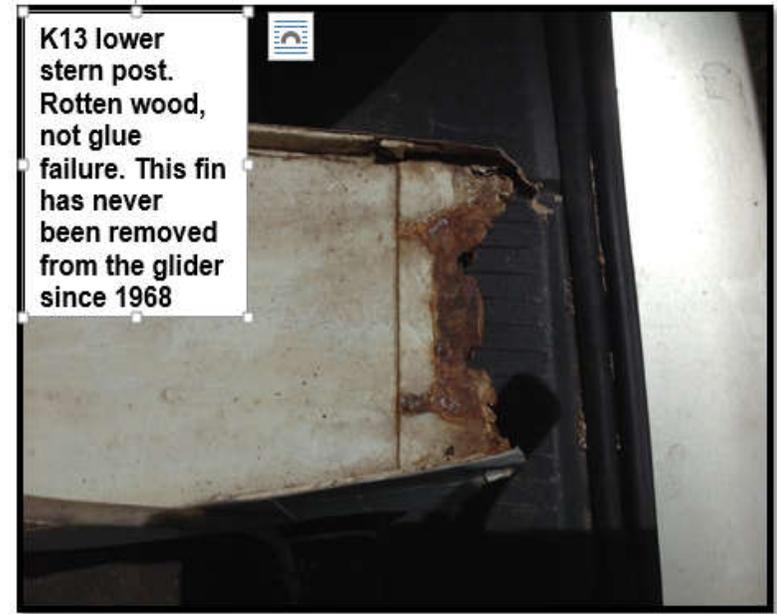
(d) Fin inspection. If performing the inspection during a fuselage recover then the fin is to be removed (except K6s where they are not bolted on) See figure 4 for images of glue failure found previously. Please look at this video for advice on how to find problems:

Remove the fin (does not require much fabric work). This must be done on all types apart from K6 and K14 types (indicate on the form returned to the BGA when the fin was last removed) as checking in situ gives very poor access and finger pressure has to be applied to ensure that the glue joints still have the required high strength. Inspect base of fin rib and put some pressure on it pulling it away from the fin. Check the entire stern post both sides by applying gentle pressure to the plywood that bonds onto the stern post spar. Apply gentle but firm pressure to shear web plywood away from the spar caps to ensure there is no dis-bonding over the entire length. You are looking for any sign of dis-bonding or rotten wood (especially at base of fin). Apply significant pressure to the elevator drive mount to ensure that rib is completely bonded. Note, often the bolts that hold the fin onto the fuselage are rusty and should be replaced.

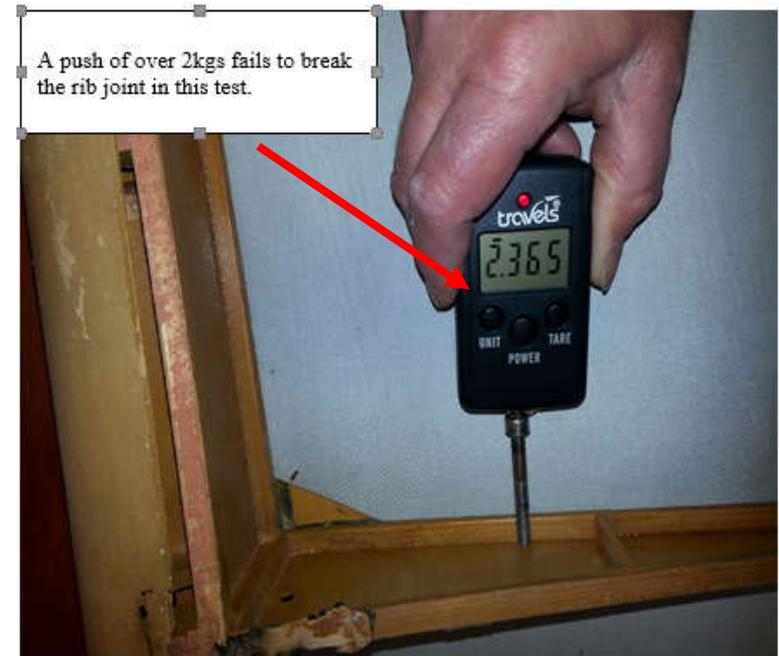
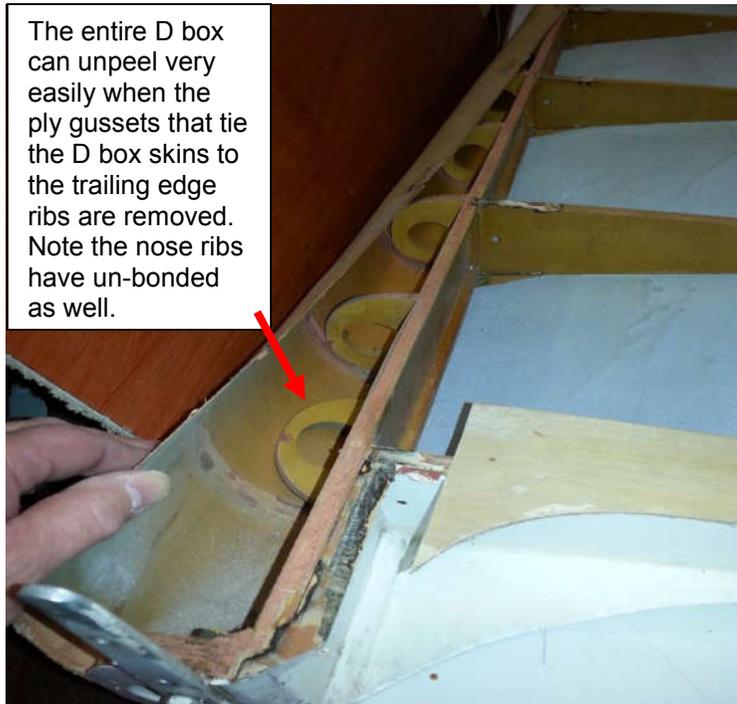
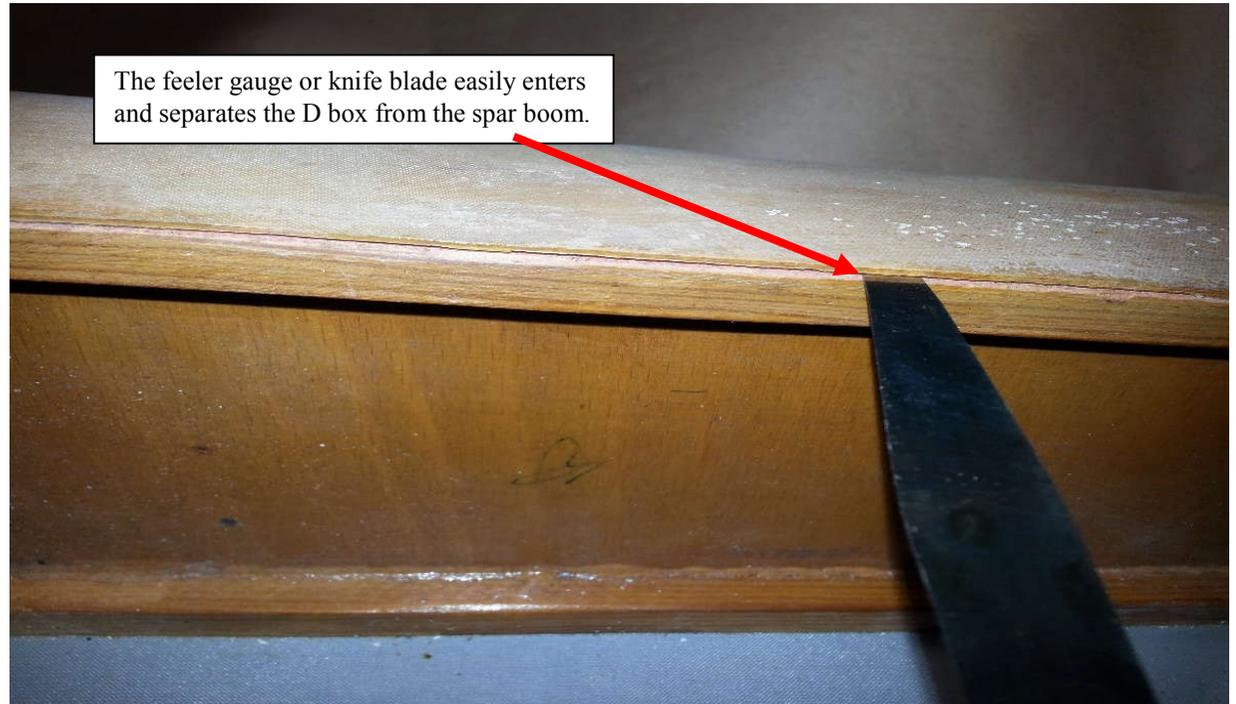
Check the trailing edge is straight and solid. Apply pressure to every rib over the entire length to ensure there are no broken sticks. The root rib requires gentle but significant pressure trying to pull it out of the spar. Using a feeler gauge (as in figure 2) check for any dis-bonding of the spar to D box skins on the root end of the spar where you have access (including inside the D

Gently push the spar shear web away from the spar booms to see if they are bonded together.

Using a knife blade or feeler gauge, try and push the blade or gauge between the Spar booms and D box skins.

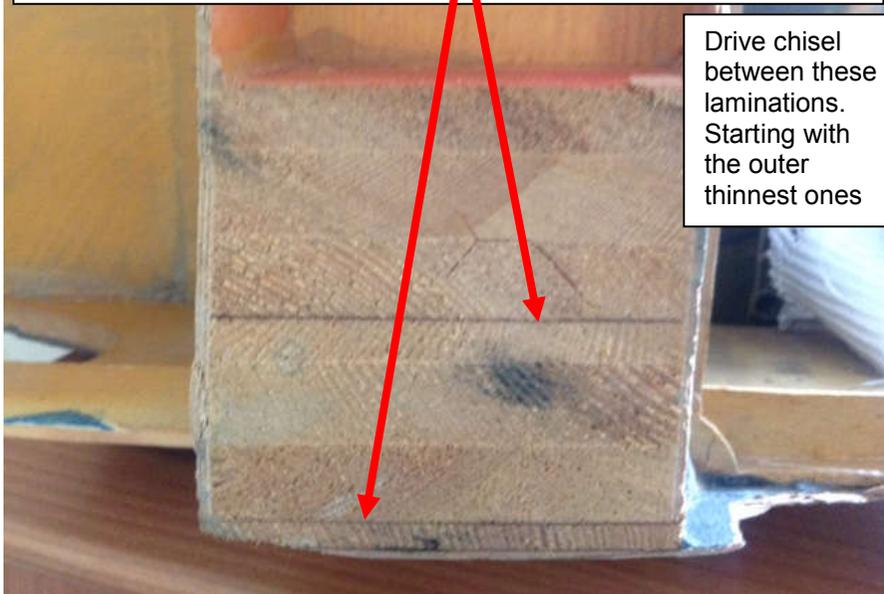
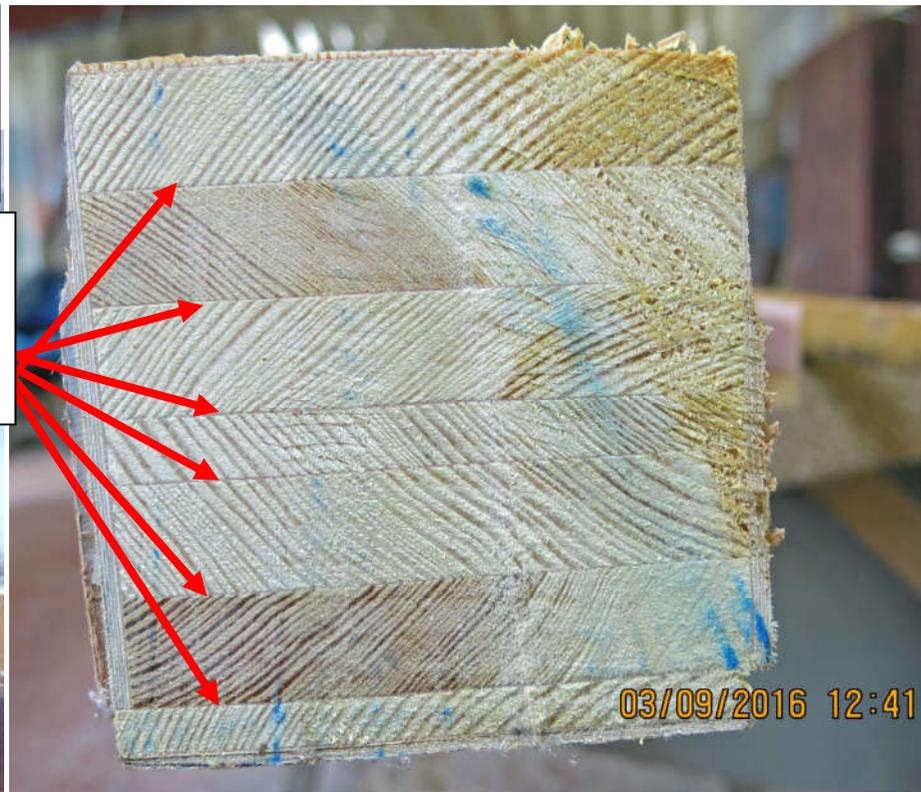
Try and drive a very sharp chisel between laminations of the spar caps only when the spar web has been removed. These spar caps (from near the root of a 1986 built ASK13 wing) have 7 laminations and 6 joints. Note this spar cap has 2 resorcinol glue laminations as well as 4 Kaurit laminations. We are only interested in the Kaurit laminations

Drive chisel between these laminations. Starting with the outer thinnest ones
