Issue 1-2015

Date: 26/02/2015

Airworthiness Information

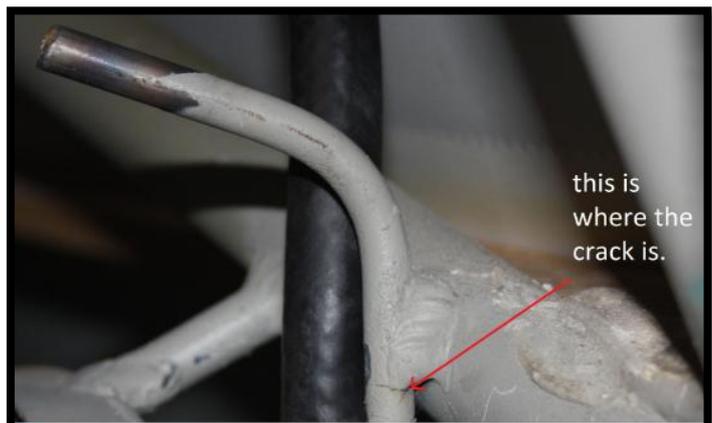
5 SF25c fuel line crack and leak Advisory

This was a well-spotted problem found on a high time (more than 5000 hours) Rotax Falke.

It is a small crack in the welded steel tube near the fuel tank.

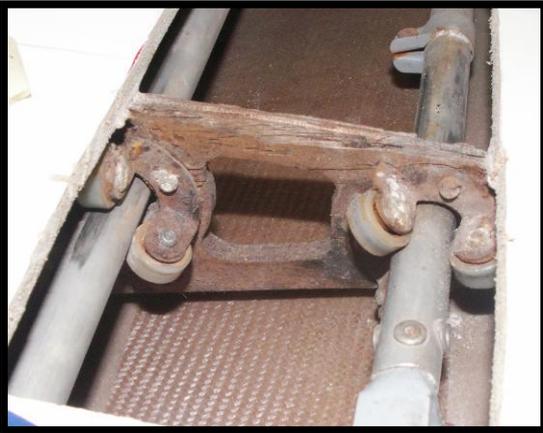
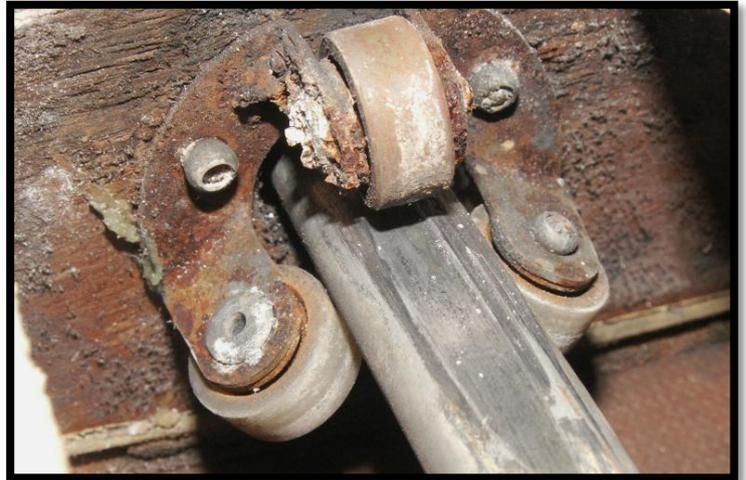
6 ASW 20f, ASW20, ASW22 and ASH25 and possibly others

Rotten ribs, metal corrosion and seized bearings in push rod rollers in wings. This has been found on quite a few BGA gliders over the years. It appears to be more likely a problem on gliders left outside a lot. A boroscope through the trailing edge root rib hole during annual is strongly advised. The only fix is to cut holes to gain access to fix the problem.

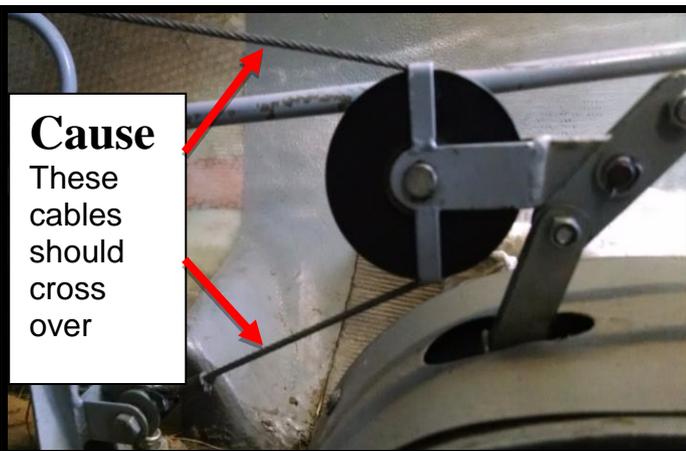
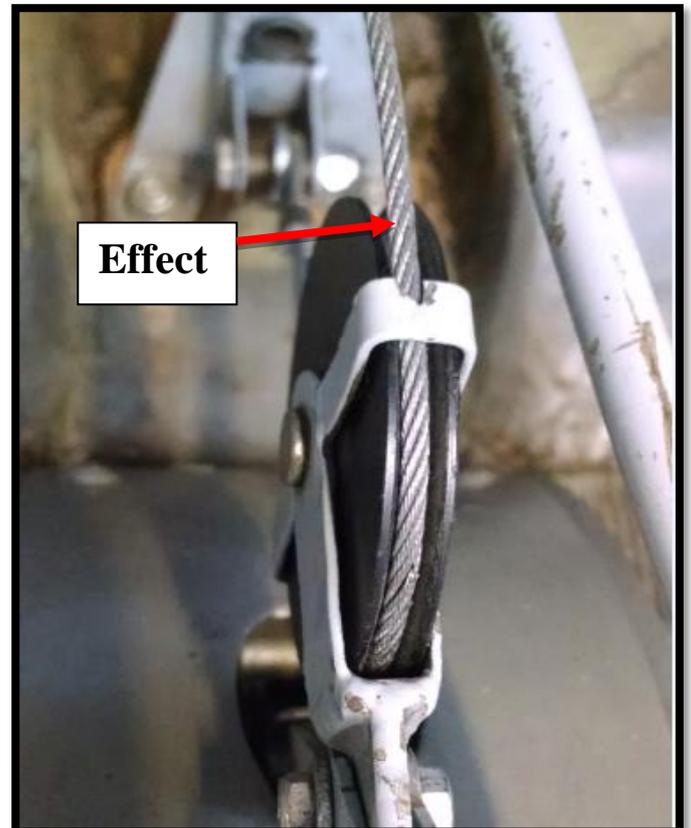
7 ASK21

Incorrect routing of aerotow release hook cable found at annual caused the cable to start sawing through the pulley cage.

A number of gliders have cables that cross over by design.

The maintenance manual or a picture taken before disassembly are ways of helping preventing this.

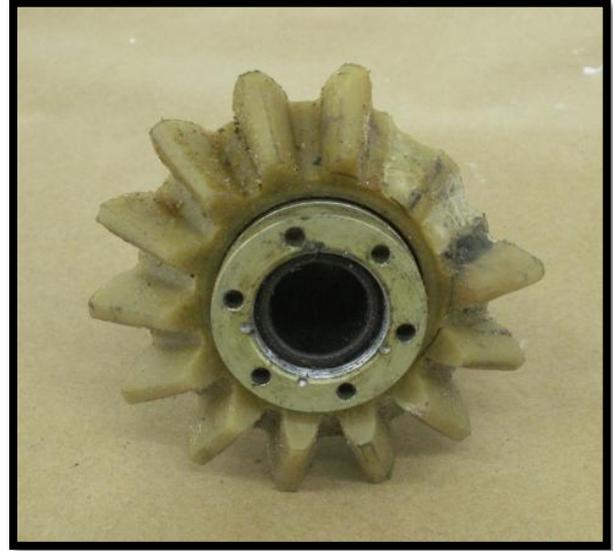
8 Puchacz broken airbrake gearbox cog. Does apply to others SZD types. **Advisory**

This is why you need to inspect most SZD brake gearbox cogs very carefully at every annual.

Any sign of cracks and they must be replaced.

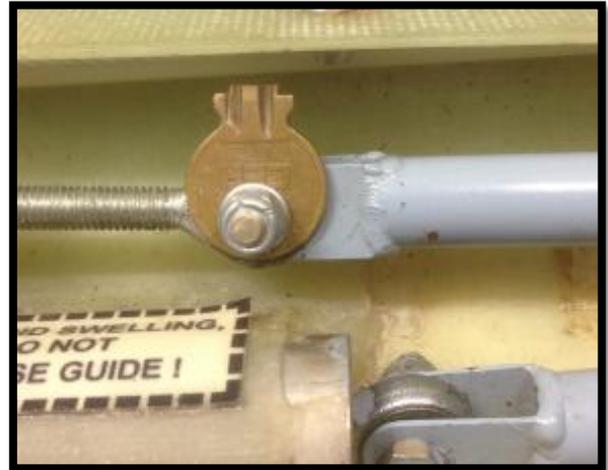
9 Unapproved Modifications

This was part of a home designed U/C warning system! Most likely fitted by a well meaning owner.

Nyloc nut not in safety, the key could potentially rotate and jam the U/C.

If you ever see anything like this, then you must remove it, no matter what the owner wants.

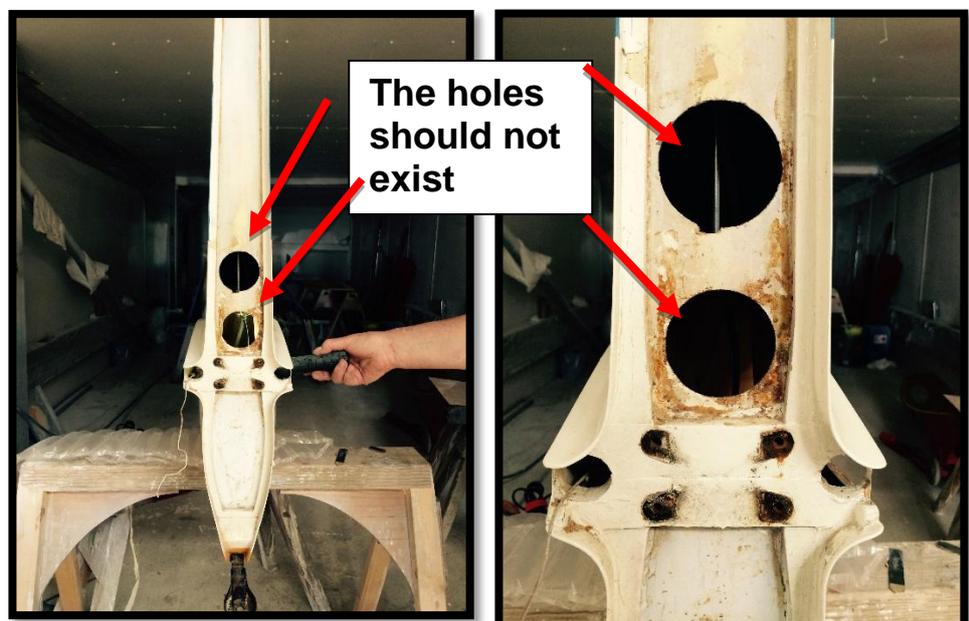
10 Holes cut in fin spar shear web

This was found during the revision 4 glue inspection upon removing a foam rubber seal covering the sternpost.

At some point in the past the holes were cut in order to fit an aerial into the fin.

Obviously a totally unapproved mod that now requires a repair.

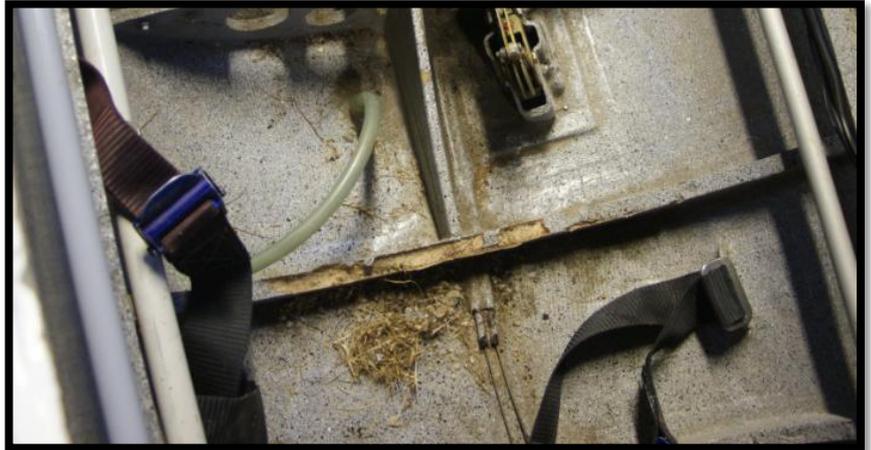
11 Puchacz mouse damage**Advisory**

The mice really made a meal of this wooden frame. Gliders, whether in trailers or hangars, are all susceptible to mouse infestation.

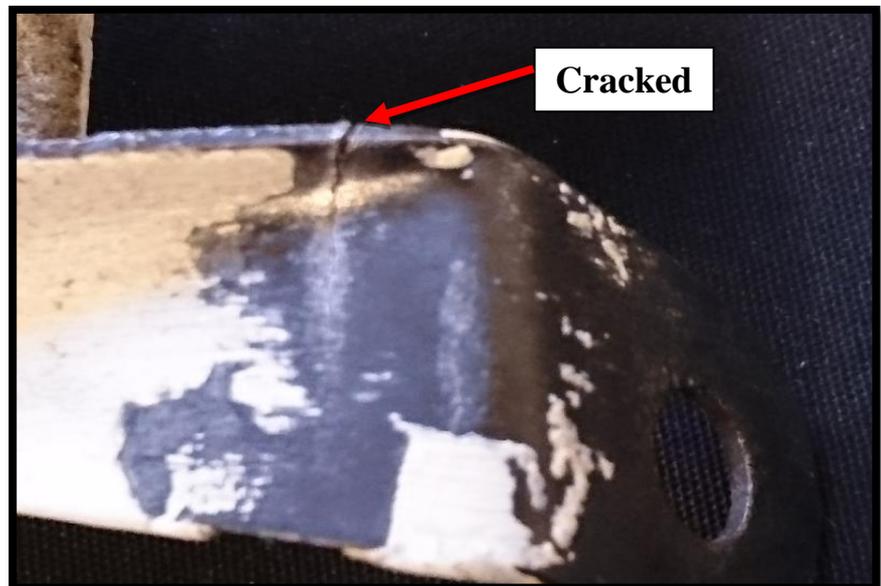
**12 All Schleicher wooden gliders lower rudder hinge, reported cracks****Advisory**

This is not a new issue but a good reminder to always take the rudder off at annuals to look for cracks on the hinge (and at the condition of the sternpost).

These cracks are on the back face of the hinge, so not so easy to inspect as it is close to the sternpost.

If cracked do not repair. New hinges are available from the agent.

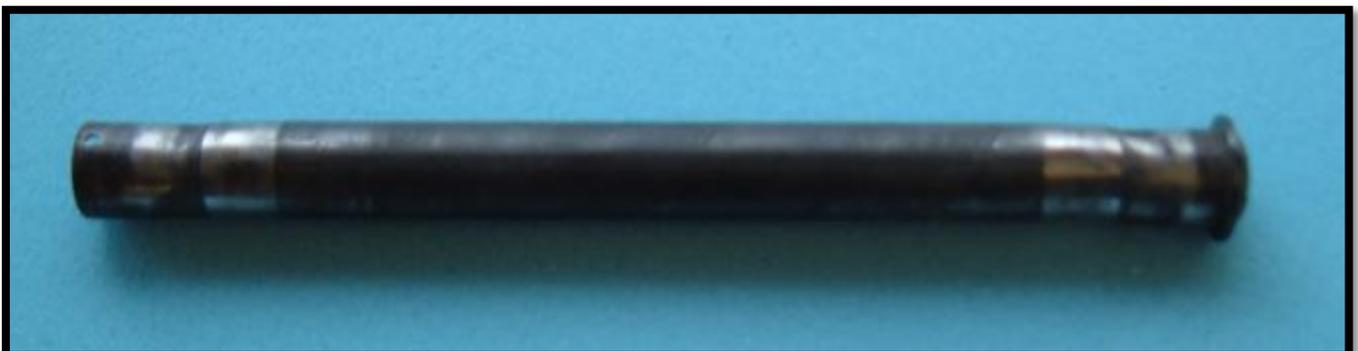
**13 Libelle 201 but could apply to many other types****Advisory**

A bent axle that is very close to failure. A good reason why you should always take the wheels out at every annual.

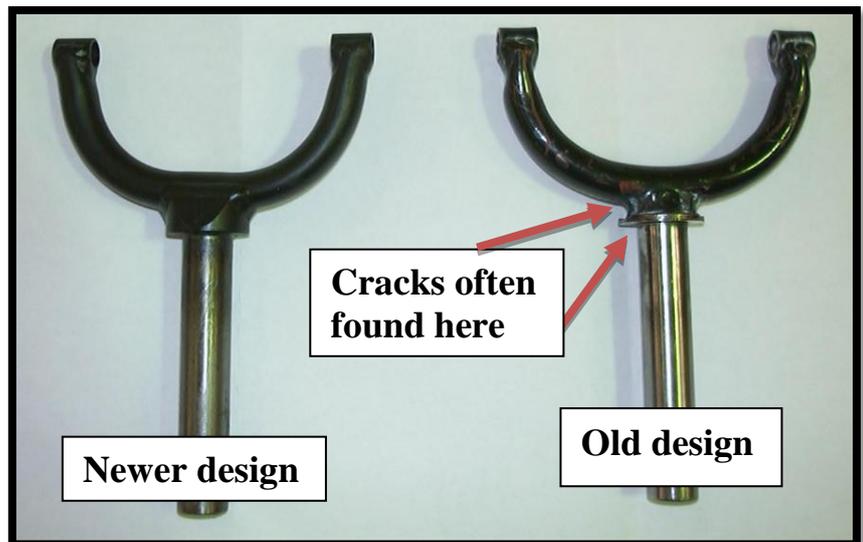
14 Slingsby Kestrel rudder drive fails annual NDT inspection**Advisory**

Cracks in Slingsby Kestrel rudder drive arms. Glasflügel Kestrels (on which the Slingsby Kestrel design is based) had to replace their rudder drive arms for stronger ones in 1987. That replacement mandate was not applied to Slingsby Kestrels as most Slingsby arms are different to the Glasflugel ones, in as much they are Imperial rather than metric.

If yours is cracked or you want to change it for a stronger arm, the only new one is built by Streifly in Germany <http://www.streifly.de/service-e.htm>

But they do not fit without a lot of work. This is not a small job, as you have to convert all the fittings at the lower rudder hinge to metric as well as fill the rudder drive hole with a Resin/PTFE/Marble flour mix. This can all be bought from Streifly.

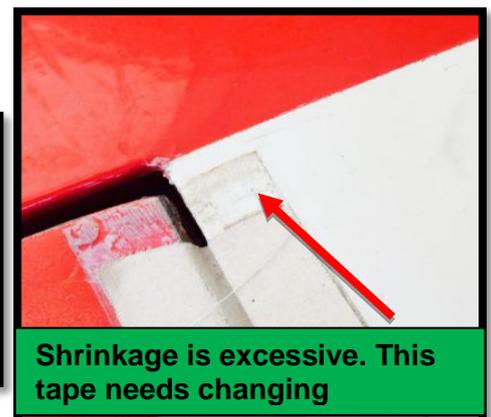
Teflon PTFE tape

Shrinkage is excessive. This tape needs changing

You must change Tessa fabric type tapes every year or earlier if the shrinkage is excessive (see image).

You might consider using wide Teflon PTFE tapes instead; they appear to be less prone to shrinkage. They become translucent after few days of U/V exposure.
