MANDATORY BULLETIN
No BE-058/SZD-50-3/2006 „PUCHACZ”

DESIGNATION-TYPE/MODEL: SZD-50-3 „Puchacz”

CONCERNS: Inspection of the rudder bottom hinge and revision to the Technical Service Manual

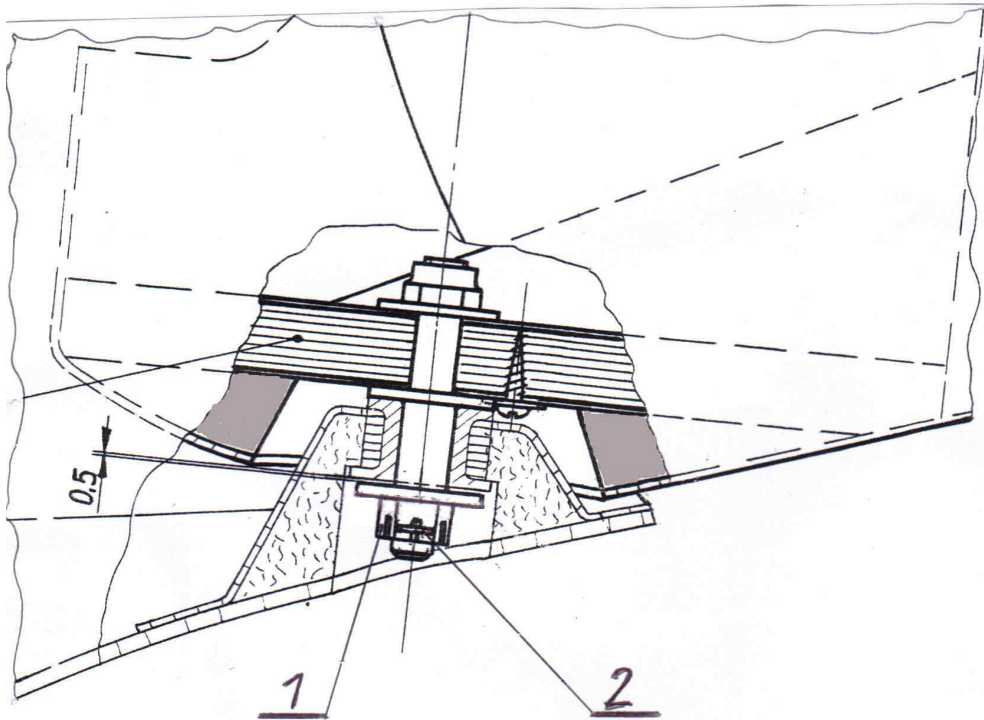
Fig. A

On one PUCHACZ glider, in the take-off phase, the rudder slipped out of its hinges and separated from the glider. The cause might be unscrewing of the fastening the bottom hinge castellated nut, not secured with the cotter pin, or unscrewing of the employed self-locking nut. Comparison between the design documentation and the Technical Service Manual revealed that no revision concerning the exchange of the self-locking nut to the secured with cotter pin castellated nut has been done to the Manual. The castellated nut is used in production from the Fact. No B-967. Also, the Bulletin No BE-06/50-3/81 SZD-50-3 "Puchacz" introducing the exchange of the self-locking nut with the castellated one on operated already Fact. Nos up to B-966 has been issued. The non modified entry in the Technical Service Manual may cause that in an inspection and disassembly of the rudder, instead of a castellated nut with cotter pin, a self-locking nut may be used to secure the rudder bottom hinge.

- 4.1 , Check by visual inspection the nut securing the lower hinge – see Fig. A. This one must be of the hexagon, castellated model (1) with the visible cotter pin (2).
- 4.2 In case of nut different from this one specified under item 4.1, proceed as follows:
 - undo the nut,
 - disassemble the rudder from hinges,
 - clean the opening for a cotter pin, one located in the bottom, threaded portion of the rudder pin,
 - grease the hinge bolts 14 and 15, as well as the pins 16 – Technical Service Manual, Fig. 8 or 7/2 (see item 4.3),
 - re-assemble the rudder on a vertical fin,
 - install the 6 mm diameter, 1.5 mm thick steel washer
 - screw on the M6 aircraft thin, castellated nut
 - install the 1.6 mm diameter cotter pin

In necessity of a nut exchange – the M6 aircraft thin, castellated nut and the 1.6 mm diameter cotter pin can be purchased at Allstar PZL Glider, or substituted with the analogous aircraft model.
