Société Nouvelle Centrair

No. 101-06 rev.1

SN CENTRAIR 101 GLIDERS
all "Pegasus" types

SUBJECT: CHECK OF THE BONDING AND CONDITION OF THE FUSELAGE FRAMES

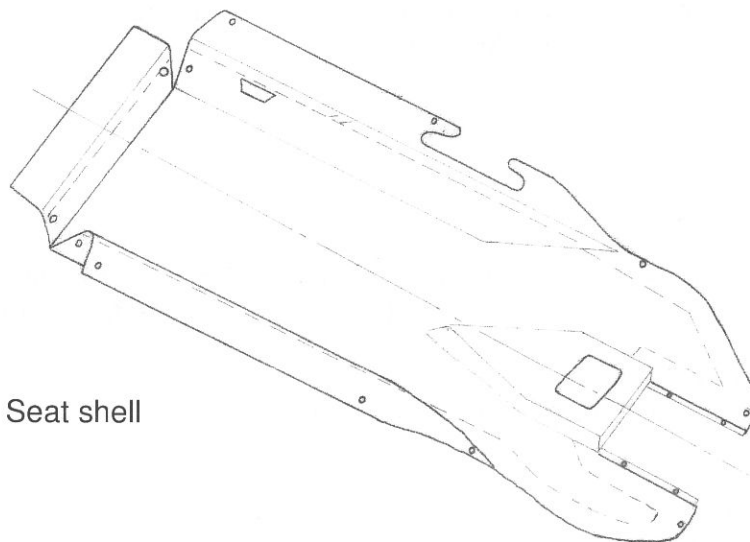
Seat shell

The frames and internal reinforcements are accessible after removal of the seat, which is attached by screws around its periphery:

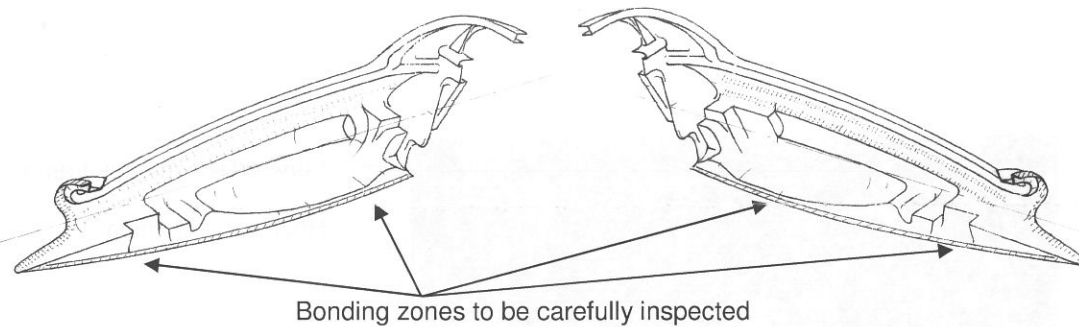
The reinforcements correspond to the items in the sketch below. They are bonded around their periphery to the skin forming the shell of the fuselage.

Bonding zones to be carefully inspected

Right side reinforcement

Left side reinforcement

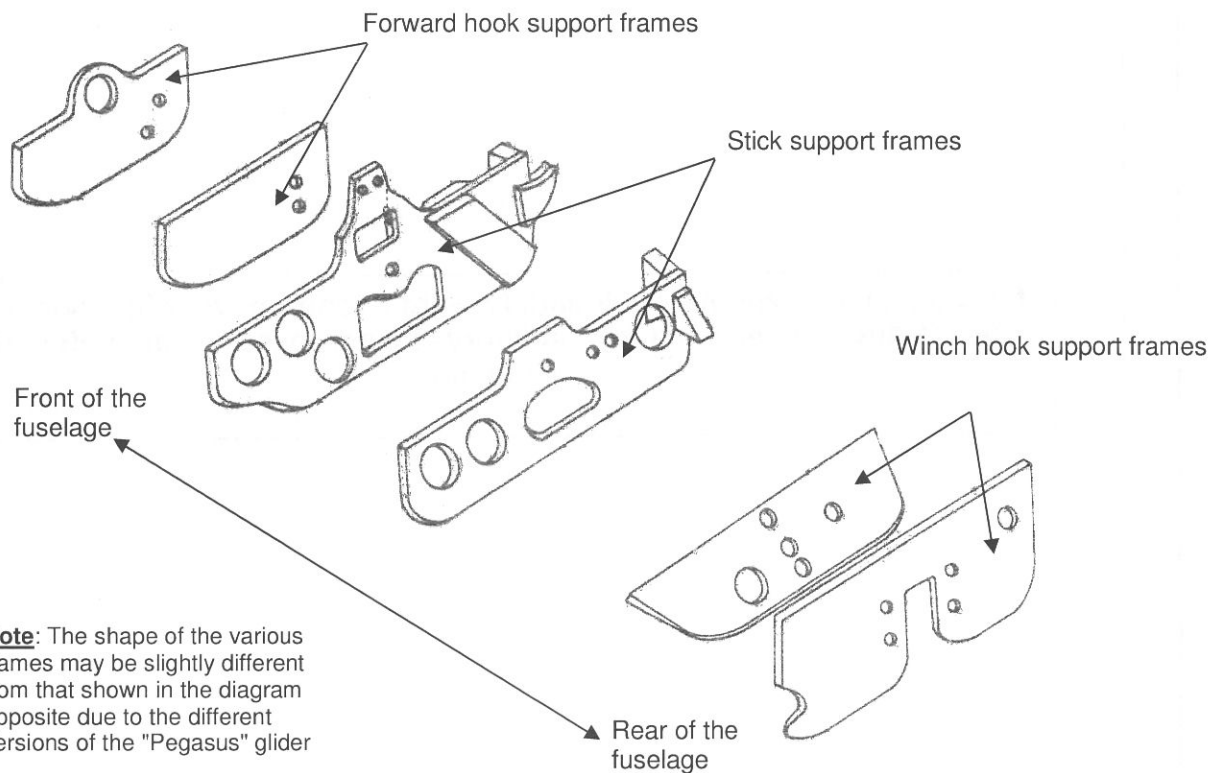
Detail of the 6 frames to be inspected in the cockpit in addition to the main landing gear support frame

Note: The shape of the various frames may be slightly different from that shown in the diagram opposite due to the different versions of the "Pegasus" glider

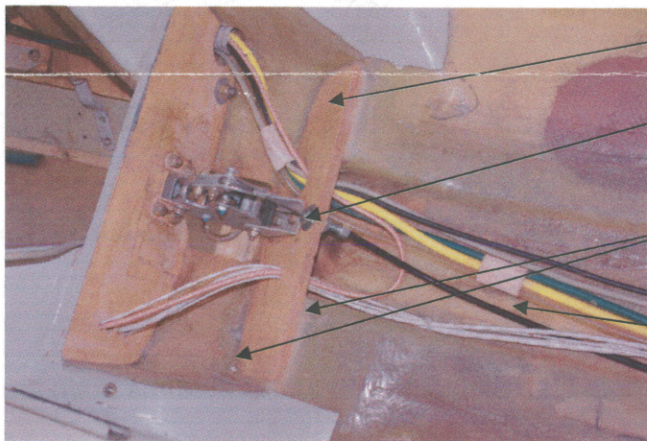
For gliders which use the winch hook, particular attention must be paid to the forward frame supporting the winching hook, which is highly loaded, and for which the forward hook fitting must be removed to enable proper analysis of its condition (cf. photo on page 4).

For gliders using the winch hook, careful attention must be paid to the zone of the forward hook support frame as shown in the photograph below looking in particular for any cracks on the centre-line of the frame in the zone corresponding to the hook fitting (inspection after removal of the winch hook attachment fitting on the forward frame)

Forward winch hook frame

Hook forward fitting

Bonding of the forward hook frame to the internal reinforcement

Internal reinforcements, bonding zones to the fuselage skin (if necessary, move any pneumatic hoses and electric cables to provide unrestricted access to the bonding zones).

If any damage or anomaly is found, forward a report of your findings to SN CENTRAIR and perform the mandatory and approved repairs before the next flight.
