**Airworthiness
Directive
1994-001/2**

L`Hotellier ball and socket connectors

L`Hotellier ball and socket connectors with locking cams (type .45; ratchet), if installed in sailplanes, powered sailplanes and aeroplanes

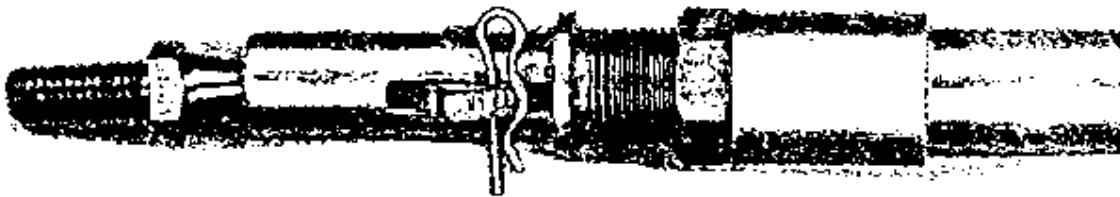
Section I

The socket is to be slid completely over the ball on the rod with the locking cam pulled back. During locking the locking cam moves back slightly so that in a correct connection the hole on the averted edge of the locking cam becomes visible.

The safety pin is to be inserted in this hole thus securing the ball and socket connector.

Attention:
By loading the connection full engagement of the ball is to be verified!

Warning:
Unsecured ball and socket connectors may open automatically in flight.

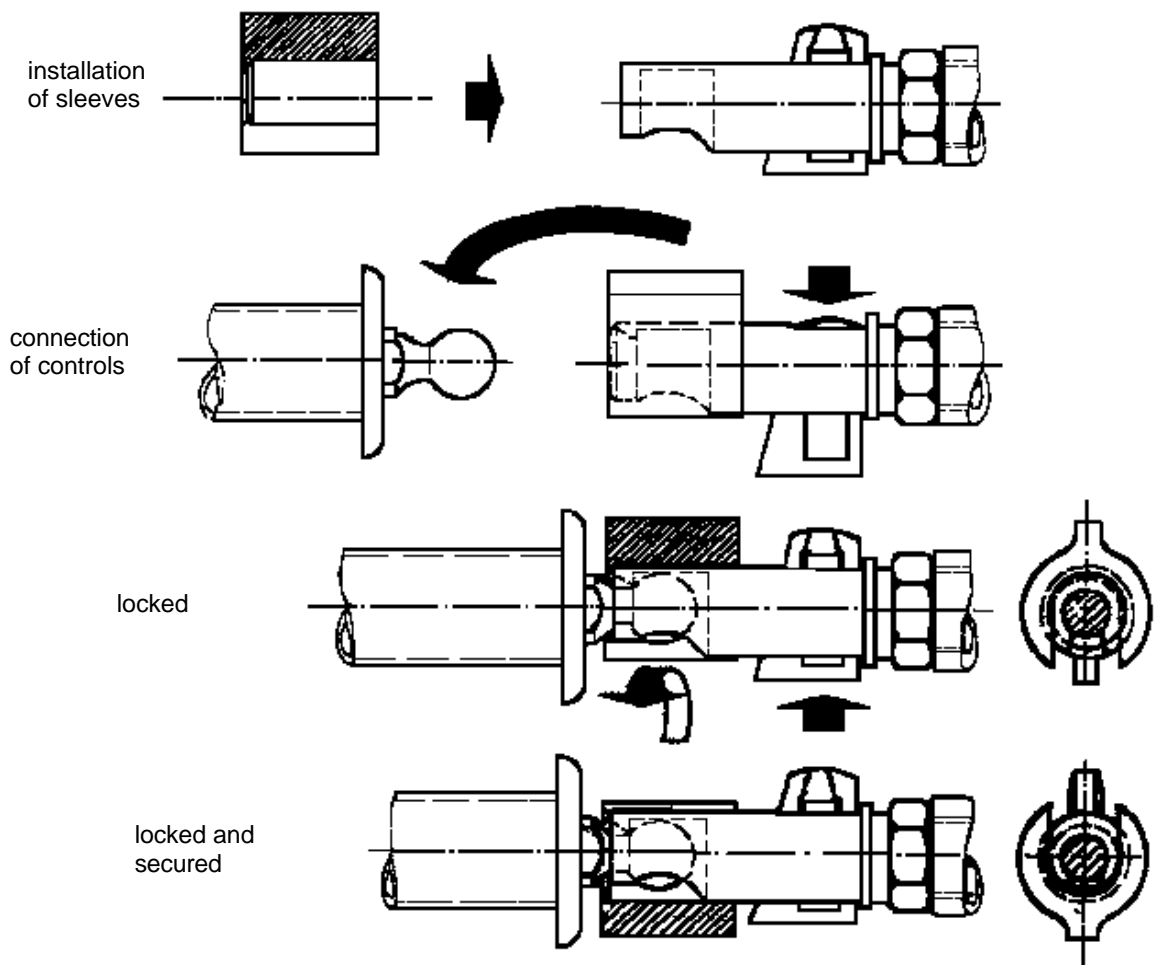
Section III

They may by no means be clipped radially onto the L'Hotellier ball and socket connector. Radial clipping (excessive opening of the sleeve) may lead to cracks or ruptures due to overstressing so that the sleeve cannot function properly any more.

For installation, the sleeves have to be slid axially onto the L'Hotellier ball and socket connectors.
