## British Gliding Association Aircraft Inspection

Number: 025/02/2002	Issue: 1
------------------------	-------------

- Subject:** Wing spar corrosion – continued airworthiness inspections
- Applicability:** Elliots of Newbury Olympia 460 series with metal reinforced main spars

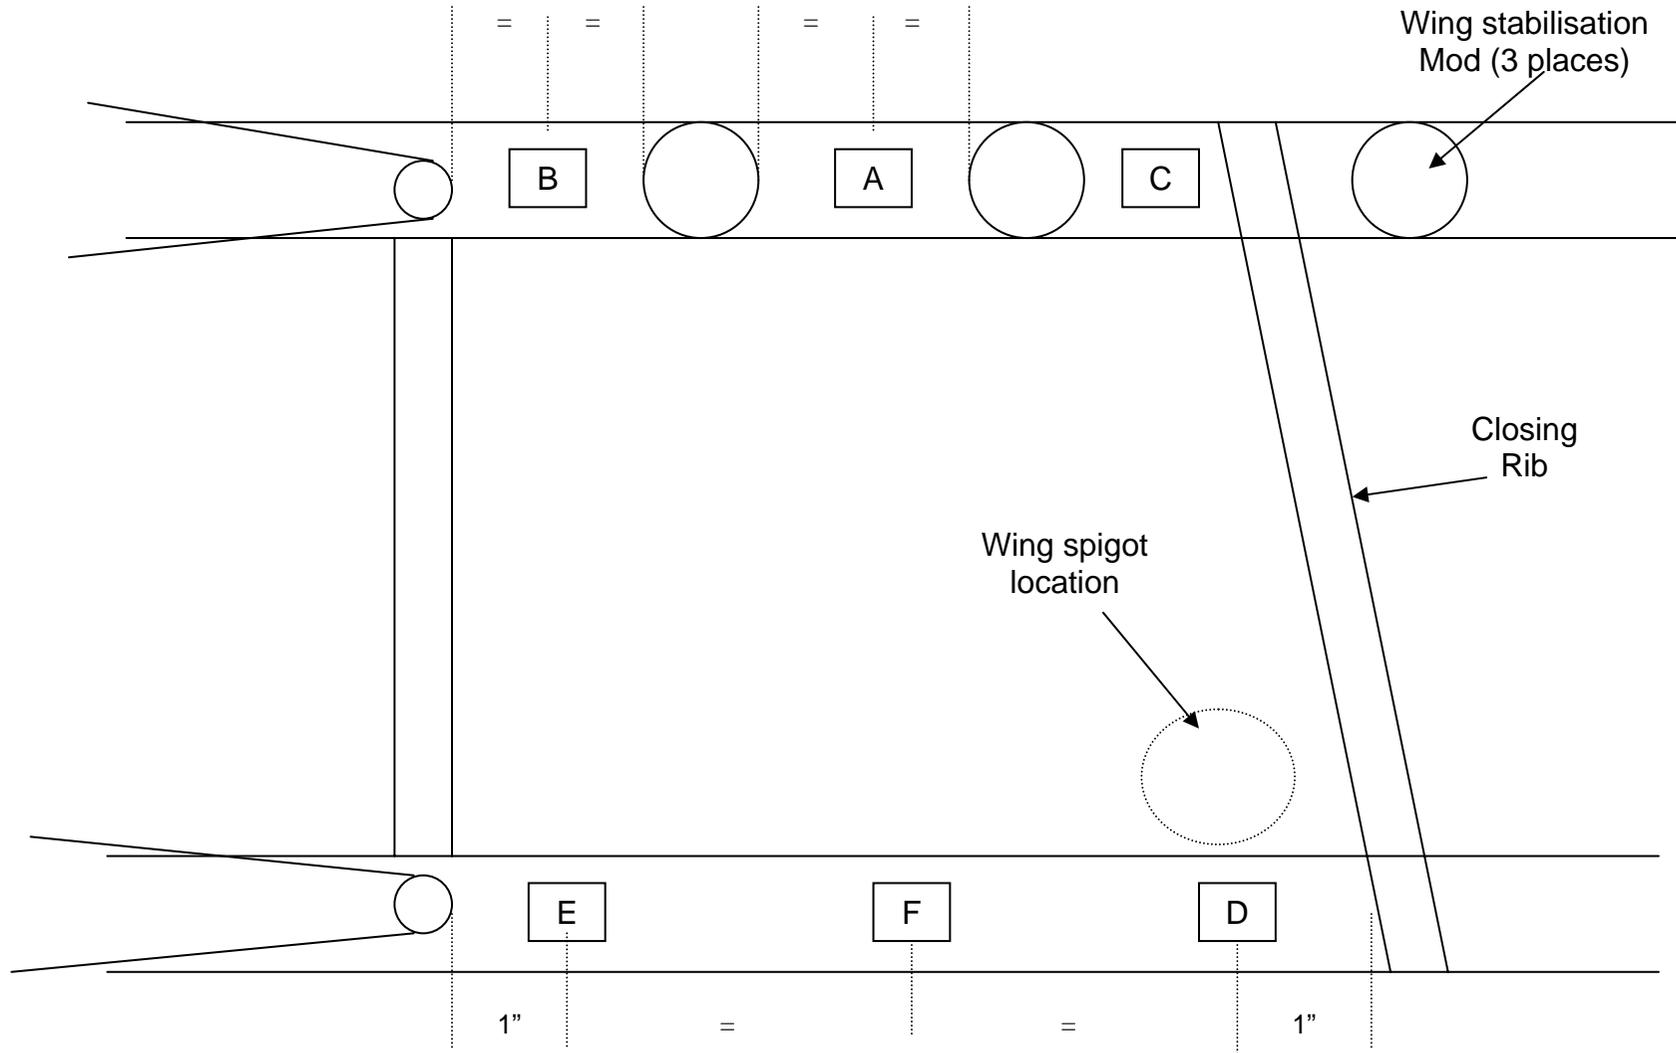
# Olympia 460 Wing measurement locations

7. With a micrometer (preferred) or a digital vernier gauge, measure the width of the spar booms, on the centre line of the boom at positions (A) to (F) as detailed below (see sketch for positions)

8. **Top boom** – position (A), between the two visible 2BA bolts of the mandatory modification.
  9. **Top boom** – position (B), between the inboard 2BA bolt and the joint plate.

10. **Top boom** – position (C), between the closing rib and the middle 2BA bolt of the mandatory modification. See note.
  11. **Lower boom** – position (D), 1 inch from the closing rib

12. **Lower boom** – position (E), 1 inch from the spar joint plate.
  13. **Lower boom** – position (F), at a point midway between point (D) & (E)
- Note:** depending on the layout of the stabilization modification it may not be possible to measure position (C) if this is the case a note should be made in the log book when recording the measurements
