British Gliding Association Aircraft Inspection

Number: 048/01/2010	Issue: 1
------------------------	-------------

Subject: Aft Tail Plane Attachment Fitting - Cracks

Applicability: PW-5 and PW-6

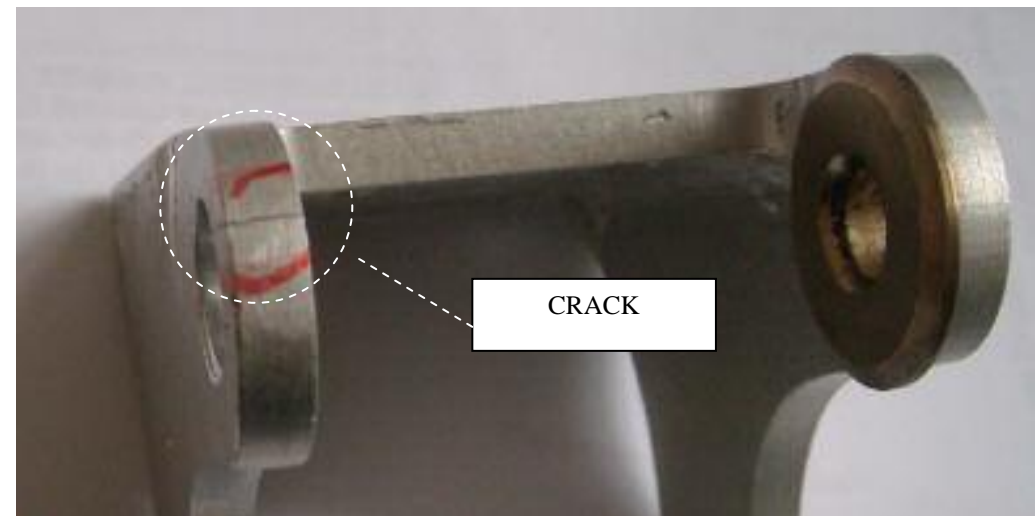
Reason: Cracked tail plane aft attachment fitting at location pin holes found on PW-6U sailplane. The PW-5 is included in the initial inspection as it is of similar design. This inspection is to assure continued airworthiness.

Instructions: With tail plane removed, carry out close visual inspection of the aft tail plane attachment fitting lugs and bronze bushes for cracks or other signs of distress.

This inspection may be carried out as pilot Maintenance, if any defects or queries are noted The inspection should be referred to a BGA Inspector. If cracked the aircraft may not fly.
