British Gliding Association Aircraft Inspection

Number: 050/05/2010	Issue: 1
------------------------	-------------

Subject: Slingsby Capstan Inspection guidelines for inspection of wing fittings

Applicability: Slingsby T49 Capstan

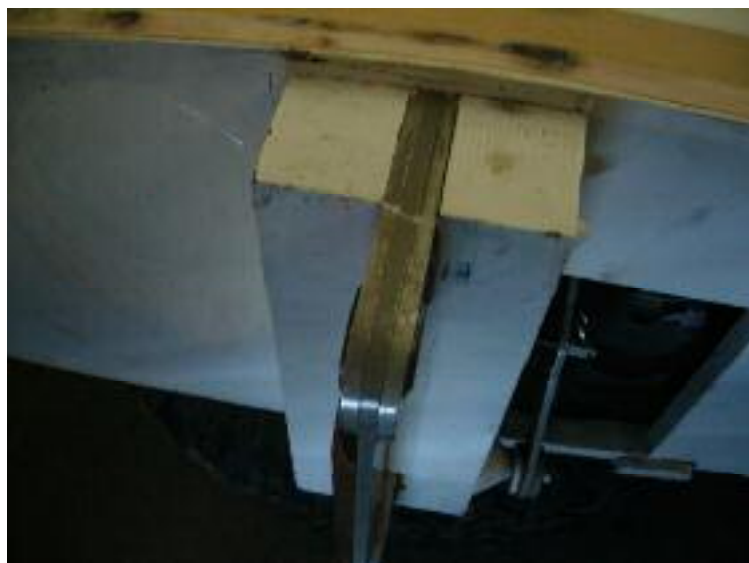
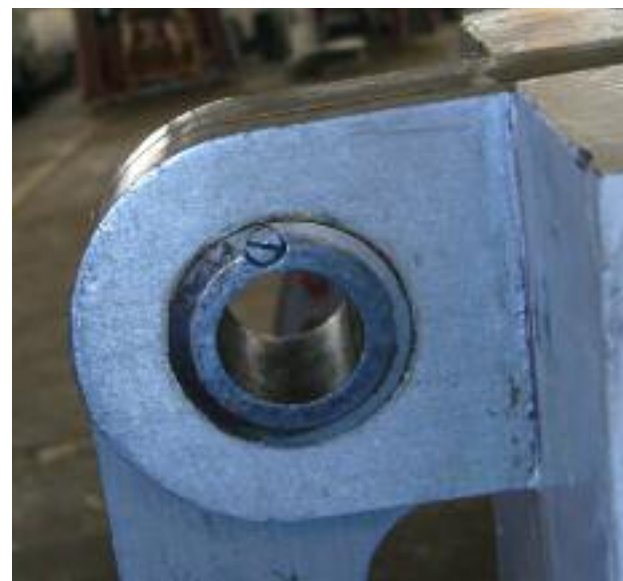
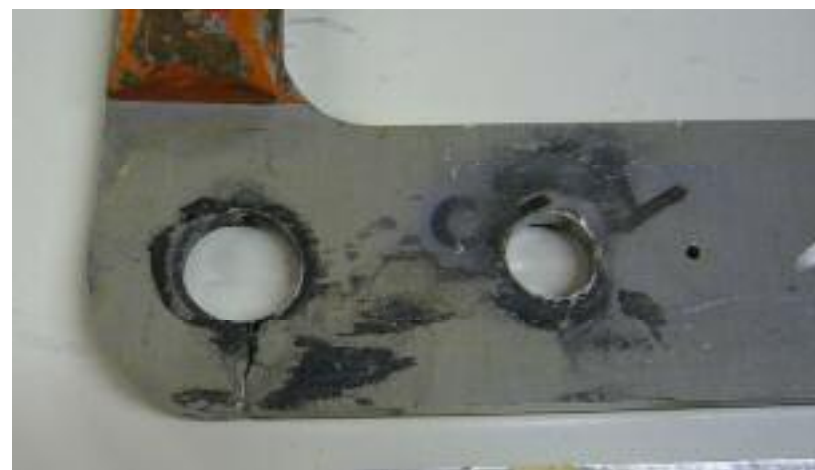
Reason: Crack found in centre lamination of wing main spar to fuselage attachment with loose bushing

3/ Visually inspect the fittings, (with the wings removed for better access), paying particular attention to the area around the lower main spar rigging pin, (as that is the fitting under tension in normal flight loads). On the damaged fitting found, the crack was visible on the centre of the 3 laminations of the wing part of the fitting, roughly opposite the centre-line of the rigging pin (i.e. the thinnest, most highly stressed part of the fitting)

Findings: there was about 30 thou movement between the steel bush and the aluminium plates in the wing half of the lower fitting, which should have been obvious, even if the crack had been missed.

1/ Remove both wing root fairing panels to expose the wing to fuselage fittings.

2/ With the wings still rigged to the fuselage, but the root fairing panels removed, have 2 assistants push upwards fairly hard on both wing tips, whilst watching (or feeling with a finger) the root fittings closely for any movement. There should be zero movement between the steel bush and the aluminium plates of either the wing half of the fitting, or the steel bush and aluminium plates of the fuselage half of the fittings. There may be a small amount of movement between the rigging pin and the steel bush, which is normal wear and tear, but zero movement between the steel bushes and aluminium plates. Look at both top and bottom fittings, but pay particular attention to the lower fittings.
