1.0 MORE AIRWORTHINESS 'AGGRO'

Airworthiness Directive

LTA-No. 75-168 Glasflügel Affected sailplane models:

TECHNISCHE MITTEILUNG
TECHNICAL NOTE

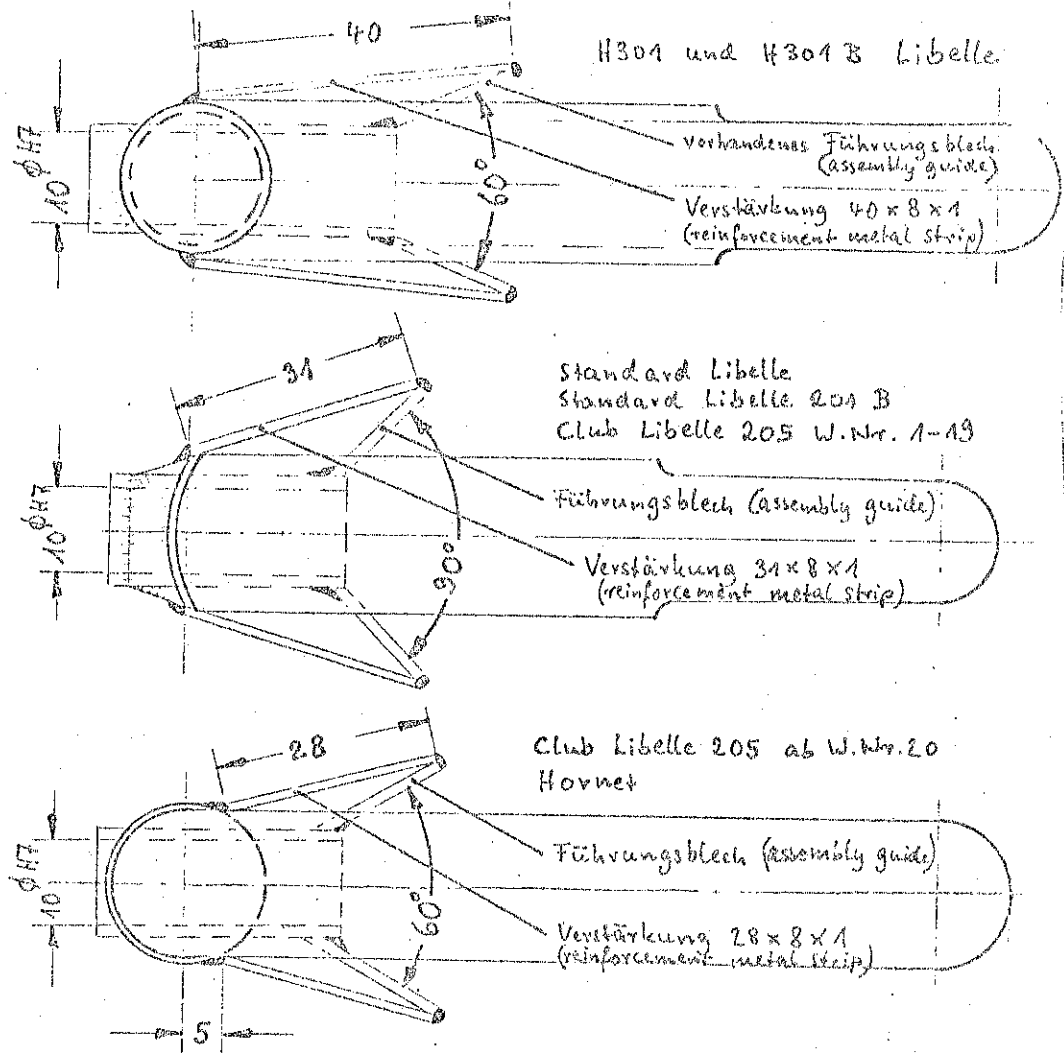
Reason: Careless assembly of the tailplane caused damaged elevator assembly guides, resulting in a possible improper assembly of the tailplane and loss of elevator control.

Method: 1. With a 5 x powered magnifier visually inspect the assembly guides for distortion, bending and/or for cracks in the welded seam.
 2. If damage is found replace the bracket immediately with a bracket to be reinforced according to method 4.
 3. If no damage is found replace the bracket with a bracket to be reinforced according to method 4 before the date quoted in "Urgency".
 4. Weld in two sheet metal strips according to the following drawings to reinforce both guides. (see next page)
