BRITISH GLIDING ASSOCIATION

TECHNICAL NEWS-SHEET 2/3/4/76

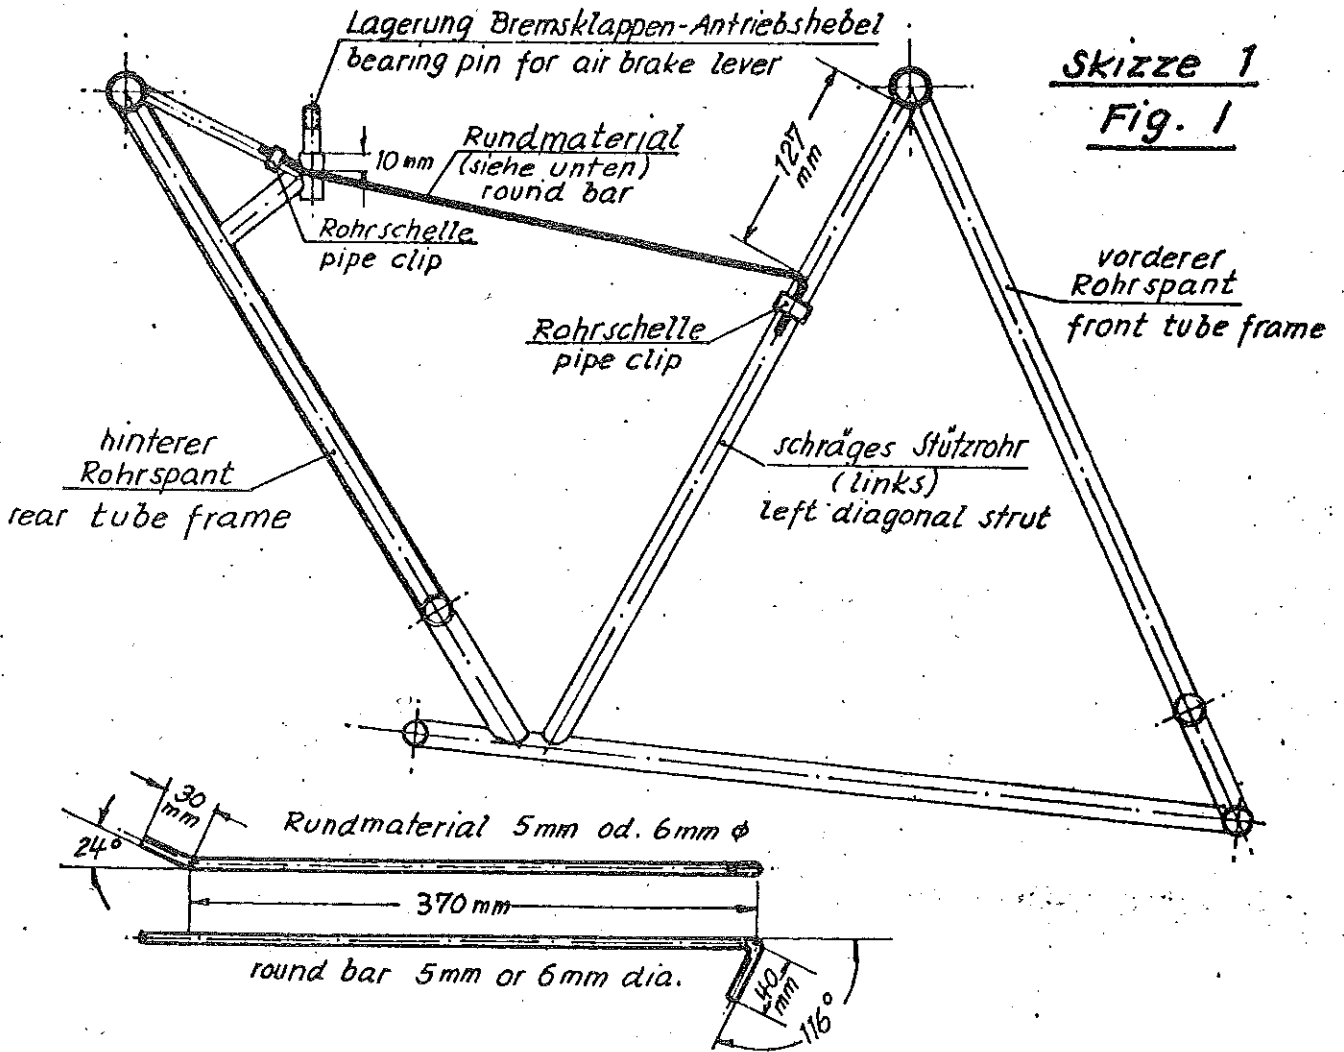
Skizze 1  
Fig. 1

The intermediate rod may cause jamming of the aileron control, if the left aileron push rod is not connected.

Install in accordance with Technical Note a safety brace in the fuselage frame between the airbrake lever bearing and the left diagonal strut.

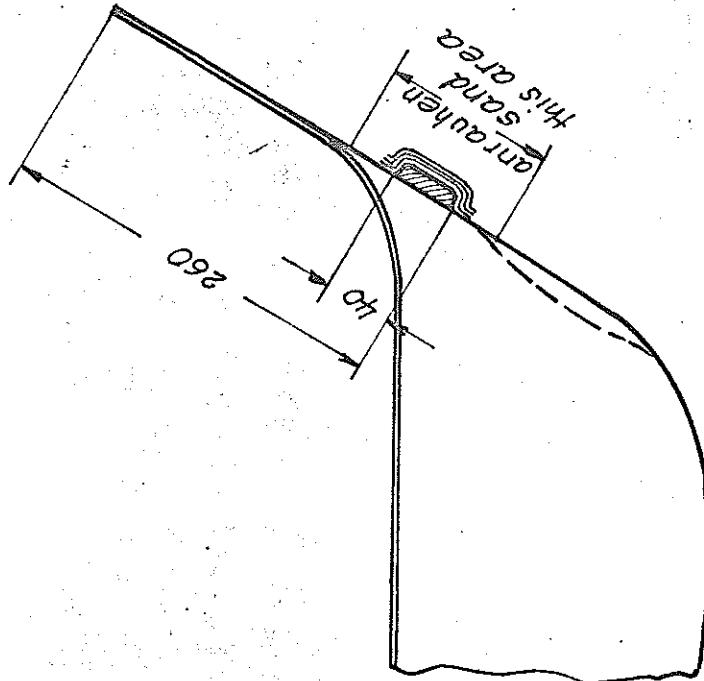
Versteifung der Sitzwanne  
Reinforcement of the seat

Possible jamming of the tow release lever due to warping of the seat.

1. Unless already accomplished, reinforce the seat in accordance with the instructions of the manufacturer.
2. Perform a functional test.

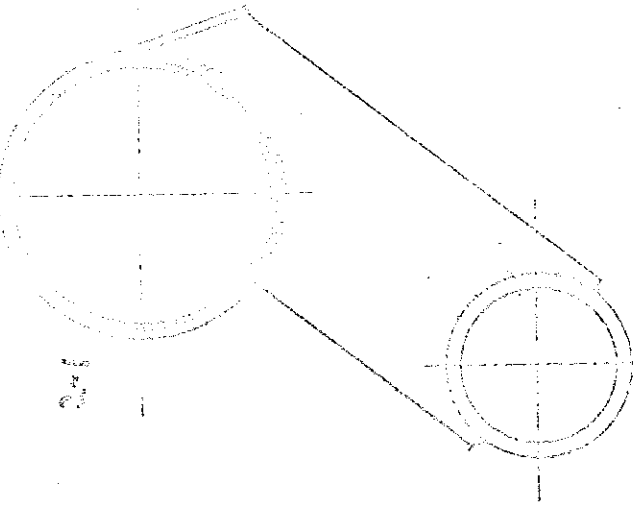
Abb 2

Blech 1 mm vollständig  
 um das Halbrohr gelegt

6. If no cracks are observed, and, furthermore, if the cover plate completely surrounds the tube, then covering and painting are to be refitted and the aileron reassembled.

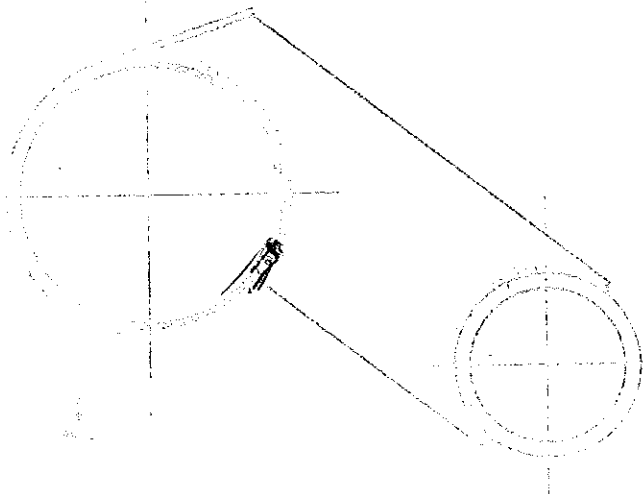
Abb 1

Blech 1 mm nicht vollständig  
 um das Halbrohr gelegt

4. If cracks are observed or if the cover plate does not completely surround the the spar tube, then the reinforcement illustrated in Fig: 3 is to be fitted. (Material: Sheet metal 1 mm 1.7214.4).

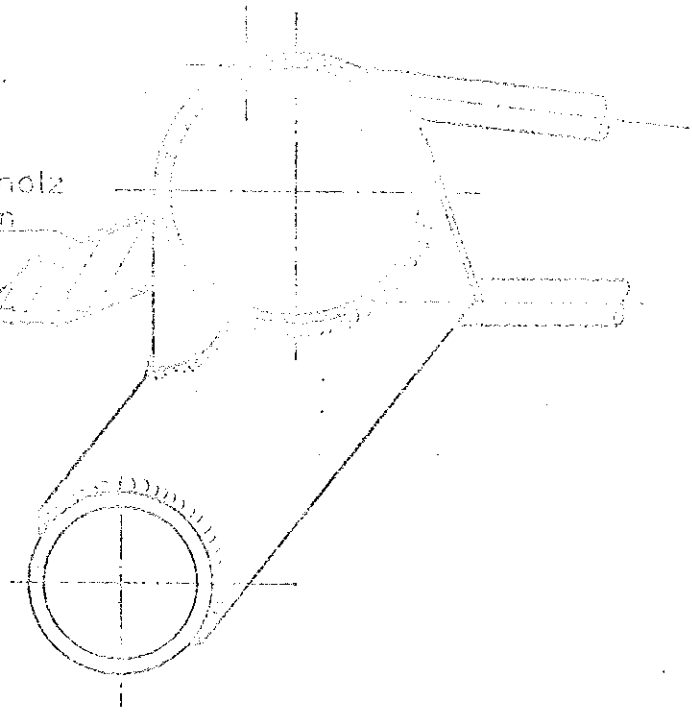
Abb. 4

- ↳ 1 Sperrholz 1mm
- ↳ 2 Frisekanteleiste

↳ 3 Schnittstellen in der Frisekanteleiste

Before fitting the reinforcement, the frise edge bar in the neighbourhood of the operating lever is to be removed (see Fig: 4). The paint beside the welded seams is to be removed and the surface cleaned. Cracks are to be welded. The reinforcement must be clean when fitted. It must only be autogen welded with welding wire G 1 DIN 8554.

5. Finally the frise edge bar is reassembled as shewn in Fig: 4, and the covering and paint replaced.
