BRITISH GLIDING ASSOCIATION

TECHNICAL NEWS SHEET 5/6/7/76.

1. AIRWORTHINESS 'AGGRO'.

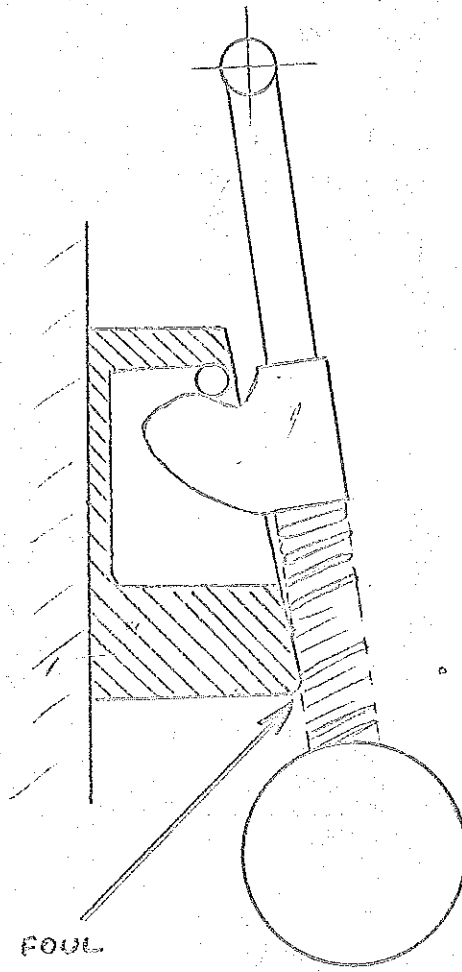
ASK 18 - CANOPY LOCK

The enclosed sketch from RAF Germany G.C. highlights an obvious malfunction that has already produced one in-flight incident.

PREVENTING  
FULL ENGAGEMENT.
