"B.G.A. Technical Committee"
Technical Newsheet 3/4/77

TNS 3/4/77

Ref: TNS/3/77.

Rudder Cable Modifications at Rudder Pedals.

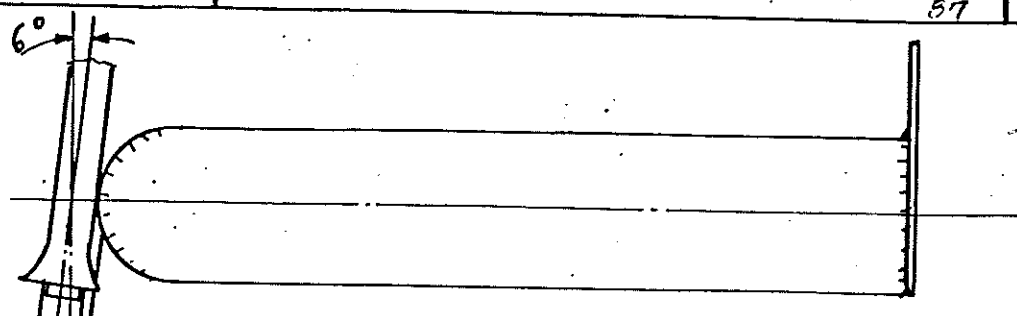
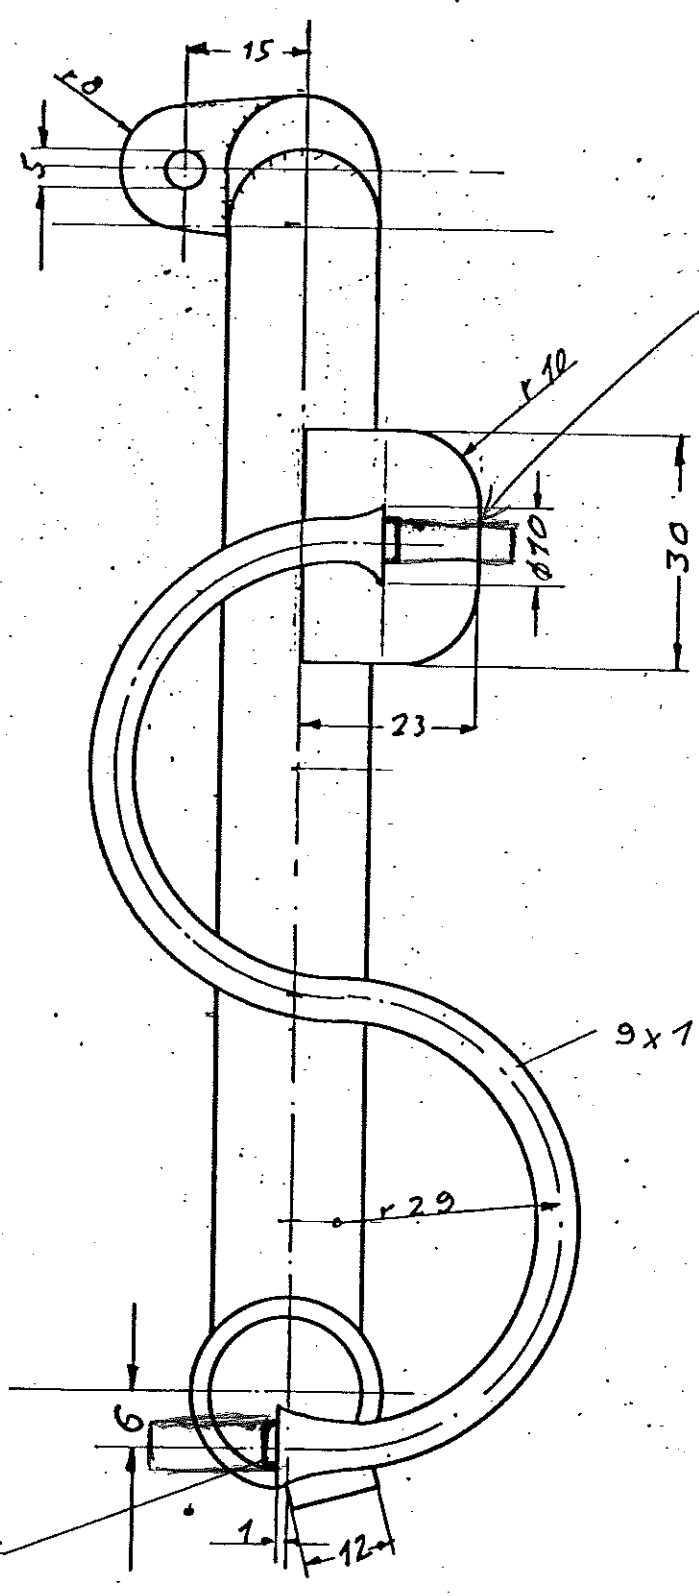
D.G. 100

Glaser-Dirks have advised the B.G.A. in a letter dated 8/3/77, that a modification to fit nylon tubes in the "S" type conduits, has been introduced.

Before U.K. based DG100s are issued with B.G.A. Certificates of Airworthiness, the B.G.A. Technical Committee require this modification to be embodied.
