PART 1 AIRWORTHINESS 'AGGRO' (GLIDERS).

Please add these items to the 1977 list of Mandatory Mods and Inspections.

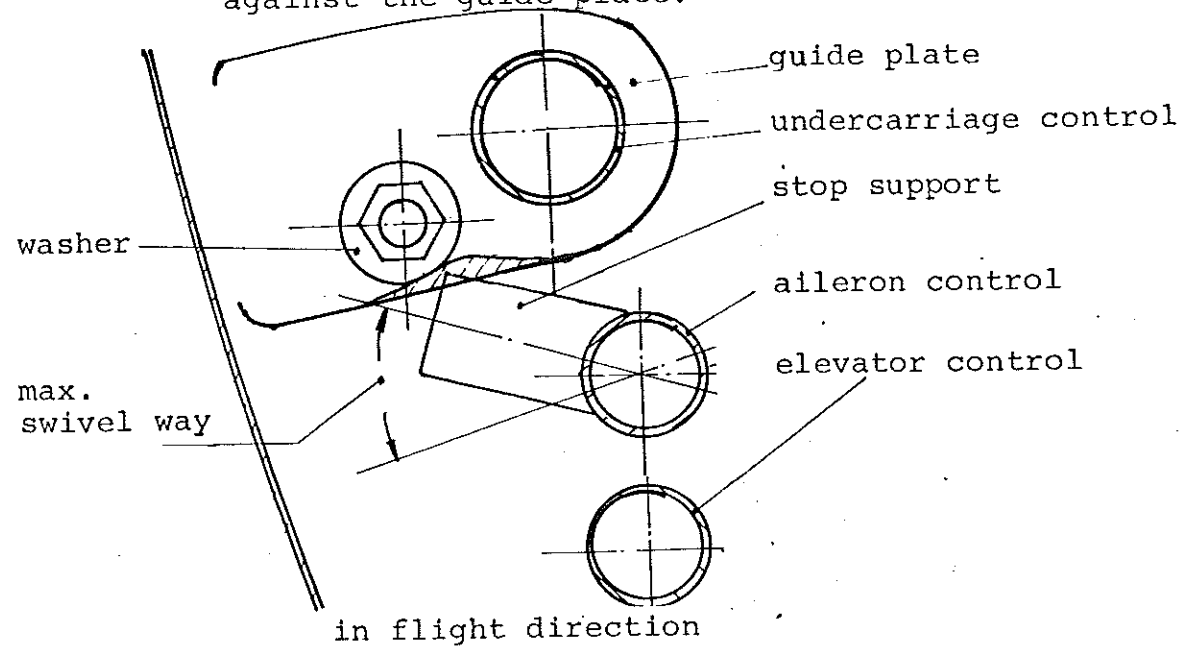
TN 301-4-2 (attached) requires inspection of aileron controls in the cockpit for foul between guide plate and undercarriage control. Inspection to be carried out as soon as possible.

Reason: If the guide plate of the under carriage control push rod is not filed out enough, the stop support of the aileron control push rod may butt against it.
 (Pushrod turned upwards to the most unfavorable position, see figure)
 This might happen during flight conditions under negativ -g- loads.

- Instructions:**
1. Remove the left side covering in the cockpit.
 2. Turn the aileron control pushrod upwards (see figure) and check the stop support for butting against the guide plate.

3. If the stop support push^s against the hatched region of the guide plate, file out this region. If necessary change the installed washer (outside diameter 18 mm) against one with outside diameter 12 mm. (6,4 DIN 125).
4. clean the area of filings
5. reinstall the side covering
6. Book the executed work in your log book.

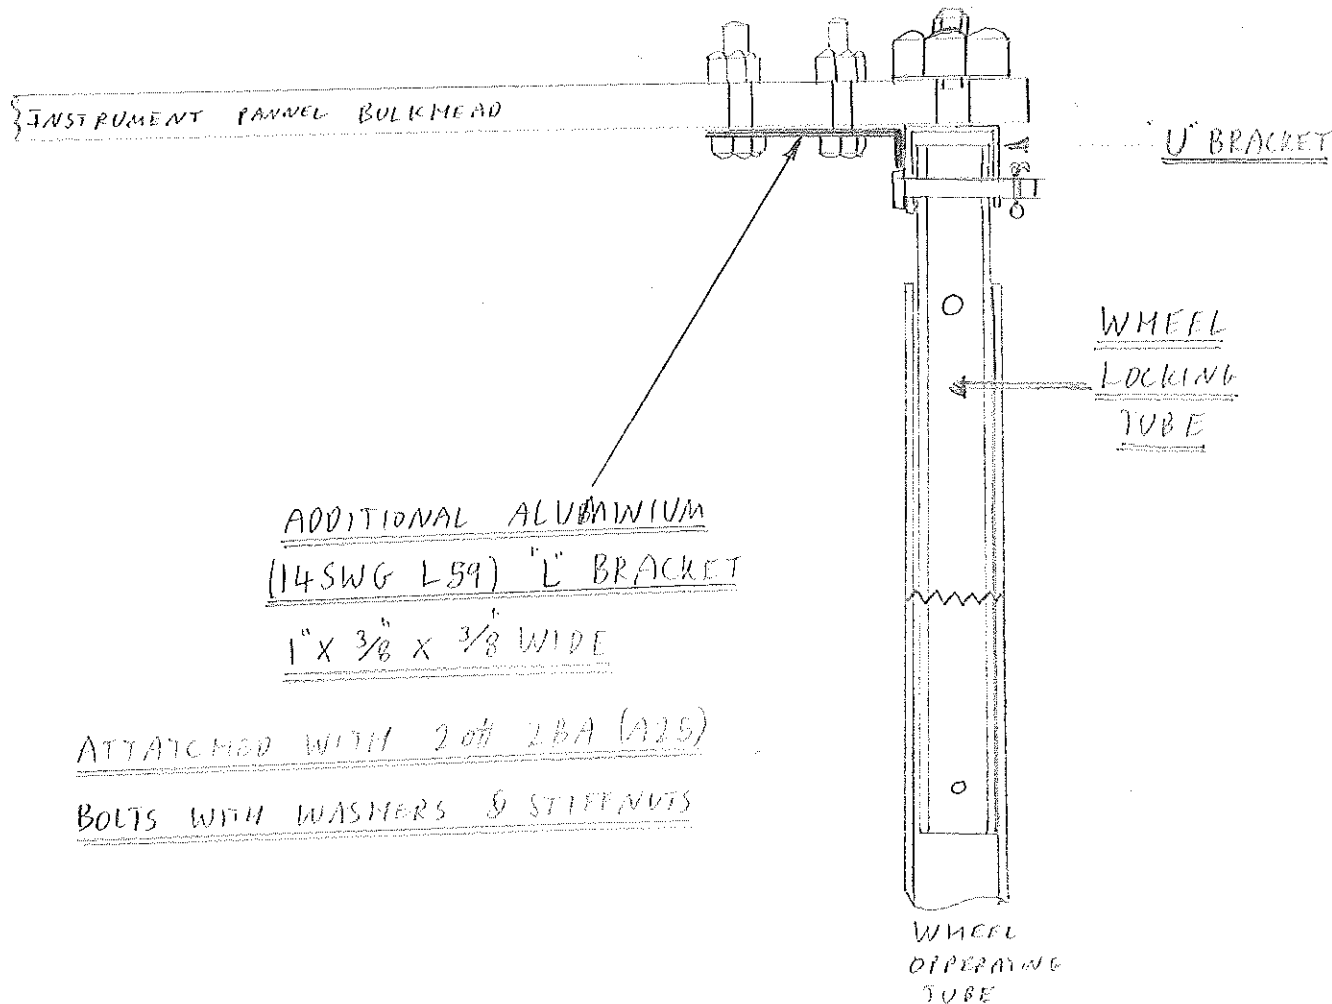
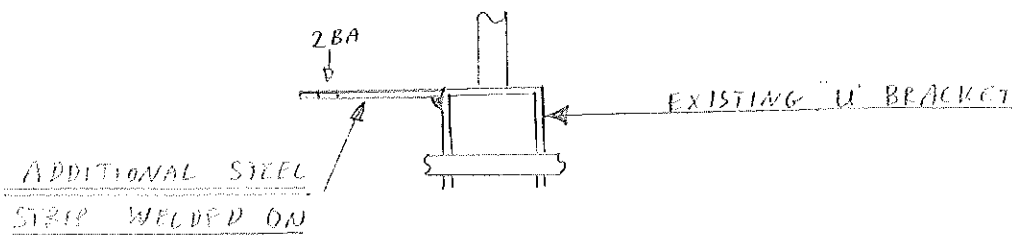
ADDITIONAL "L" BRACKET TO PREVENT THE WHEEL LOCKING

a) Lock failure due to rotation of the wheel locking shaft. Ref sketch by Tim Macfadyen.

The Bracket is mounted hard up against a flat on the locking tube end.

ATTACHED WITH 20# LBA (A25)
BOLTS WITH WASHERS & STIFFNUTS

A neater engineering solution would be to weld a $\frac{3}{4}$ " x $\frac{3}{8}$ " x 16 SWG
steel strip to the "U" bracket that is pinned to the locking tube end
and bolt this to the bulkhead.

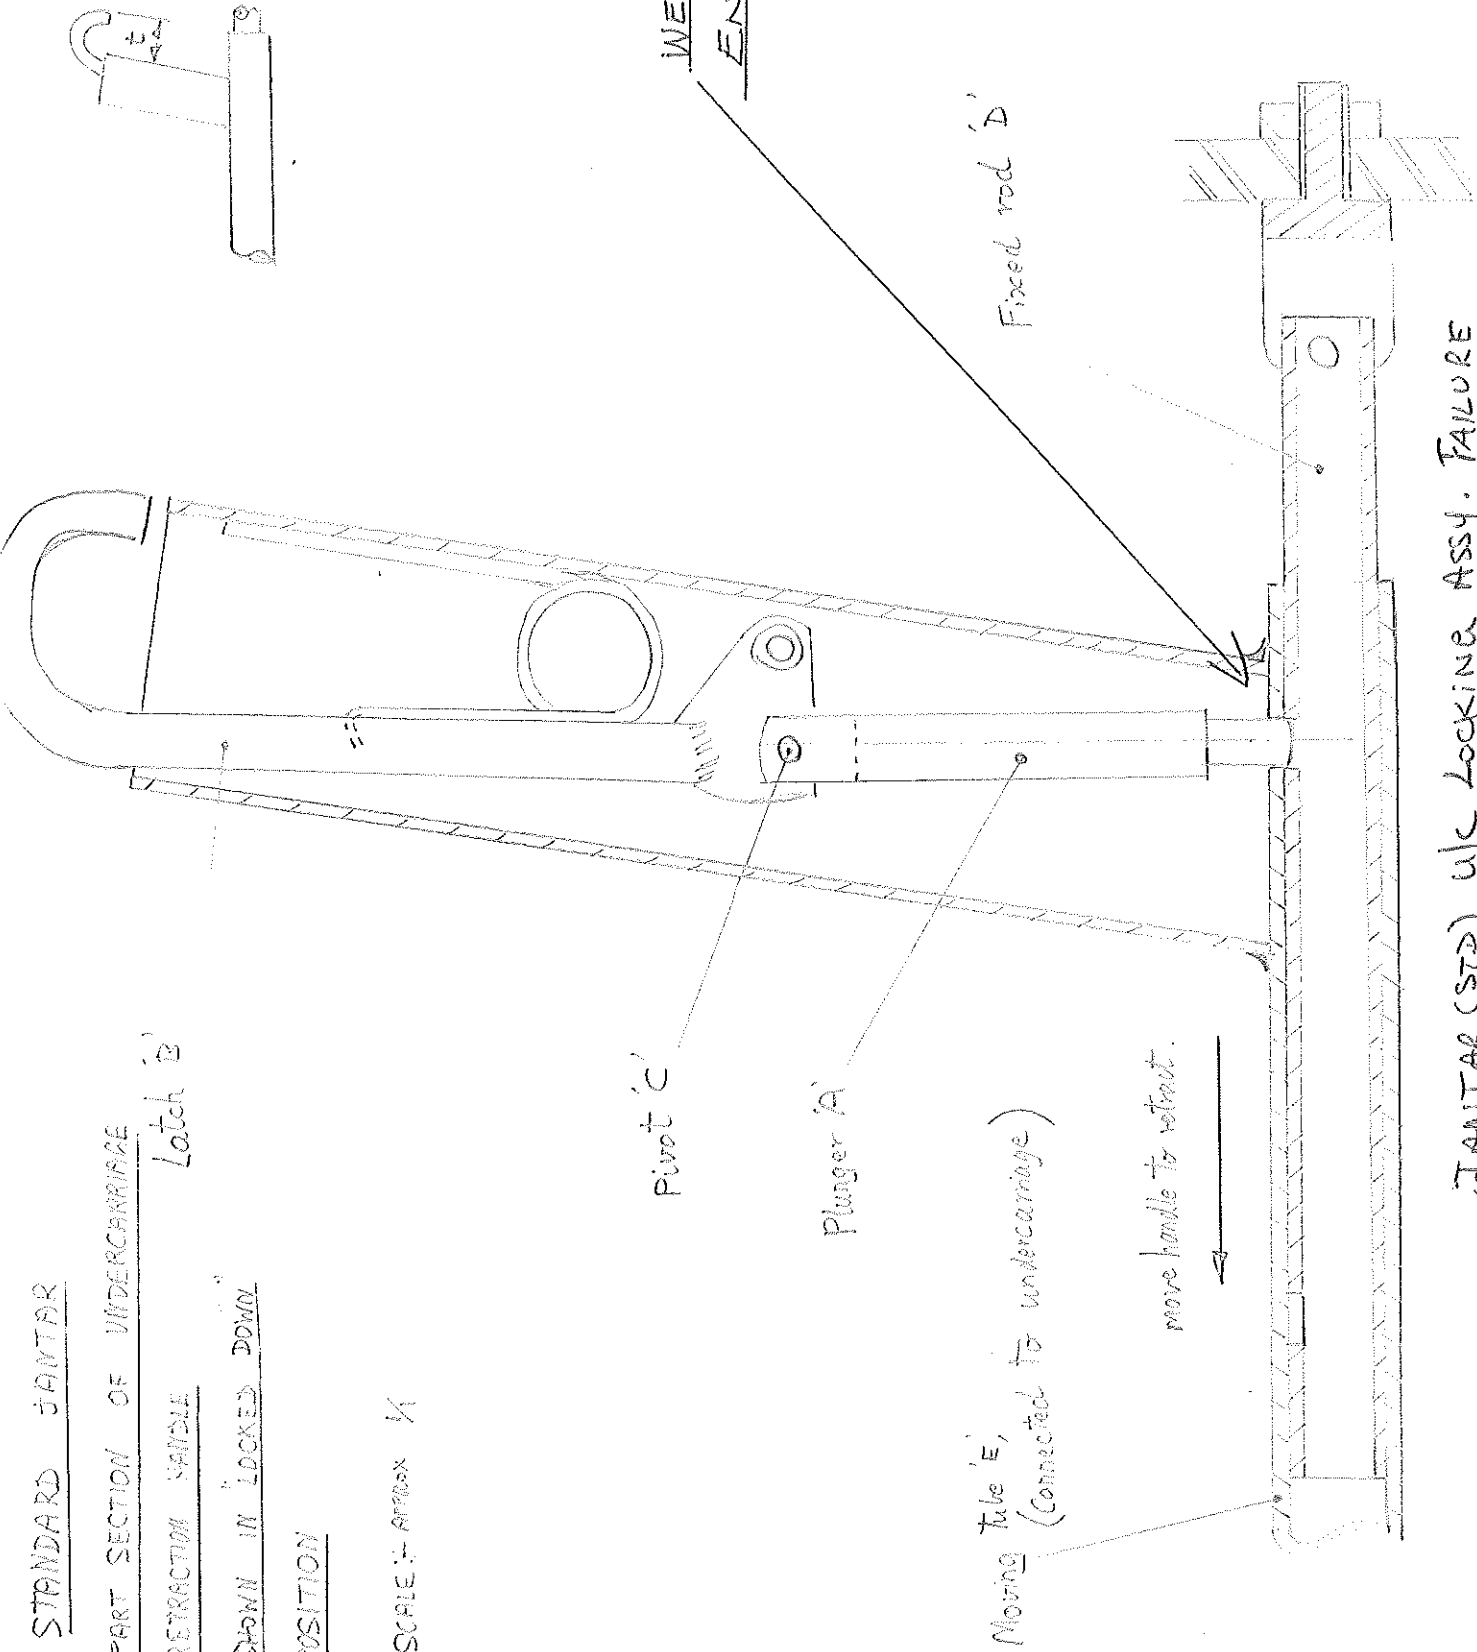
JANTAR (STD) U/C LOCKING ASSY. FAILURE TO LOCK.

b) Lock failure due to wear etc on locking plunger - Ref sketch by R. Blackmore.

WEAR & LACK OF ENGAGEMENT

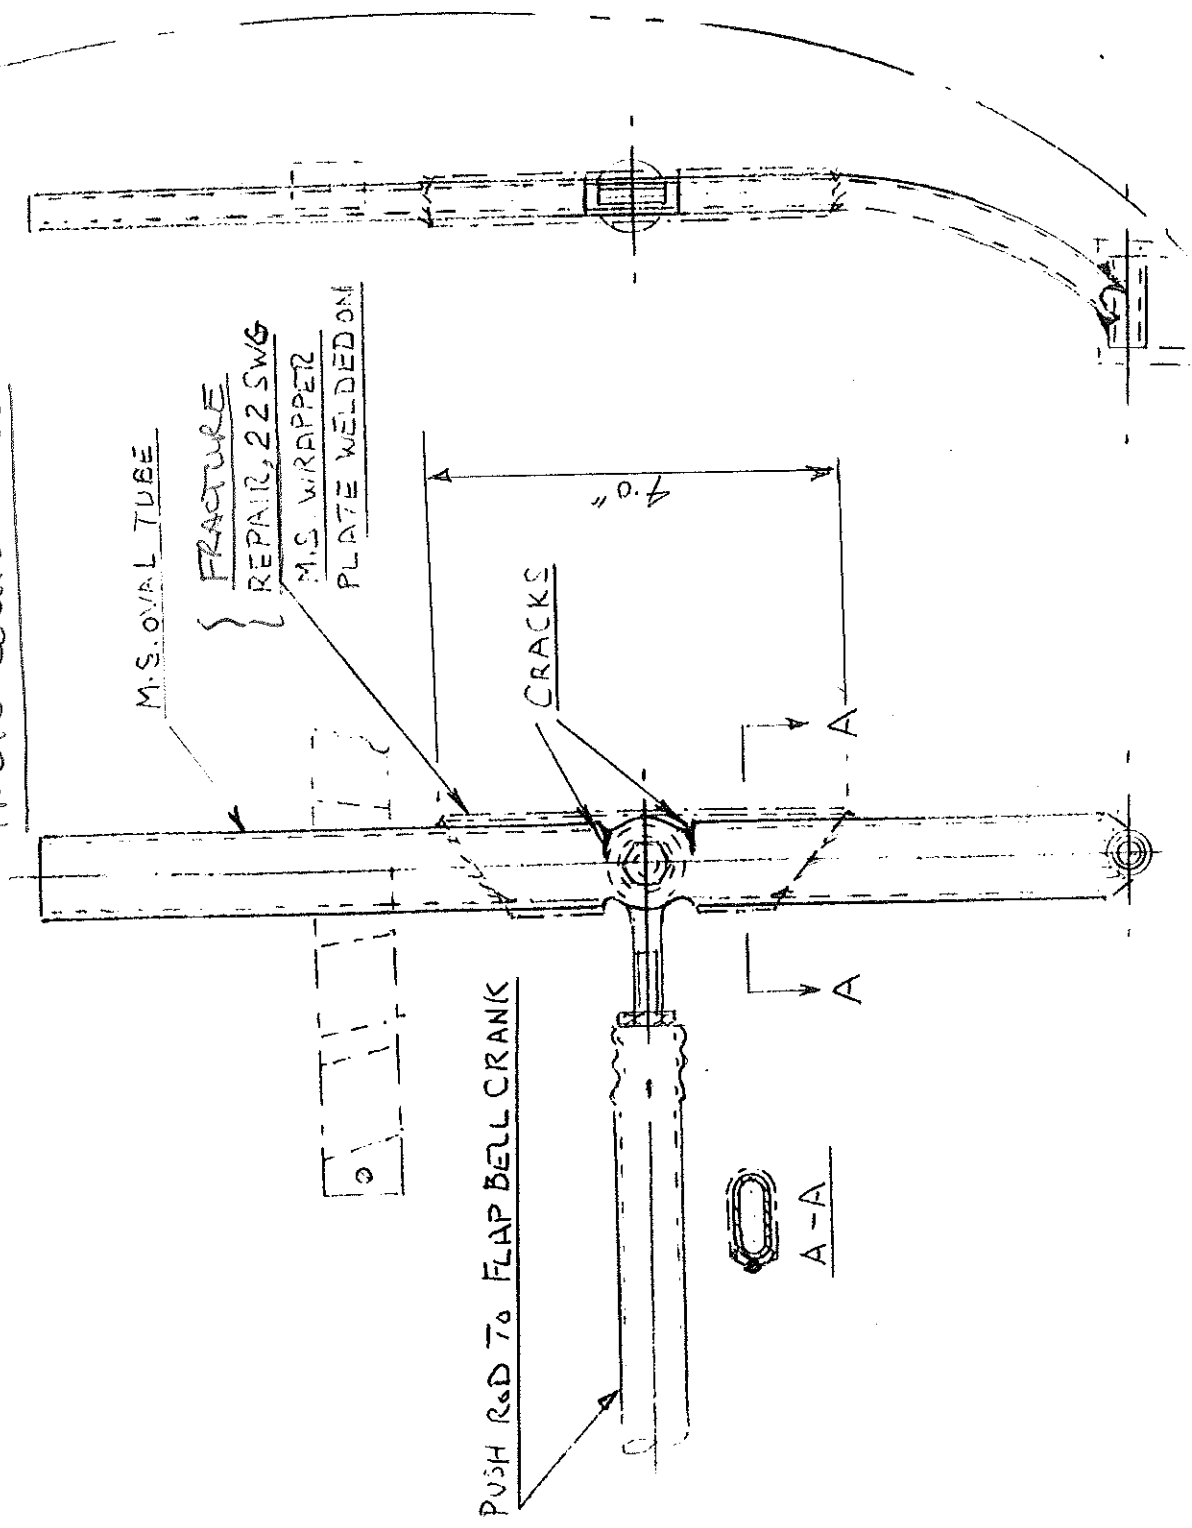
JANTAR I (SZD 38A) FLAP OPERATING LEVER

Flap operating lever fractures. Attached sketch by P. Davis (Lasham) gives details of fracture/repair of pilot's flap operating lever.

FRACTURE

CRACKS

REPAIR, 22 SWG

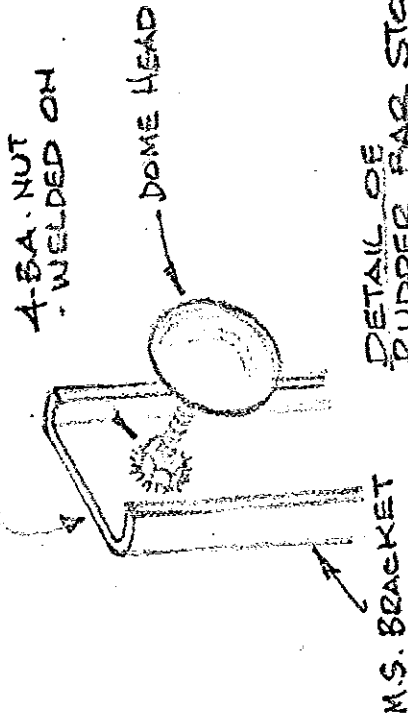
RUDDER BAR STOPS
ON T.49 AIRCRAFT.

Rudder Pedal Stops - Bent, allowing rudder to lock-over. Ref sketch from Len Morris (Swindon G.C.)

RUDDER BAR
STOP BENT

RUDDER
BAR WEDGED
UNDER STOP

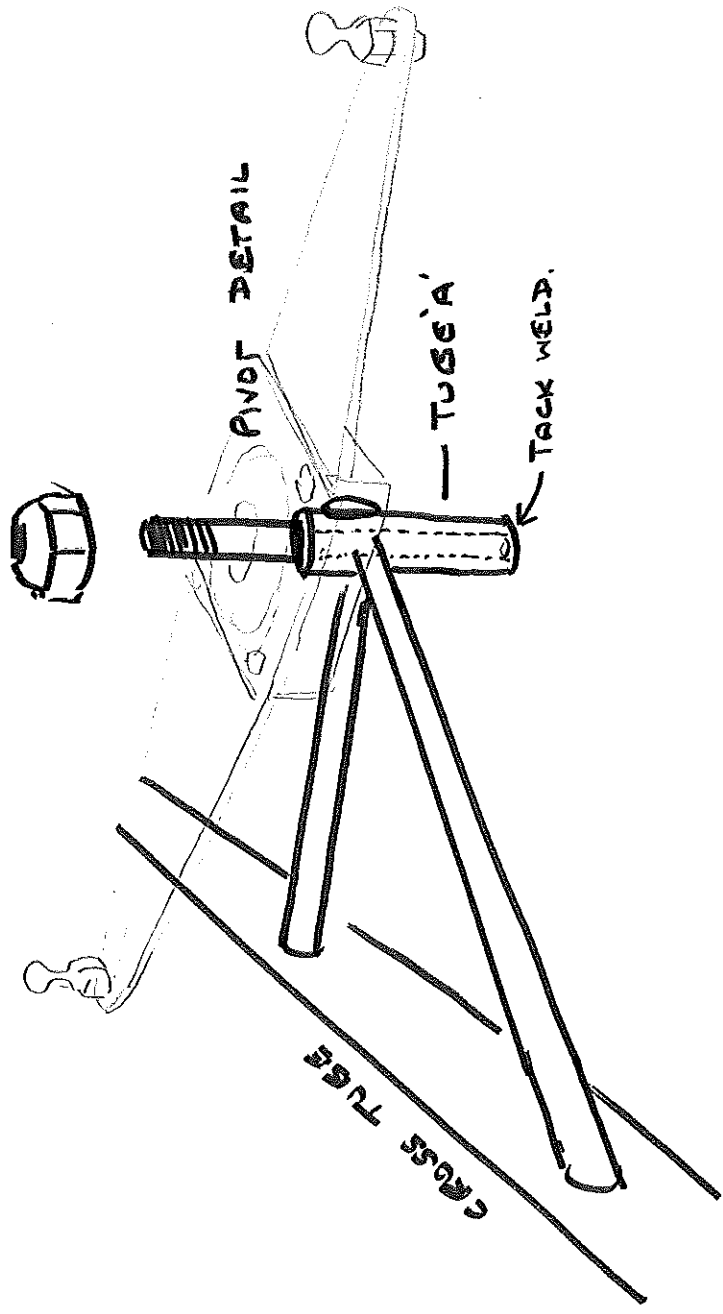
OPEN CIRRUS VTC.
AIR BRAKE QUADRANT.

Failure of air brake quadrant pivot. Tack weld failure of stud as indicated in sketch by J. S. Riddock - N.Weald.

- 1/ Quadrant found loose, in up/down plane.
- 2/ Checked nut (self locking), then the stud became free in tube A.
- 3/ Dipped stud out, & find tack weld was once securing stud, as side fixing through tube A was NBS.
- 4/ Cleaned out tube A and inserted bolt as temporary measure.
- 5/ Stud inserted, as can be seen it is bent?
- 6/ Any admin please! - yes - FIXIT! Rhv

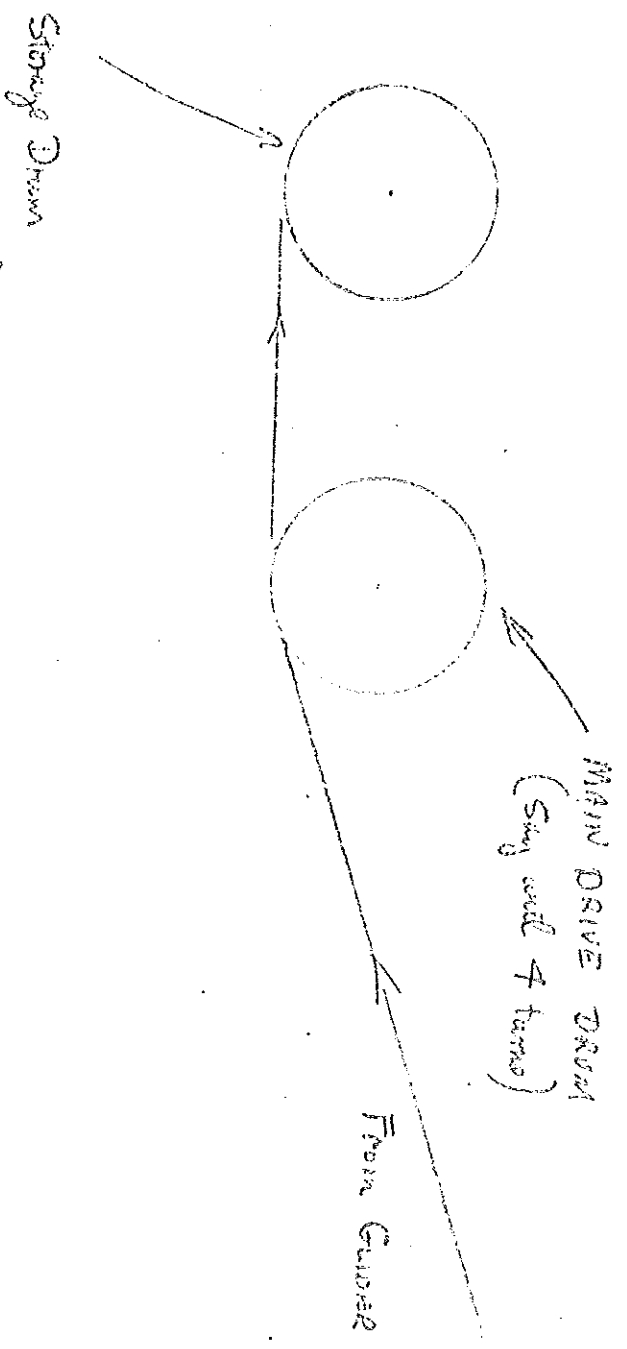
2 Drum Blower (PAPERFIL)

Drum - Parafil has a much higher elasticity than steel wires and, therefore, considerable crushing pressures can develop on multi layer drums. This can cause damage of the lower layers and a breakdown of the protective sheath. Parafil Ropes have a bigger cross section than normal steel wire cables and therefore the drum capacity must be increased accordingly (this created problems on the ATC winch at Swanton Morley). It would seem that there are two possible solutions to these problems:

- 1) Limited torque
- 2) Surface speed of storage layer would be slightly slower than blower speed if Main Drum because of elastic recovery of rope under lower tension

- a) A large diameter narrow drum winch.
- b) A two drum winch where the rope is stored on a low tension drum behind the main winching drum.

The storage drum would have to be driven by device which limited the torque and therefore the tension on the Parafil Rope. See sketch attached to this letter. Winches of this type have been developed for industrial and shipping uses, although I am not aware of any winch that is suitable size for Glider Launching applications.
