BGA TECHNICAL COMMITTEE

Technical Newsheet. TNS2/3/78.

PART 1. AIRWORTHINESS "AGGRO". (Please add to the 1978 "Pink" Compendium).

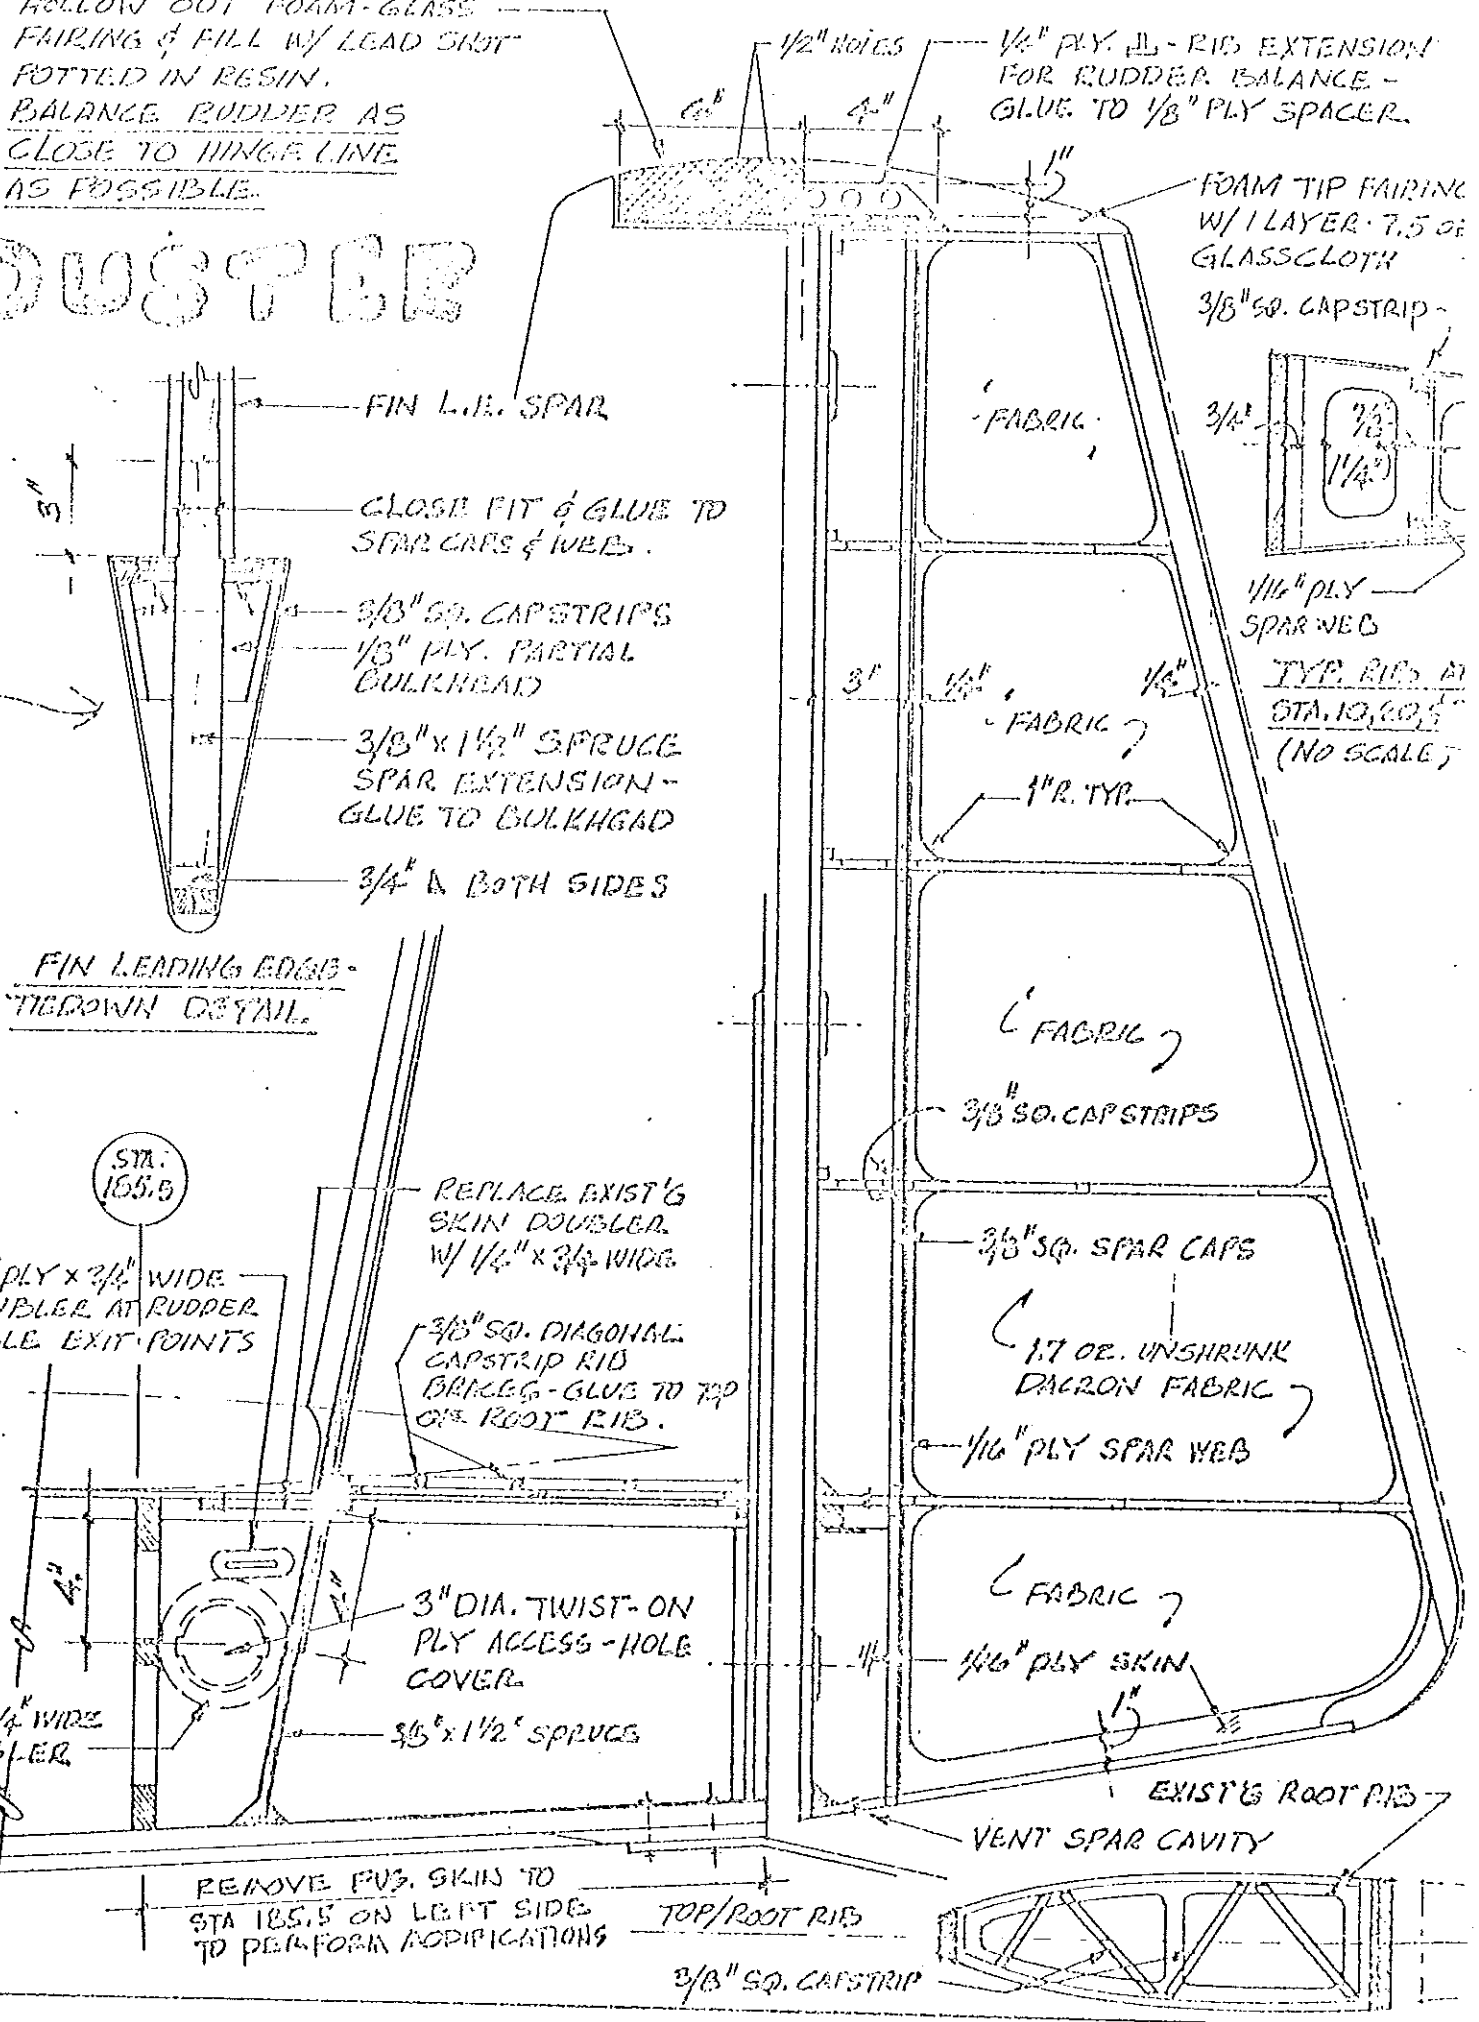
MANDATORY FIN & RUDDER MODIFICATION - Jan 12-78 H.E. PIER

A structural weakness in the fin attachment has come to light which makes the fin susceptible to damage in case of hard landing loads or dropping of the tail during ground-handling. Skin delamination or glue separation between the fuselage deck and the fin root-rib is possible which can in turn cause catastrophic vertical tail flutter at speeds as low as 60 knots. The structural damage as described may be visible only after very close inspection, and all owners who are presently flying their DUSTERS are advised to make an immediate inspection of fin root-rib area.

- A. Install a partial bulkhead which ties the fin leading-edge into the fuselage structure. (see enclosed dwg)
- B. Replace skin doubler at elevator control-horn slot in fuselage deck with 1/4"x3/4" wide doubler, extending it behind the fin leading-edge extension.
- C. Install access-hole cover (smaller and relocated downward) on left side of fuselage aft of sta. 185.5 .
- D. Install 1/8"x3/4" wide skin doubler inside fuselage skins at rudder cable exit points.
- E. Install 3/8" capstrip bracing on top side of fin root-rib.
- F. Replace rudder with redesigned fabric-covered and balanced unit.
- G. Lower  $V_{ne}$  to 100 knots.

The above modifications will necessitate removal of the left-side fuselage skin aft of sta. 185.5 . A standard (ten x t) scarf joint is called for, centered over the bulkhead at sta. 185.5, so take care when removing the discarded skin piece that the area to be scarfed remains intact on the fuselage.

*DUSTER PLANS HAVE BEEN CHANGED TO SHOW FIN LEADING EDGE WEB AND CAP STRIPS RUNNING FULL DEPTH INTO FUSELAGE TO FORM A LEADING EDGE SPAR-WEB/BULKHEAD.*

HOLLOW OUT FOAM-GLASS FAIRING & FILL W/ LEAD SHOT POTTED IN RESIN. BALANCE RUDDER AS CLOSE TO HINGE LINE AS POSSIBLE.

FIN LEADING EDGES - TIEDOWN DETAIL.

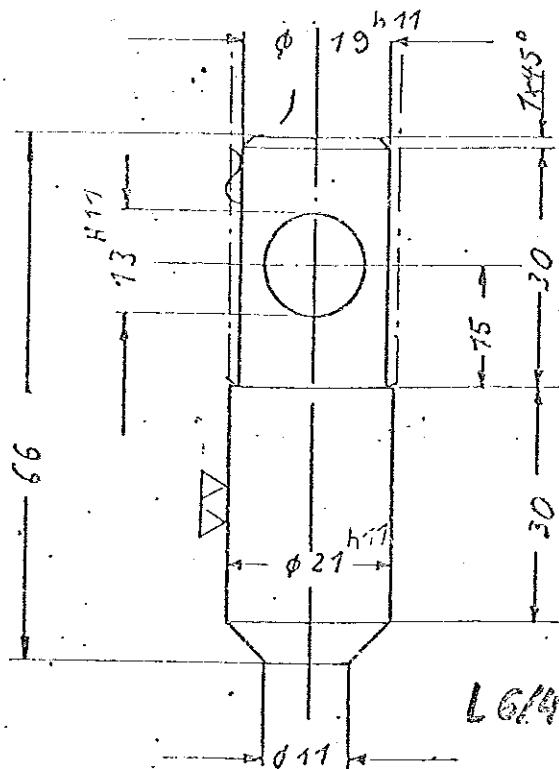
Subject: Assembly of the all flying tailplane  
 Effectivity: DG-100 all W.Nrs. (not DG-100 G)  
 Accomplishment: Till 30. May 1978  
 Reason: Caused by an incomplete assembly of the tailplane a DG-100 crashed.  
 To prevent a repetition a modification was worked out so that an incomplete assembly is to be seen from far away.  
 Instructions: 1.) A plastic pin is to be glued into the main fitting of the all flying tailplane (see flight manual page 18 a).

- Degrease with acetone: Inside of tubular part of all flying tailplane fitting and cylindrical part L 6/4
  - Scour with 100 grit sandpaper: Inside of tubular part and cylindrical part L 6/4 at 19 mm  $\phi$ .
  - Apply metal adhesive Araldit AW 106 with hardener HV 953 U or similar on cylindrical part outside and inside tube, push part L 6/4 into tubular part. Remove excess glue. The bore for the pip-pin must remain clean and open.
  - Allow 20 hrs at min. 20<sup>o</sup> C. to cure.
- Change Service Manual page 18 article 5 by hand: "The cockpit trim control should be in the aft position."
  - Add on Page 2 Ammendments: "Assembly of the all flying tailplane, page 18."
