British Gliding Association

TNS 10/11/12 /77

- PART I Airworthiness Aggro - (Please add to mandatory list)
- 1.1. ASK. 16 (Motor glider) AD 77-234 and Schleicher Tech. Note 8 requires modification to WHEEL to prevent possible breakage of bolts; (copy herewith).

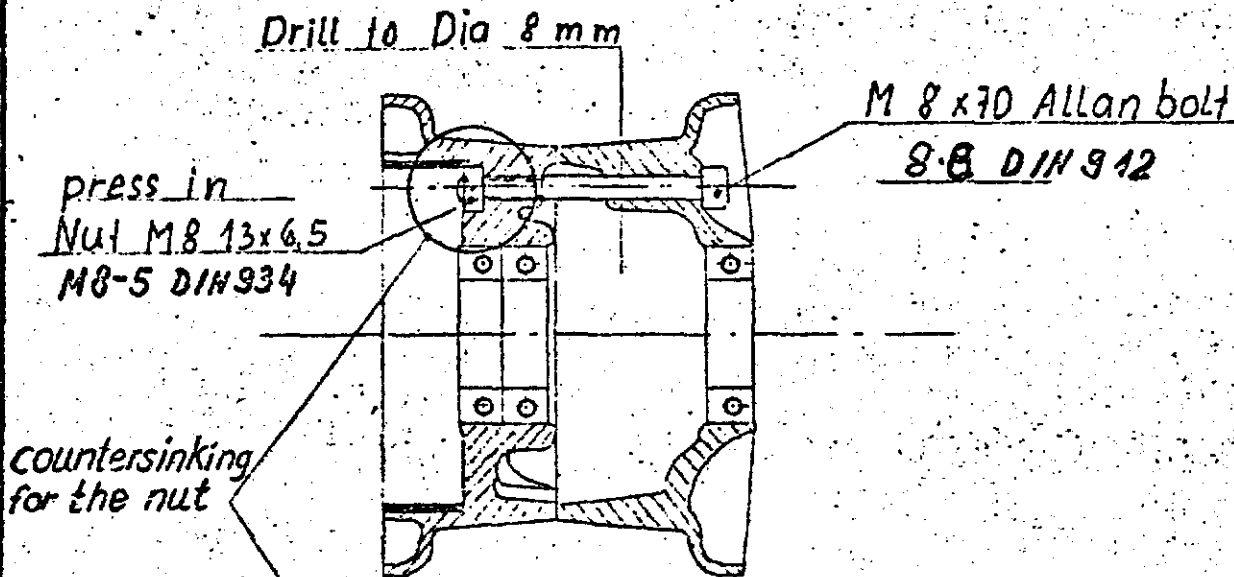
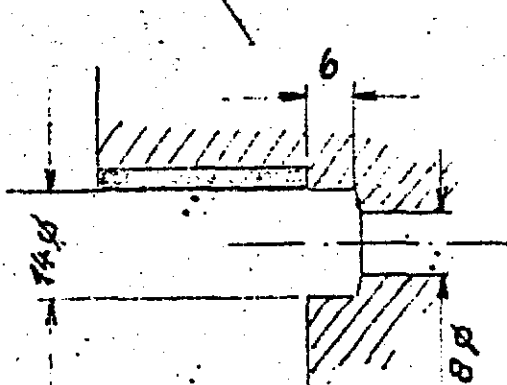
Technical Note

Subject: Enlarging of the bolts at the wheel hub
Effectivity: Powered glider ASK 16
Accomplishment: Changing of the screws
Material: See drawing
Weight and balance: To be neglected

Set drill to
15°

All measures in m.m.

The modification has to be made until **31. Dez. 1977**
 It is recommended to send the hubs to Fa. Tost, 8000 München 2,
 Thalkirchenerstr. 62, Tel. 089-534472 for making the modification.

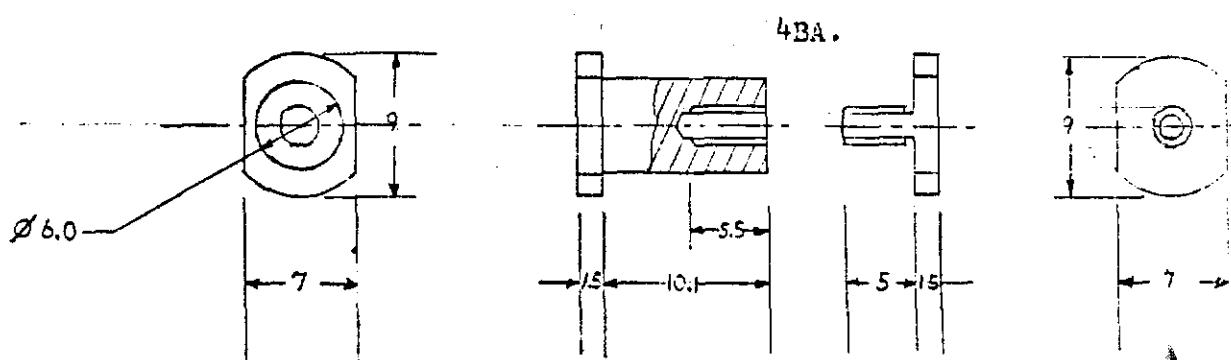
NIMBUS 15M. BEARING FAILURE

- 1.9. Mini-Nimbus H-S7 (15 metre). Failure of BEARING in air-brake system at bell-crank lever. Attached sketch supplied by I.R. Cook provides repair scheme.

Procedure:- Drill end of bearing mounting shaft off. Discard shaft and remains of bearing. Fit new bearing, retained shim washers and assemble Bolt and Nut using grade A Loctite.
