PART 1. Airworthiness 'Aggro' (Gliders and Motor-Gliders)  
(Please add to the Pink Compendium)

Technical note Nr. 301/6

DG - 100  
DG - 100 G

**Subject:** elevator control (bearing stand RU 19)  
**Effectivity:** DG-100 and DG-100 G W.-Nr. 5, 21 - 103  
**Accomplishment:** Before the next flight  
**Reason:** If a washer 6,4 DIN 9021 is not installed in the bearing stand RU 19 it is possible that the elevator control lever might loosen.

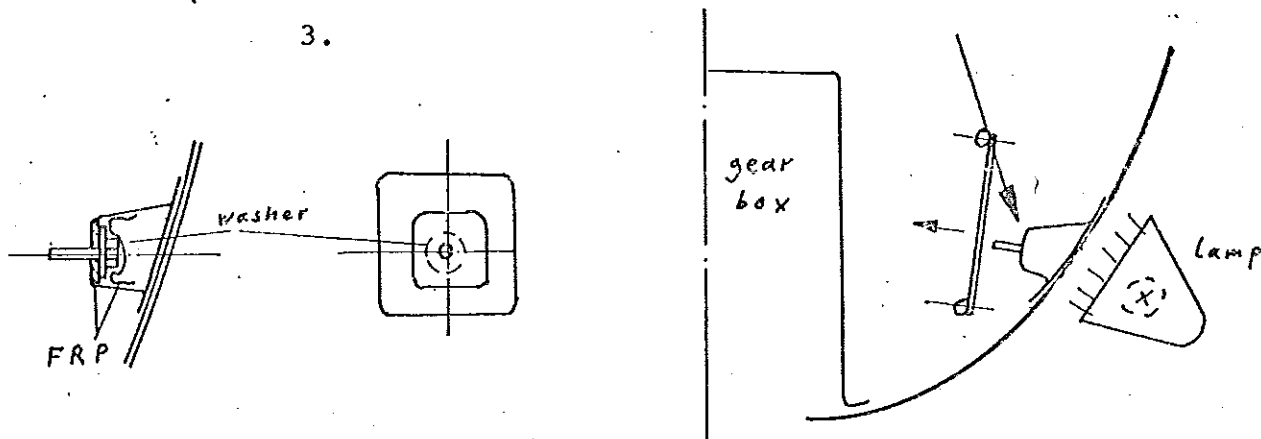
1. To carry out the works the fuselage must be accessible from the bagage compartment and from the left side.
2. Remove the left bagage compartment bottom.
- 3.

Remove the self locking nut M 6 DIN 985 from the bearing stand and draw off the control lever.

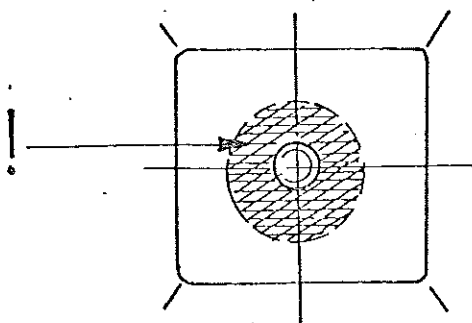
4. Take a powerful lamp (500 - 1000W), hold it against the fuselage from the outside and shine through the bearing stand. To prevent heating of the fuselage shell lighten only for short times. Make this work in a darkened room.
5. Look at the bearing stand from the bagage compartment.
6. a)

If the washer with 18 mm outside diameter is visible you can reassemble the control lever. Use a new self locking nut M 6 DIN 985.
