# BRITISH GLIDING ASSOCIATION

Tech.Committee.TNS 2/3/79.

Reparaturanweisung DG-100

Reparatur des Lagerbocks RU 19

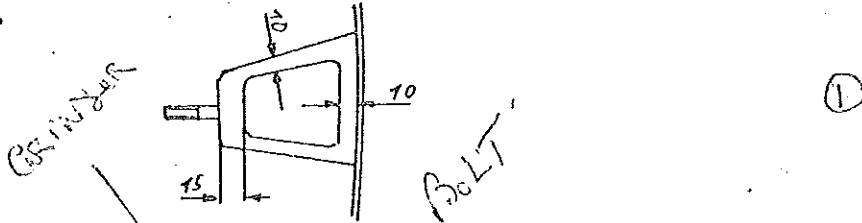
1. Den Höhensteuerumlenkhebel demontieren.
2. Ein Loch von oben in den Bock fräsen. Dabei s. Skizze Abstand zu den Seiten halten.

3. Das Gewebe hinter dem Schraubenkopf wegschleifen. Werkzeug. Hochtouriger Schleifer mit Schleifkopf  $\varnothing$  14mm. Körnung 60-80.

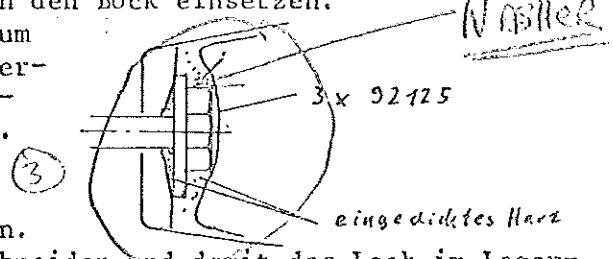
4. Die Schraube herausschlagen.
5. Den Bock innen an der Stelle des Schraubenkopfes aufräumen.
6. Schraube M6 x 35 LN 9037 mit Scheibe 6,4 DIN 9021 entfetten, an Einklebestelle etwas anrauen und mit eingedicktem Harz in den Bock einsetzen.
7. eingedicktes Harz um den Schraubenkopf herum angeben. 3 Lagen 92125 auf einer Folie außerhalb laminieren. Ein Stück 30mm x 30mm ausschneiden und über den Schraubenkopf legen.

8. Bock außen 20mm um das Loch herum aufräumen.
9. Ein passendes Stück aus den 3 x 92125 ausschneiden und damit das Loch im Lagerbock wieder schließen. Dabei Überlappung min. 15mm einhalten.
10. Mindestens 12h bei 20° C Raumtemperatur aushärten lassen.
11. Den Umlenkhebel wieder montieren. Eine neue Stoppmutter M 6 DIN 985 verwenden.

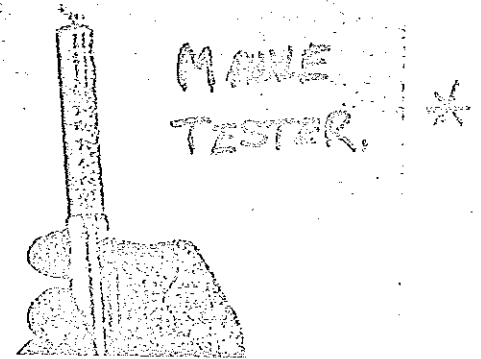
Fig. 37 Punch type fabric testers give a good indication of the relative strength of the fabric, but an indication of weak fabric should be backed up with a pull test before condemning the fabric.

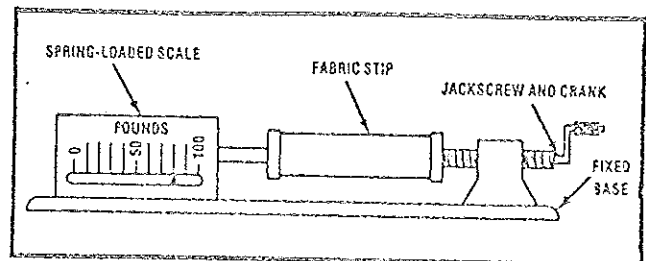
Fig. 38 Fabric pull tester

If the punch tester shows the fabric to be marginal, a strip of fabric should be removed from the airplane, usually from the top of the wing, and if at all possible from a dark painted area. Remove all of the dope from the fabric and wash it in acetone, then ravel it to exactly one inch in width. The strip is then placed in a pull tester and an even pull is applied to it until it breaks. If it breaks below the required strength, the airplane must be re-covered before it can be returned to service.
