BRITISH GLIDING ASSOCIATION

TECH. COMMITTEE. TNS 4.5.79.

Airworthiness Directive

Technical Note No. 278 - 23

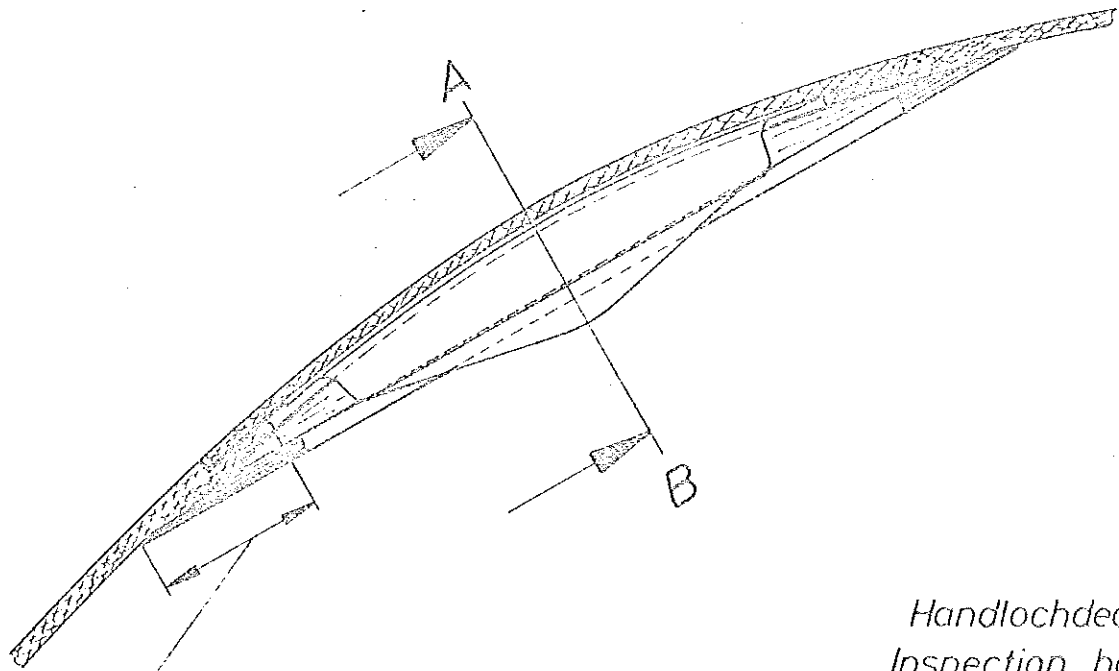
Reason : During a cross country flight with an ASW 20 the inspection hole cover which was not taped was lifted up during a pullup into a strong thermal and was, subsequently, pulled into the fuselage by the attached bungee. There it jammed temporarily the aileron and flap control.

Instructions : TN 4a :
By means of a plywood ring shield (P/N 200.11.0127) the hole of which is narrower than the smallest width of the inspection hole cover it is prevented that the cover can get into the fuselage.

For the cover itself or the bungee no modification is necessary.
See drawing on sheet 4 of this TN.

diesen Bereich vor dem
verkleben aufrauhen

Sand this area prior to glueing

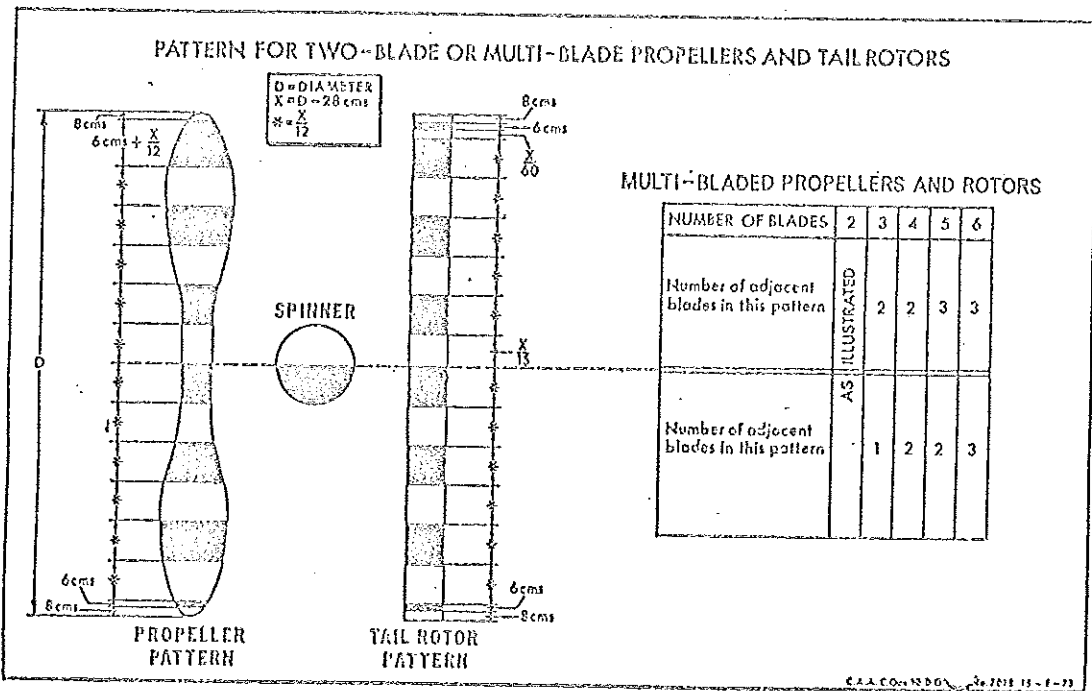
A recent fatal accident involved a passenger who walked into a propeller while the engines were running. A survey of UK accidents of this type shows that a total of 24 occurred between 1962 and the present time; 12 of these were fatal, 5 on single-engined aircraft and 7 on multi-engined aircraft.

Colours: Markings should be in black and white.

Painting: The finish should be gloss. Aircraft owners should consult the aircraft manufacturer in cases where no specific information is available as to what types of paint may be used on propeller or rotor surfaces.

Blades to be painted: A propeller which is outside the pilot's field of vision when he looks ahead should be painted on both sides and the spinner painted as illustrated. Blade surfaces within the pilot's field of vision ahead should not be painted and any spinner similarly located should be painted completely in white.
