BRITISH GLIDING ASSOCIATION

TECH. COMMITTEE. TNS 9/10/79

BULLETIN No BE-016/79 "BOCIAN"  
EMERGENCY

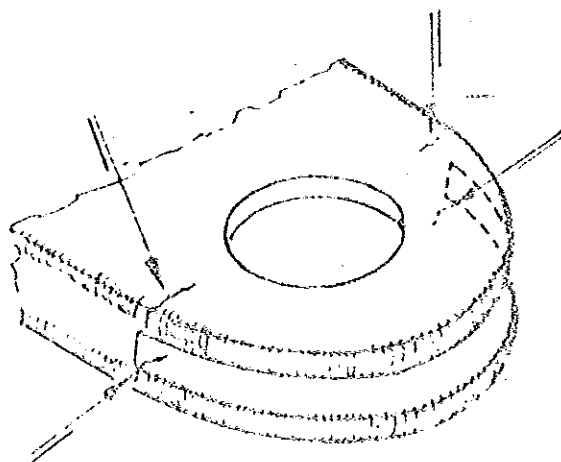
Sketch No 1

Check the condition of welding joints and fitting metal sheets using the magnifying glass of minimum 5 times augmentation and pay the special attention to the places shown on the sketches No 1 and 2. On the framework the front and upper surfaces shall be inspected.

4.10 When during the inspection acc. to item 3.00 the crack of any fitting has been found, or acc. to item 3.23 the play of parallelism of fitting arms /dimensions "A" and "B"/, the flying shall be prohibited till this failure would be corrected in the way consulted with the producer of glider.

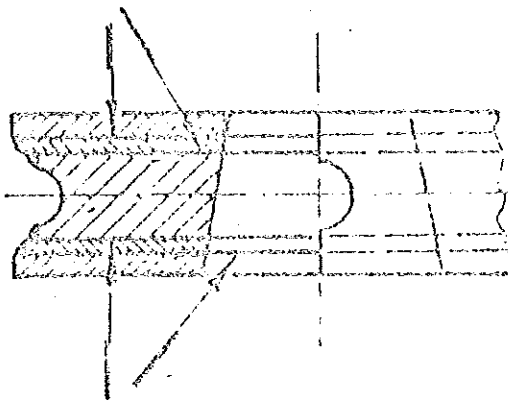
Sketch No 3

3.22. Check the splitting of the metal sheet set of the fitting.  
The maximum allowable splitting is 0.4 mm / see sketch  
No 3 /.The horizontal displacement of sheets is unacceptable

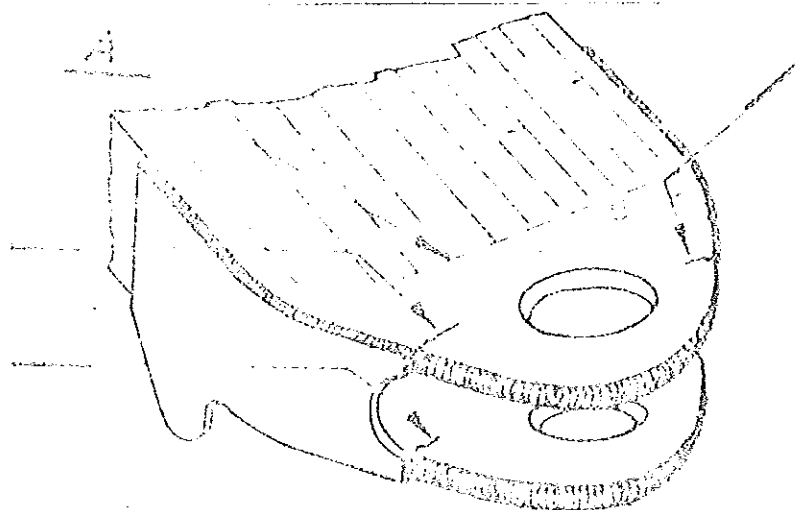
Sketch No 4

3.31 Check the condition of welding joints and fitting metal sheet using the magnifying glass of minimum 5 times augmentation and pay the special attention to the places shown on the sketch No 4. Check the absence of deformation /buckling/ of the surface aft of the line marked with arrow "A".

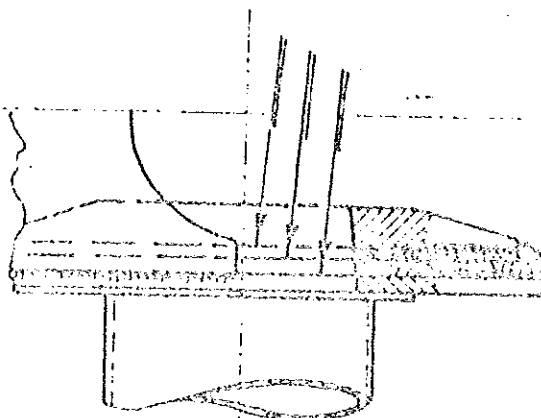
Sketch No 5

3.32 Check the splitting of metal sheet set of the fitting. The maximum allowable splitting is 0.4 mm /see sketch No 5/. The displacement of sheets is unacceptable.

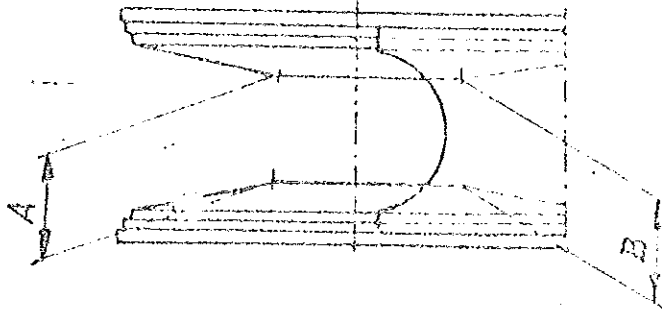
Sketch No 6

- 3.33 Check the distance between the upper and lower fitting arms /see sketch No 6/. The allowable play of parallelism is 0.55 mm, checked in the places of dimensions "A" and "B".

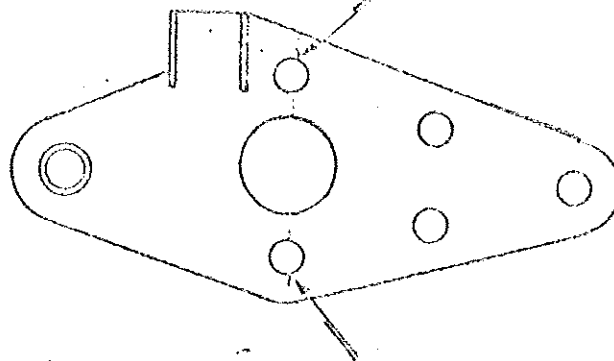
Sketch No 7

- 3.41 Through the inspection holes in the root rib check the condition of the rear spar fitting, good light provided. Pay the special attention to the absence of the cracks in places shown on sketch No 7. Access for checking of the fitting thorough the inspection hole made acc. to Bulletin No
