BGA Technical Committee

TNS/11/12/79

- 1.0. Airworthiness "Aggro" - The last for 1979. These items will be included in the 1980 GREEN pages.
- 1.1. Bocian Elevator Final Drive. Rod-end fatigue failure. The attached BGA Tech. Note was mailed to registered owners 31/10/79.

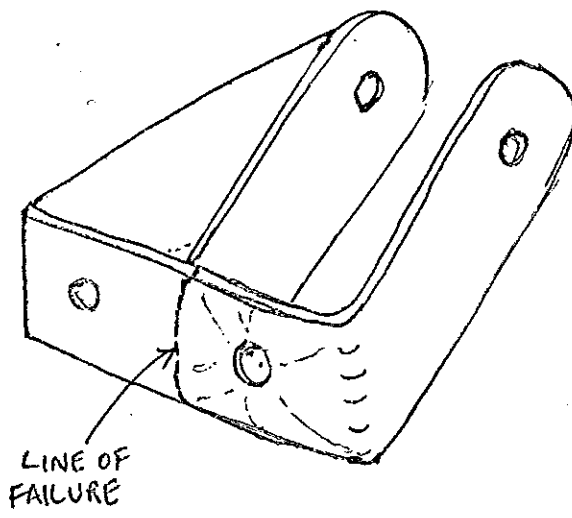
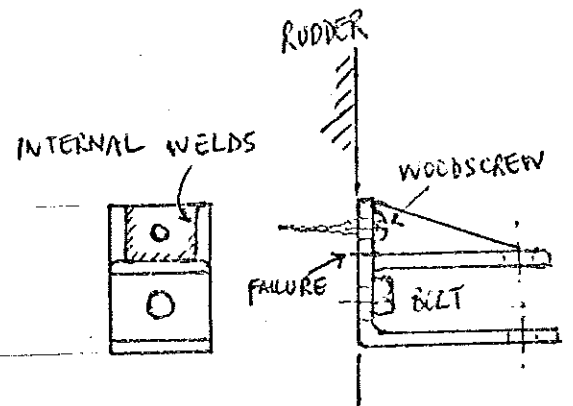
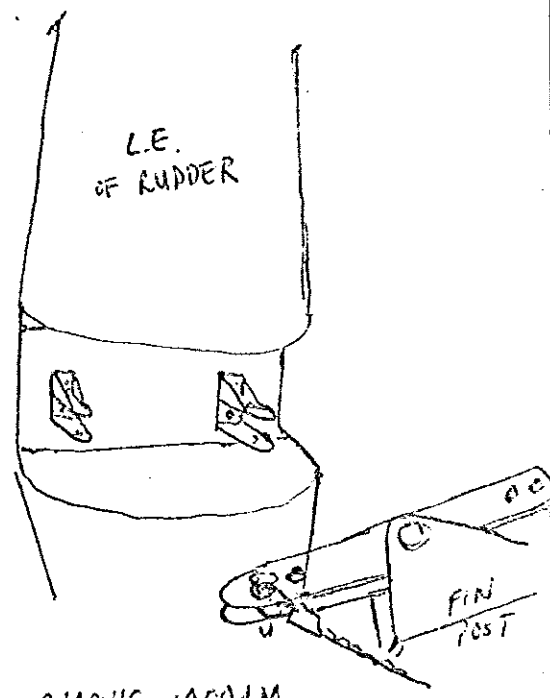
RUDDER ATTACHMENT BRACKETS (2N^o)

- 1.3. Bocian Rudder Hinge Bracket Failures. The attached sketch from S.G.U. is self-explanatory, and is a repeat of previous failures recorded in BGA Yellow Pages!

BOCIAN IE BGA 1994.

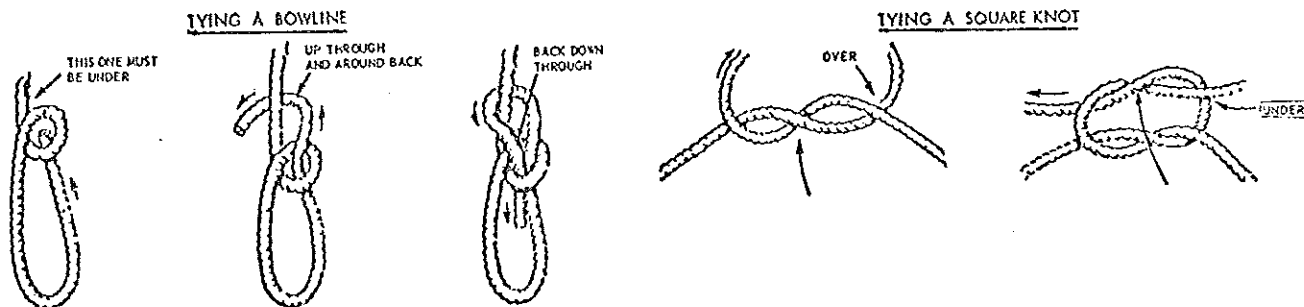
A number of twin-engined aircraft were stored in the open, and were tethered using 12 mm (1/2 in) polypropylene rope. One night there was a Force 8 to 9 gale which caused varying degrees of damage to a number of the aircraft. The whole of the rear fuselage was broken off one aircraft when another was blown on top of it.

It is well known to sailors and boating enthusiasts that polypropylene rope is not suitable for knotting with variable loads unless "jam knots" are used, eg

Although it is more expensive, nylon rope is preferable. ... A ha'p'orth of tar.

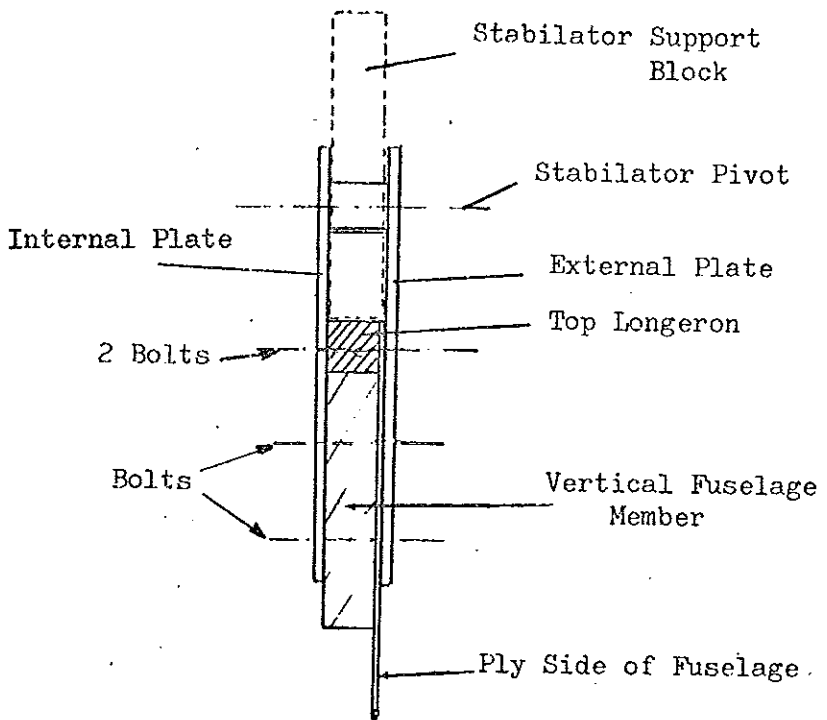
17. SEVERE CORROSION OF TAILPLANE ATTACHMENT PLATES

During the C of A renewal corrosion was found on the outside of both external plates that support the stabilator. When the plates were removed the inside face was found to be severely corroded at the top bolt holes. There are two plates each side, held by four bolts per pair. Adhesive is not used between the plates and the fuselage side. The aircraft had flown 3410 hours. Examination of other older aircraft showed some evidence of external corrosion on the plates.

CAA Comment:
The CAA has written to the manufacturer about the necessity for formal action.
