BRITISH GLIDING ASSOCIATION

TECHNICAL COMMITTEE

TNS 1/2/80

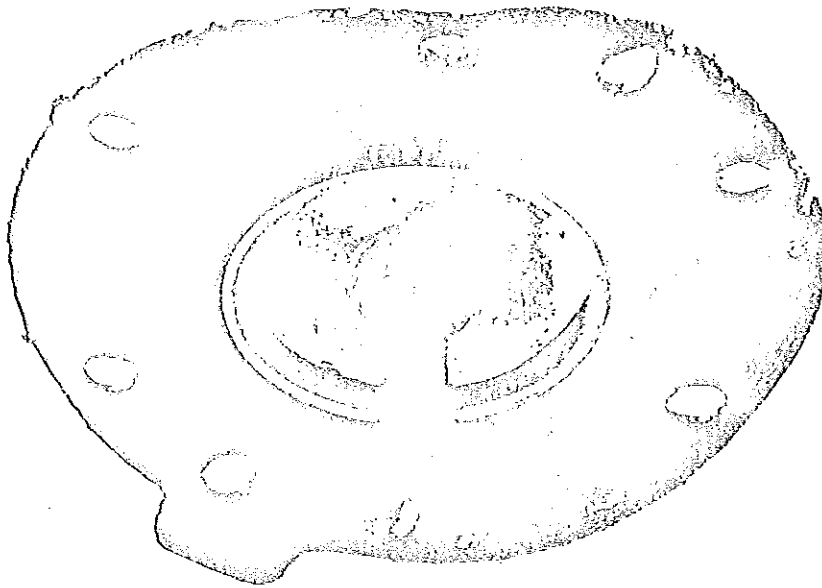
The engine stopped when the aircraft was at about 850 ft. The pilot attempted to make a forced landing into undulating farmland, but the aircraft struck the ground very heavily destroying the fuselage and wings. The wooden cockpit area to which the shoulder harness was attached also collapsed. The pilot received severe head injuries and both occupants received severe leg injuries. The cause of the engine stoppage was failure of the AC mechanical fuel pump. A back-up electric pump is not fitted to this aircraft type.

The AC mechanical pump (AC 1539867, Continental Part No 40585) had failed because the end of the slotted spindle had broken away, thus freeing the actuating lever. The likely cause was corrosion resulting from wear in the slot which removed the protective copper plating. This is the second failure of this type that we know of to this type of mechanical pump. The previous failure was on a Lycoming O-320 engine in a Glos Airtourer (see GASIL 8/77 p.1), the Lycoming Part No being 75246. All operators of aircraft with this pump should check the condition of the slot at the next convenient opportunity. This particularly applies to those aircraft types which do not have a back-up electric pump.
