BRITISH GLIDING ASSOCIATION

TECHNICAL COMMITTEE

TNS 5/6/80

Please add to the 1980 Green Pages.

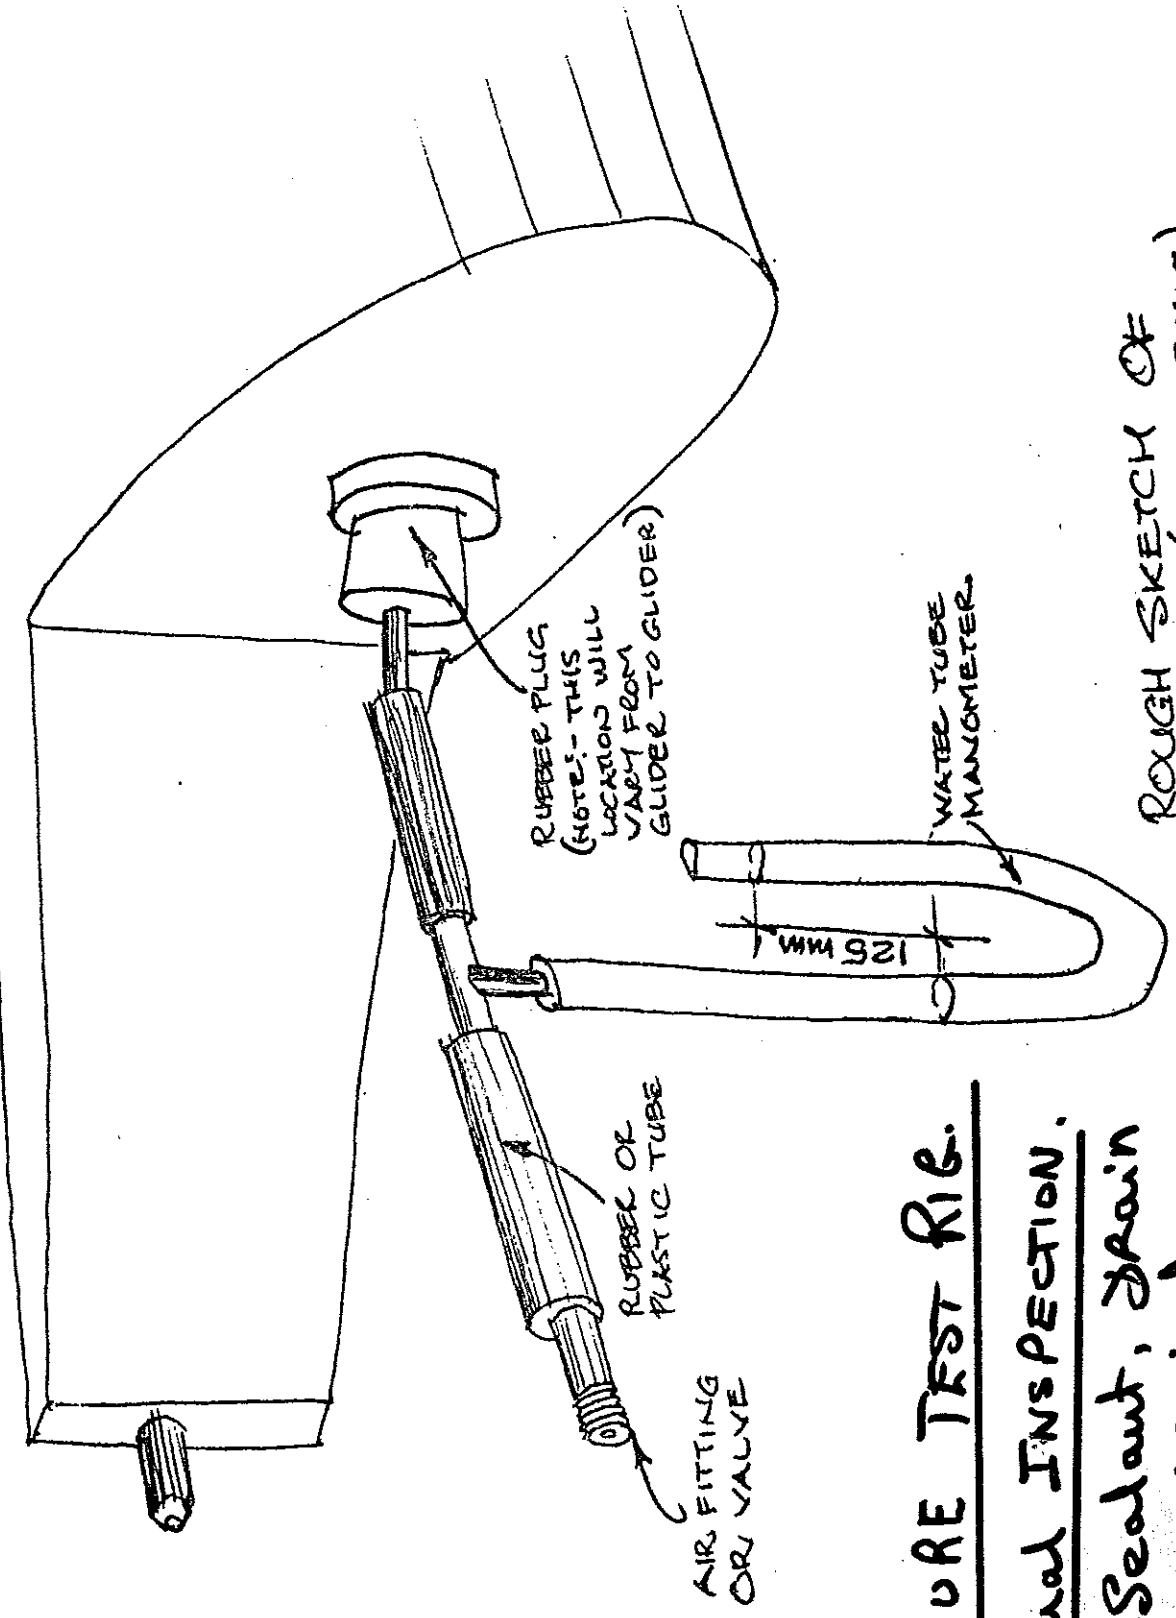
PRESSURE TEST RIG.

- 1.4. Water Ballast Tank - Leaks. The Gliding Federation of Australia have notified B.G.A. of this defect and recommended pressure test as per sketch attached. "Wet Wing" tanks may need to be "sloshed" with swimming-pool sealant, drained-off and dried, to prevent leakage into the wing structure.

WATER DALLAST TANKS.

ANNUAL INSPECTION.

LOSH' with Sealant, Drain  
is dry, as required.

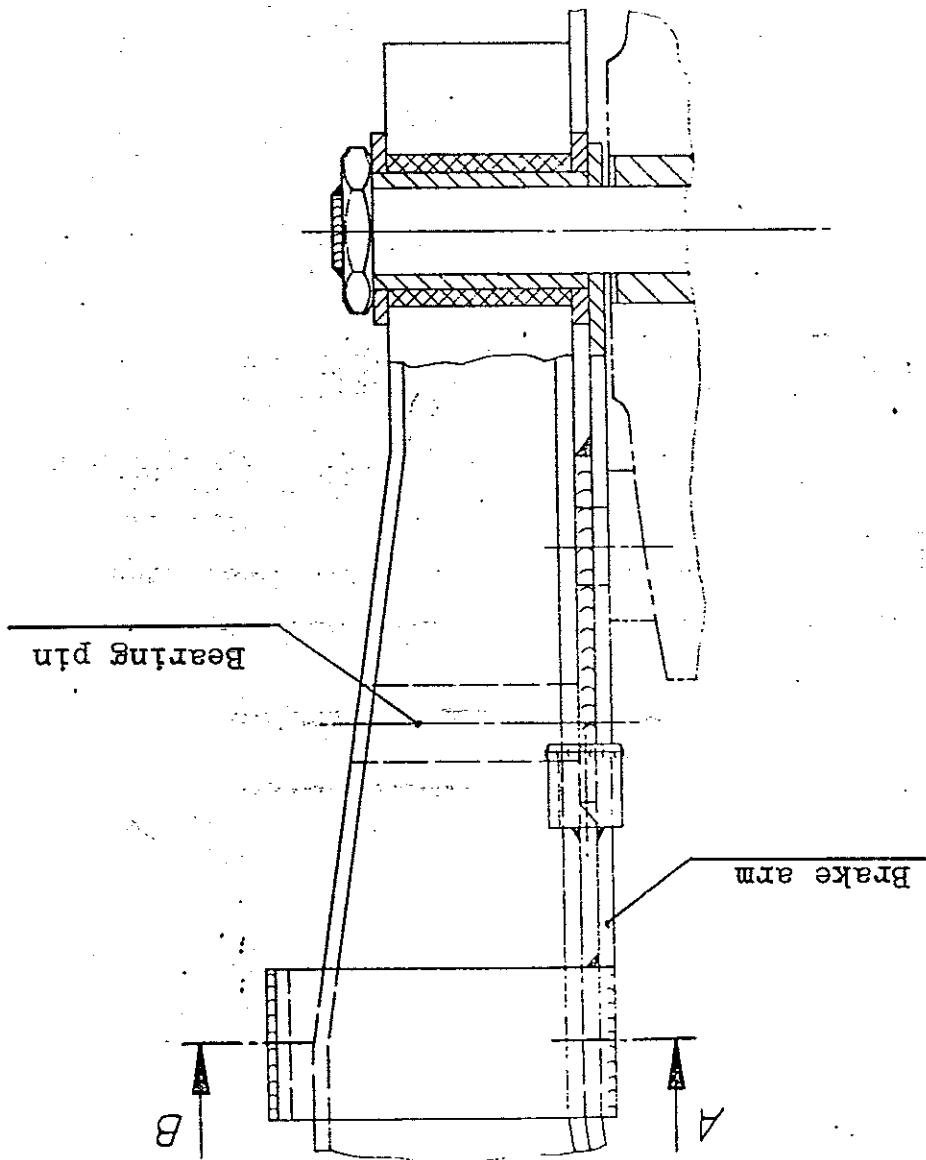
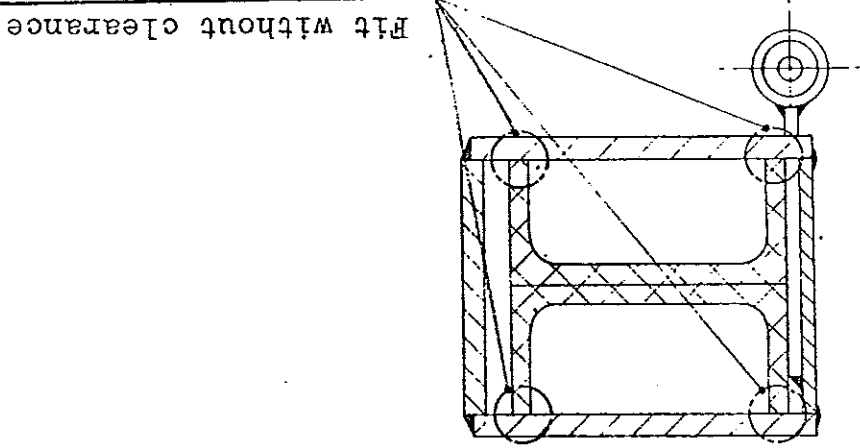
Section A - B

- 1.7. Mini-Nimbus Series - Landing Gear. Tech. Note 328-5 (attached) draws attention to damage that may occur to front landing gear strut, by the brake arm during heavy landings, with brake on.

At heavy landings with wheel brake put on it is possible that the front landing gear strut may be damaged by the bearing pin for the brake arm. Therefore a replacement of the brake arm is recommended.

1. Solder off the nipple from the brake cable and take off the wheel with the brake arm.
2. Saw off the bearing pin for the brake arm inside of the front landing gear strut and file it down.
3. Put a new brake arm (drawing Mini-Nimbus HS 7 No. 10.039 A) onto the front landing gear strut (see sketch on page 2).
4. Mount the wheel and the brake cable and solder on again the brake cable nipple.

Brake arm in accordance with the Drawing Mini-Nimbus HS 7 No. 10.039 A.

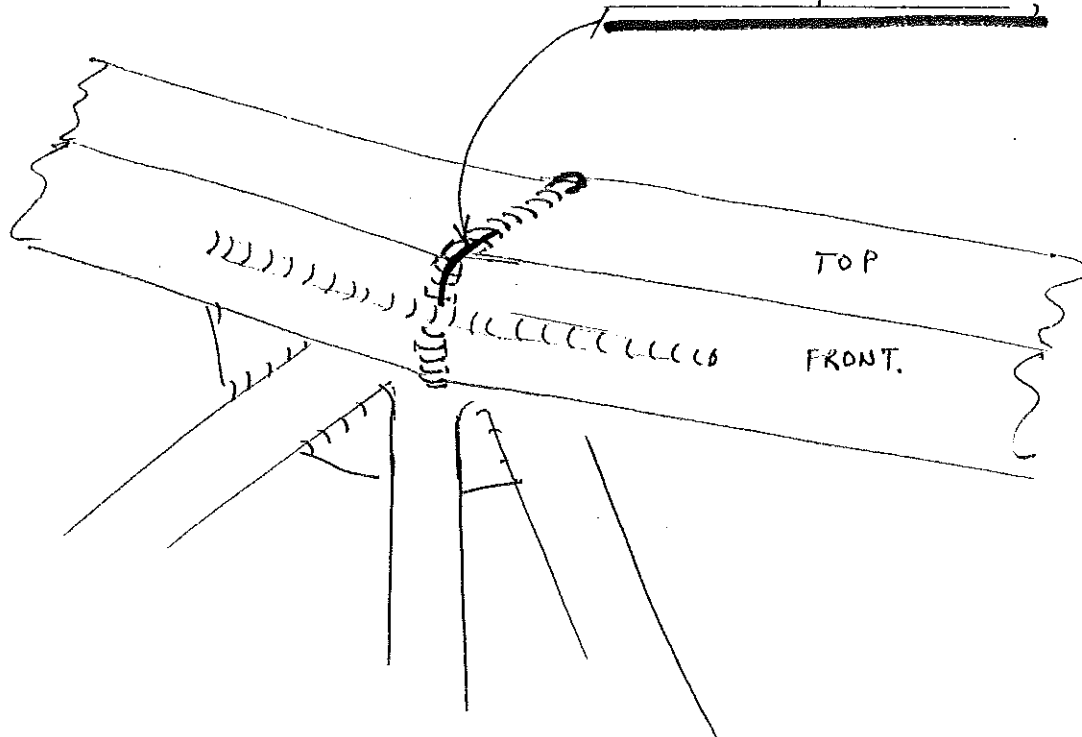
REF SKETCH N°2

- 1.1. Bocian - cracks in Centre Section Structure. Bulletin BE-016/79 and TNS 10/79, require repetitive inspection. Attached sketch illustrates cracks that may develop (Reported by R. Jarvis, S.G.U. Portmoak).

CRACK ON C/L OF WELD 1" LONG

CRACK VISIBLE  
WITHOUT MAGNIFYING  
GLASS

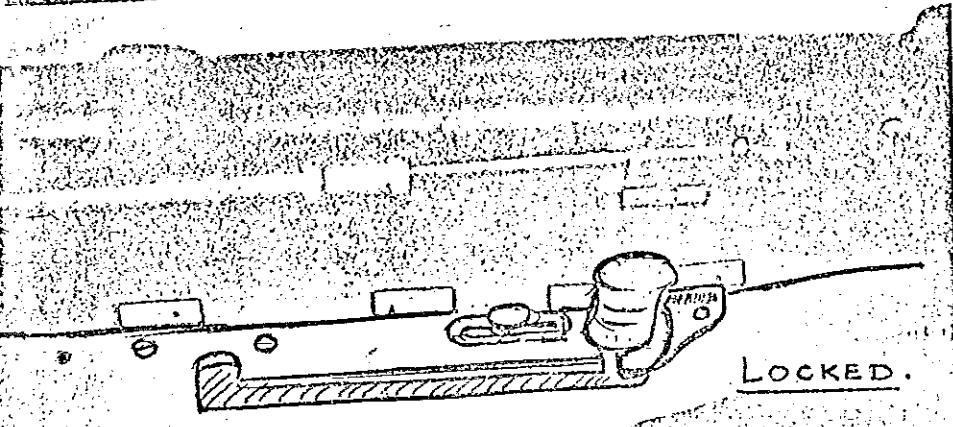
LOCKED.

- 2.2. ASW 20- Undercarriage Security Lock. R. Cousins, Kent G.C. has proposed the attached lock approved by the B.G.A. as a "Minor" modification Ref. BGA/ASW 20L/1/80.

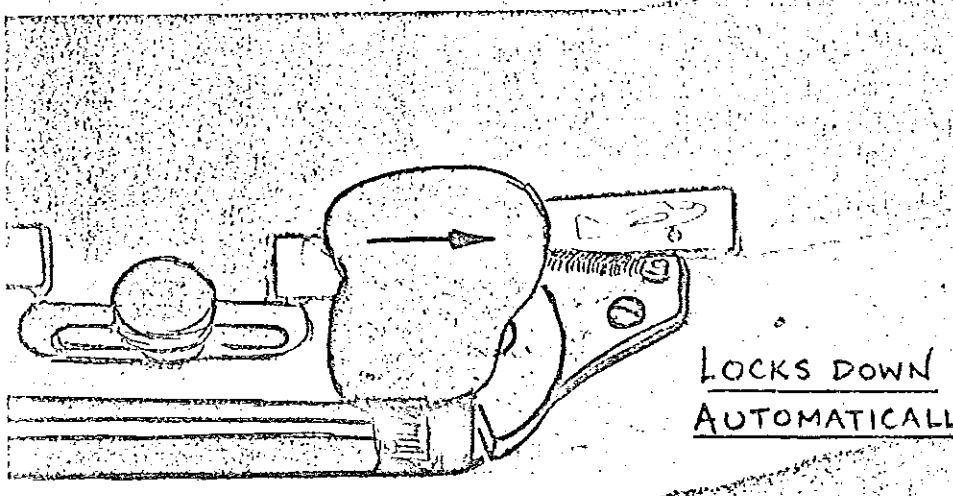
LOCKS DOWN  
AUTOMATICALLY.

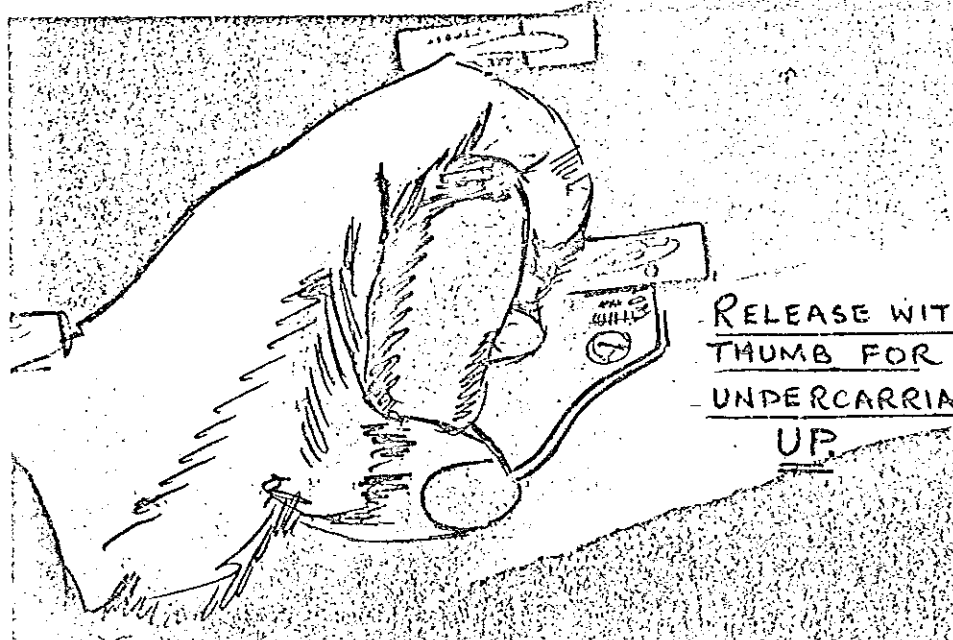
RELEASE WITH  
THUMB FOR  
UNDERCARRIAGE  
UP.

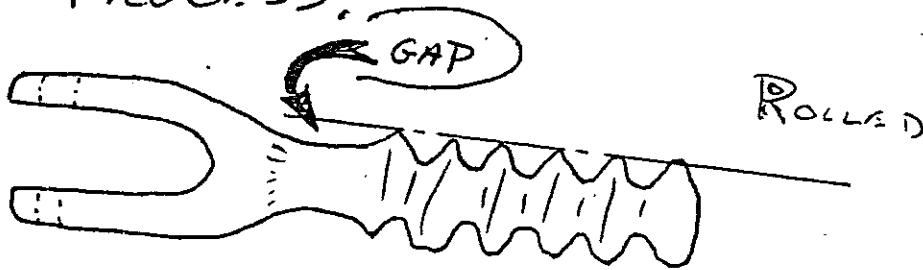
How To Identify Rolled/Machined Threads on Piper Struts.

ROLLED THREAD FORKS CAN USUALLY BE IDENTIFIED BY THE FACT THAT THE THREAD AREA IS LARGER IN DIAMETER THAN THE SHANK, DUE TO THE THREAD ROLLING PROCESS.

MACHINED THREADS ARE USUALLY THE SAME DIAMETER AS THE FORK SHANK FROM WHICH THE MATERIAL WAS MACHINED (CUT)

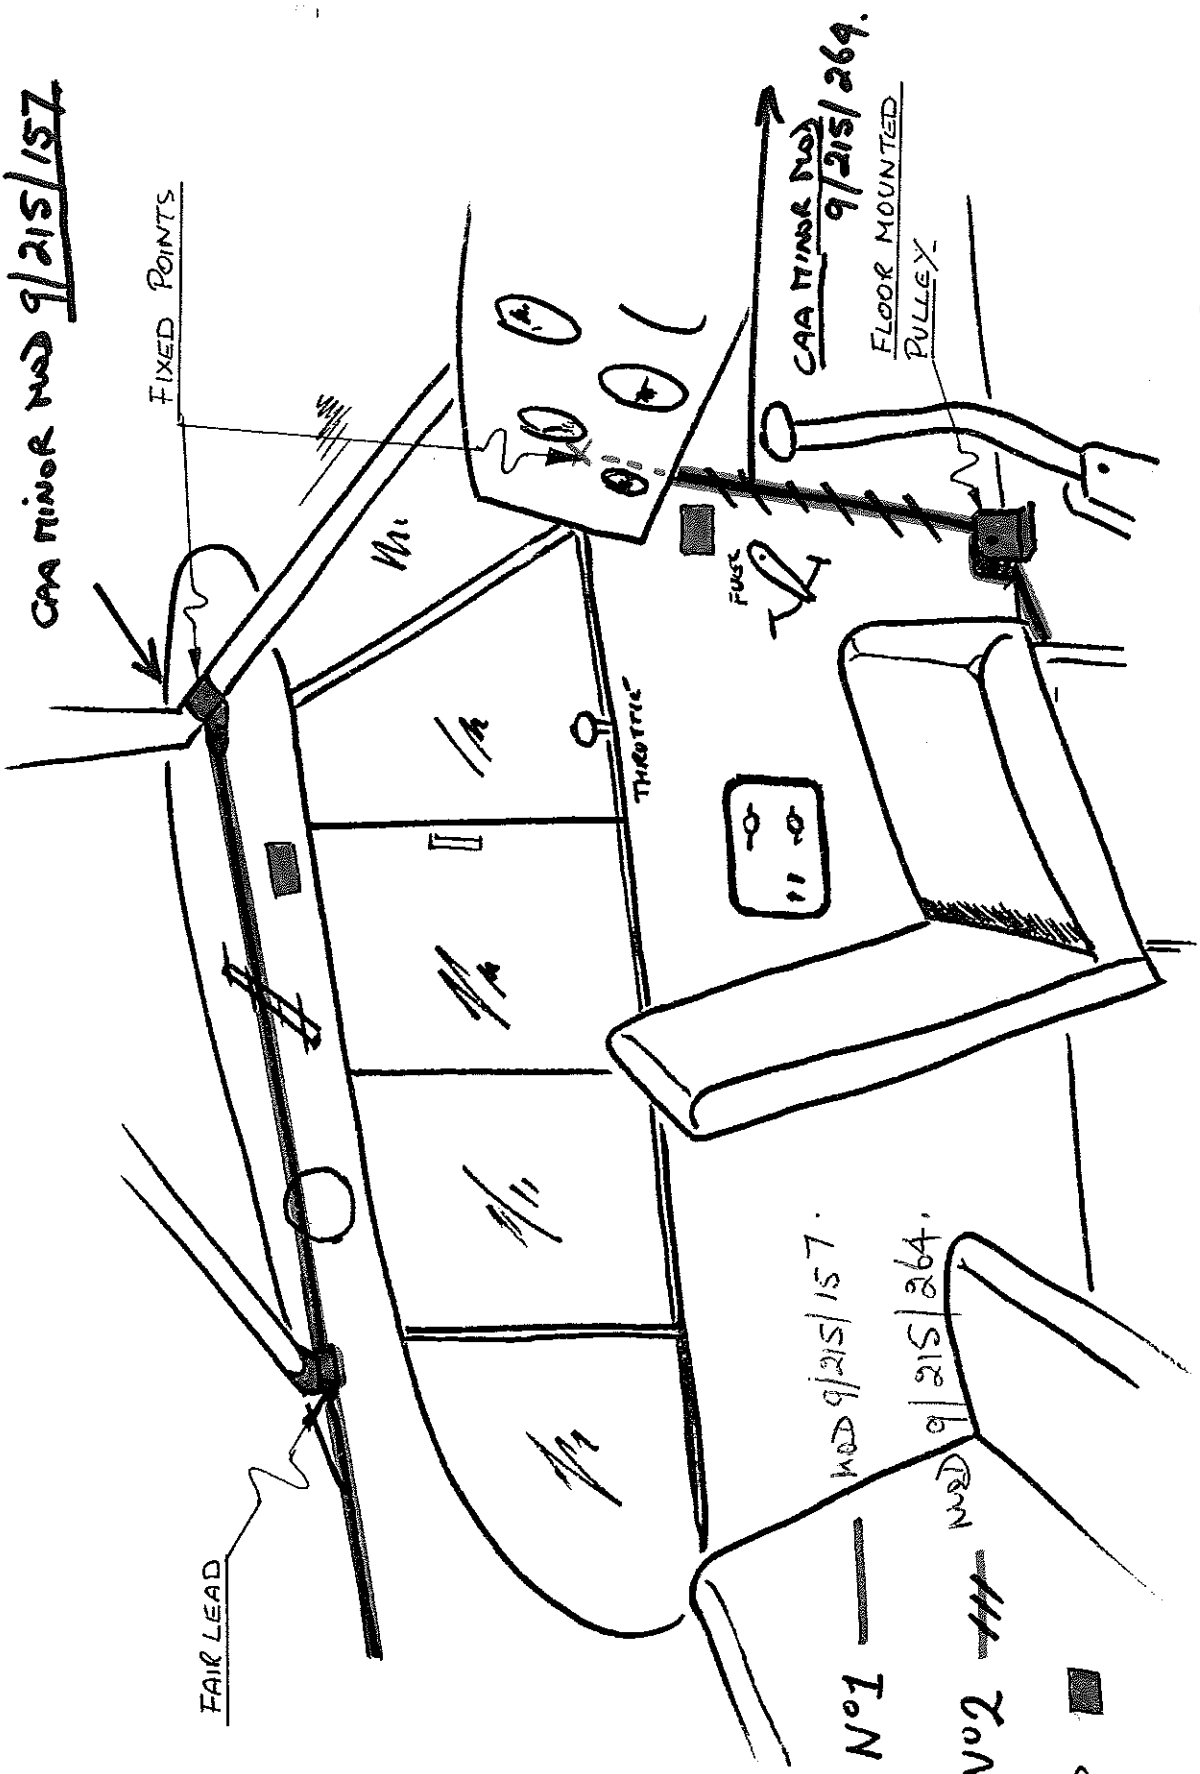
ALTERNATIVE SYSTEMS FOR GLIDER RELEASE

- 3.5. Tug Tow Releases. With two fatal tug accidents in 1978 no club/owner/operator should be complacent about the correct location of tow releases, adjacent to the hand operating the engine power-lever and easily accessible, with upper-body restraint tight and under negative "G" conditions! (sketch attached).

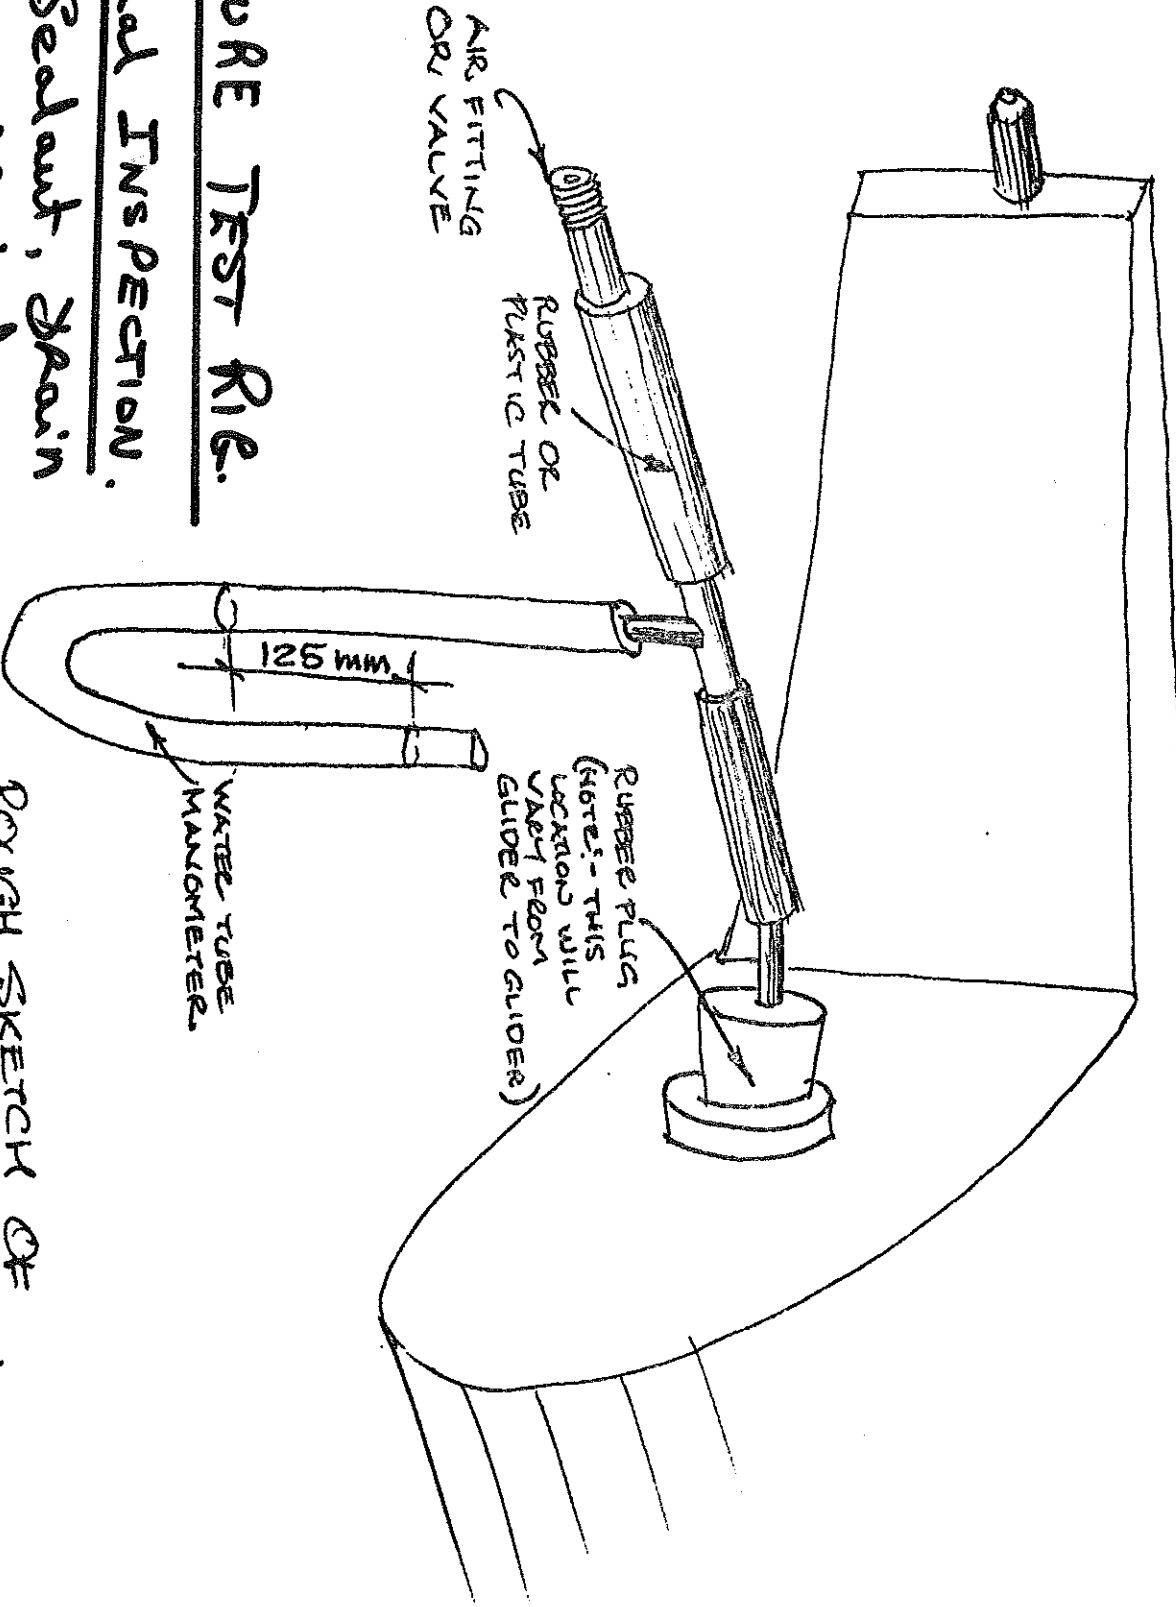
## PRESSURE TEST RIG.

# WATER BALLAST TANKS.

### Annual INSPECTION.

"SLOSH" with Sealant, Drain and dry, as required.
