BRITISH GLIDING ASSOCIATION

TECHNICAL COMMITTEE

TNS 3/4/80

1. AIRWORTHINESS "AGGRO"

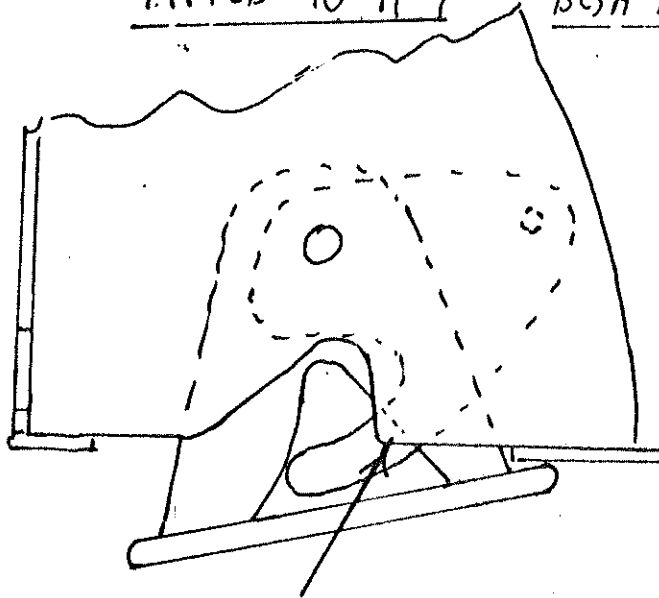
BGA 1349

- 1.8. Slick Magnetos (Certain Tugs & Motor Gliders). FAA (Emergency) A/D (attached) requires inspection for soft pins in impulse couplings.
- 1.9. KA-7 with Ottfur Tow Hooks. Damage to side plates by the small ring, may impair back release (sketch attached from J.A. Little, Northumbria G.C.).

WINCH CABLE SMALL RING HAD
BEEN BEARING ON THIS POINT
& DISTORTED METAL TO FORM A
LARGE RAG ON THE INSIDE. IF
THIS HAD INCREASED IN SIZE SLIGHTLY
IT COULD HAVE PREVENTED BACK
RELEASE OPERATING
