BRITISH GLIDING ASSOCIATION

TECHNICAL COMMITTEE

TNS 7/8/80

1. AIRWORTHINESS "AGGRO"

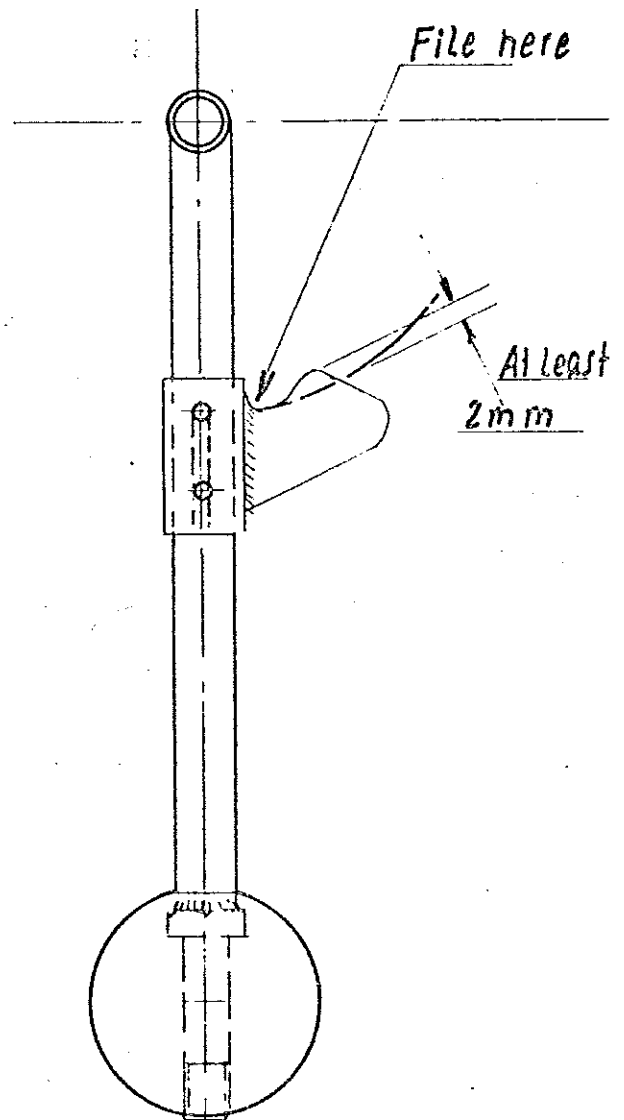
Subject: Examination of the canopy lock

It is possible, that the cam of the cockpit hood lock lever will be too flat topped owing to permanente use in course of times.

Instruction: The canopy lock has to be examined if the cam is at least 2 mm high.
 If not, take a file to make it deeper.
 Note the examination in the log book.

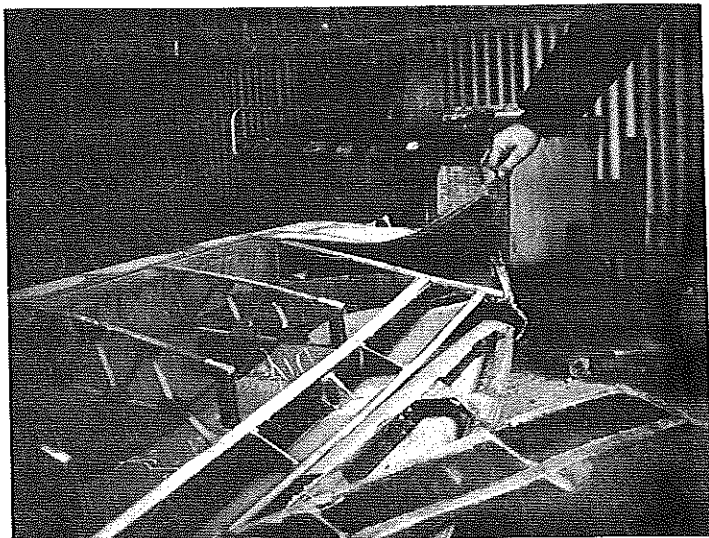
The aircraft was stored in the open for 12 months, during which it was flown for about 30 hours. Eventually the owner decided to have it re-covered. It was discovered that the wing, fuselage, and tailplane were suffering from total loss of structural integrity due to glue failure. For example the rear spar spliced joint had parted adjacent to the aileron and the plywood facing on the main spar had parted over most of the length of the spar together with separation of the spar from the ribs. Further, the wood had lost its resilience and was very brittle. The glue failure was caused by water penetration. The aircraft had spent the 1979/80 winter parked outside, but it is not known how much it had been parked outside previously.

Ribs separated from both front and rear spars, with rear spar disintegration and wing tip ply separating

It is strongly recommended that wood and fabric aircraft should not be kept outside. Any aircraft which are kept outside should be carefully examined for any sign of structural deterioration or water penetration, eg bulges indicating delamination, soft or wet patches on the underside of wings, etc. Inspection panels, etc, should be removed to facilitate the checks.
