BRITISH GLIDING ASSOCIATION

TECHNICAL COMMITTEE

TNS 9/10/80

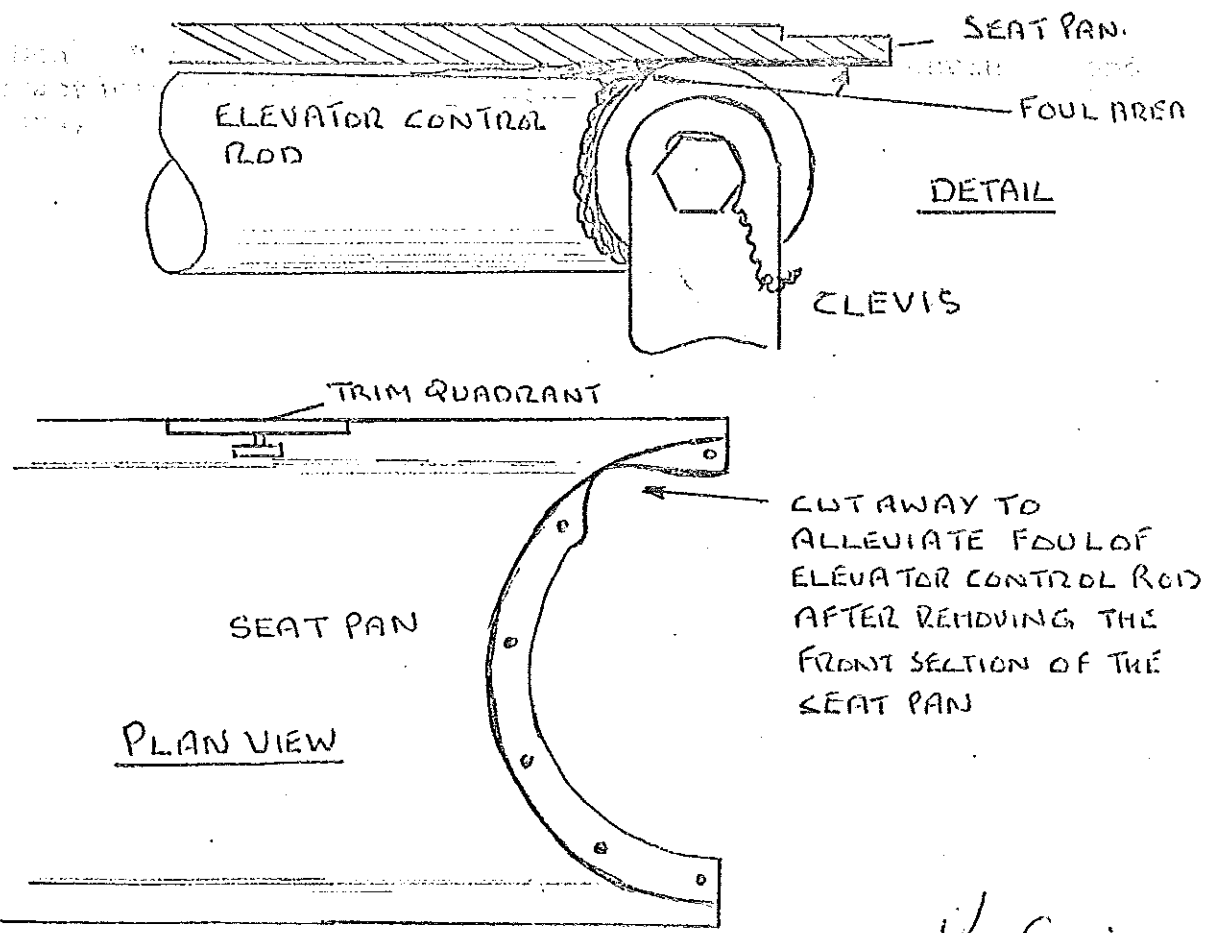
T. 65C. VEGA. SEAT PAN FOUL.

- 1.4. Slingsby T.65C. "Vega". Seat-pan fouls elevator control rod assembly - cutaway required to give clearance. (Sketch attached from Surrey & Hants G.C.).

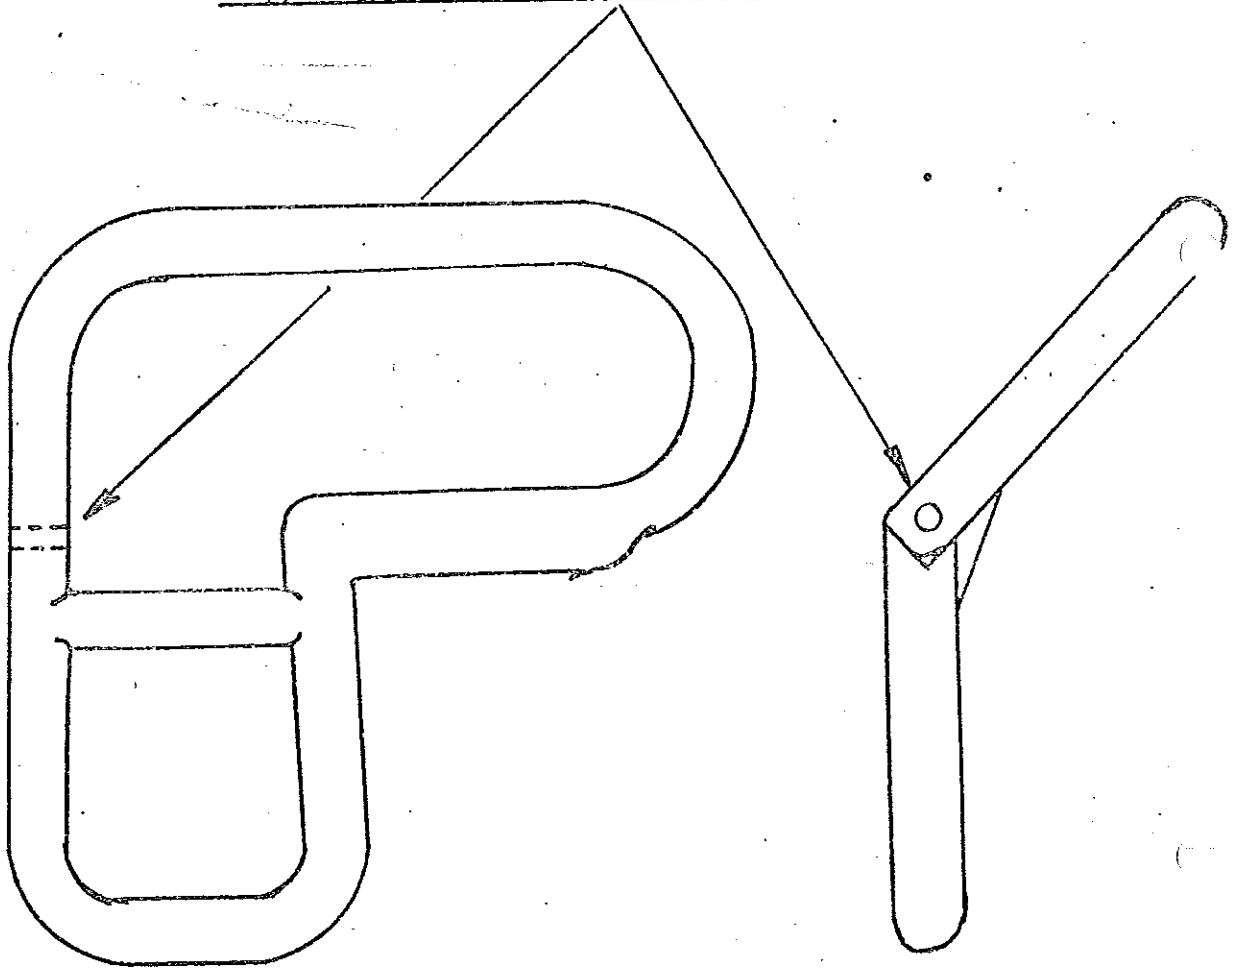
FIGURE 1

- 1.7. Personal Parachutes. Manufactured by STRONG ENTERPRISES (U.S.A.) FAA A/D herewith, requires modification to plastic ripcord handle.

REPLACE THIS HANDLE IF
RIPCORD CABLE ATTACHES HERE

To prevent the possible nondeployment of a parachute canopy due to separation of the plastic handle from the ripcord cable when subjected to the deployment pull force, accomplish the following: replace the plastic handle shown in Figure 1 with a metal handle (P/N 1025) supplied by Strong Enterprises prior to the parachute being made available for any parachute jump.

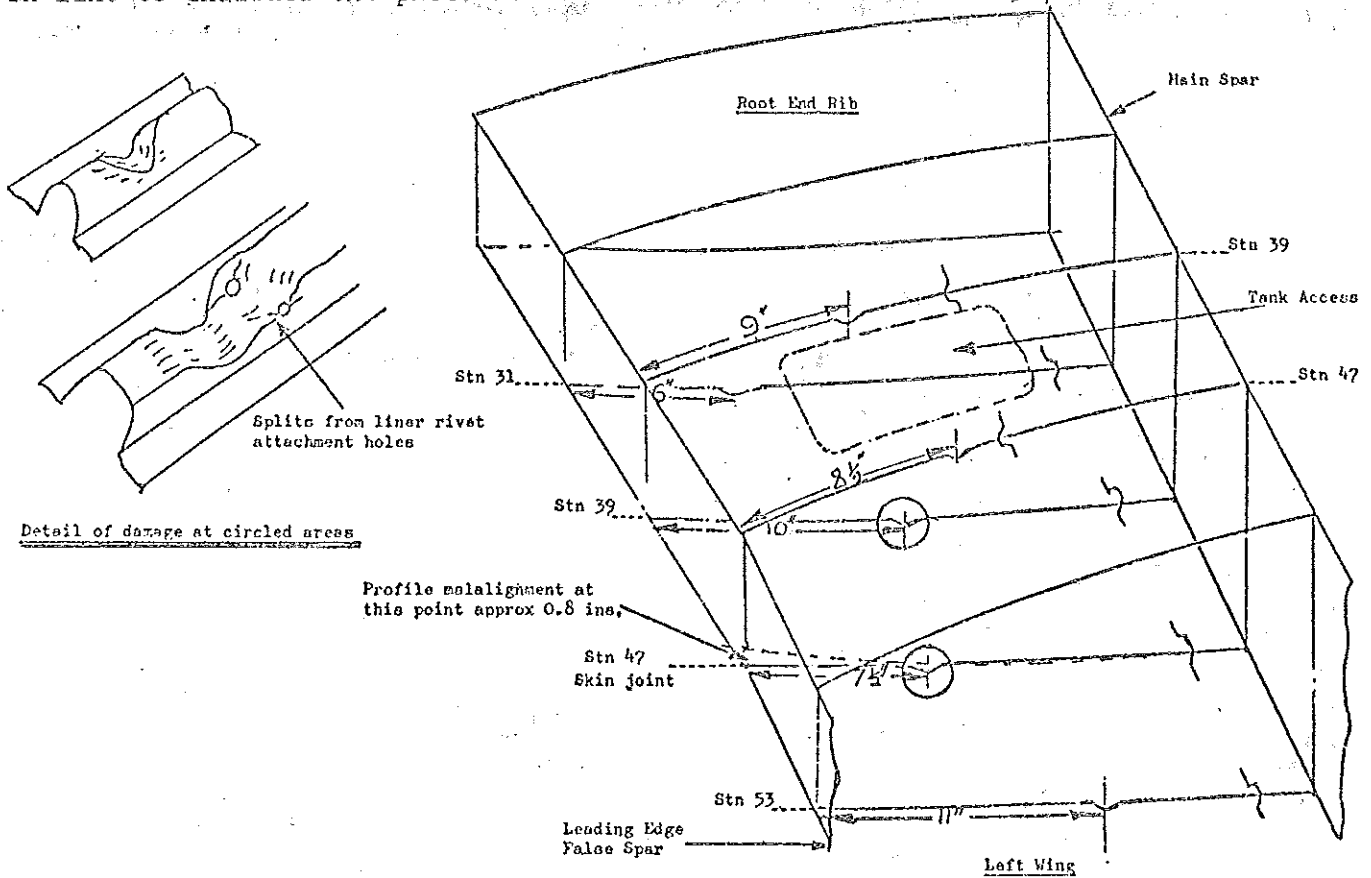
After a Check 4 and test flights had been carried out on the subject aircraft, the profile of the underside leading edge skin of the left-hand wing was found to be visibly at variance with the right-hand wing. On checking against profile jigs there was a discrepancy of 0.8 inches at stn. 47 on the left-hand wing leading edge false spar.

The skin and rivetting in this area showed no signs of internal damage being transmitted, apart from out-of-profile stretching. Removal of the left-hand main fuel cell revealed considerable distortion of the bottom tank liner, and the two halves had split the tape at stn. 47. The bottom leading edge formers at stns. 31, 39, 47 and 53 were all deformed (see sketch), and on the top skin the formers at stns. 39 and 47 were also distorted.

An identical defect was found on one of the same operator's Barons in 1972. Beech were positive in that case that the cause was over-pressurisation of the tank bay. The operator, however, was unable to find a record of this having occurred. Both before the 1972 incident and every 100 hrs since, the operator has continued the low pressure checks referred to above, using a foot pump with an open water manometer in line to indicate the pressure so that it does not exceed 0.5 p.s.i.
