BRITISH GLIDING ASSOCIATION

TECHNICAL COMMITTEE

TNS 11/12/80

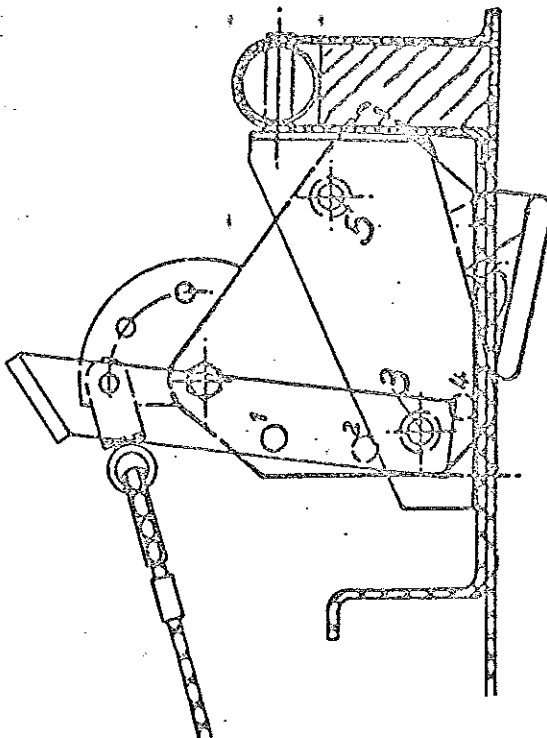
Techn. Note No. 286-14

Attachment of the tow release hook
in front of the landing wheel

Towing hook to be attached onto the bracket by the bolt 2, 3 and 5.

- ACTION:
1. Dismounting of the towing hook S 72 and removal of the two angular safety fittings.
 2. Enlargement of the cut-out in the bottom of the fuselage in accord with the drawing:
Nimbus-2 No. 10.082 A - Installation of the towing hook.

3. Installation of the C.G. towing hook Europa G 72 or Europa G 73 in compliance with the drawing:
Nimbus-2 No. 10.082 A - Installation of the towing hook.

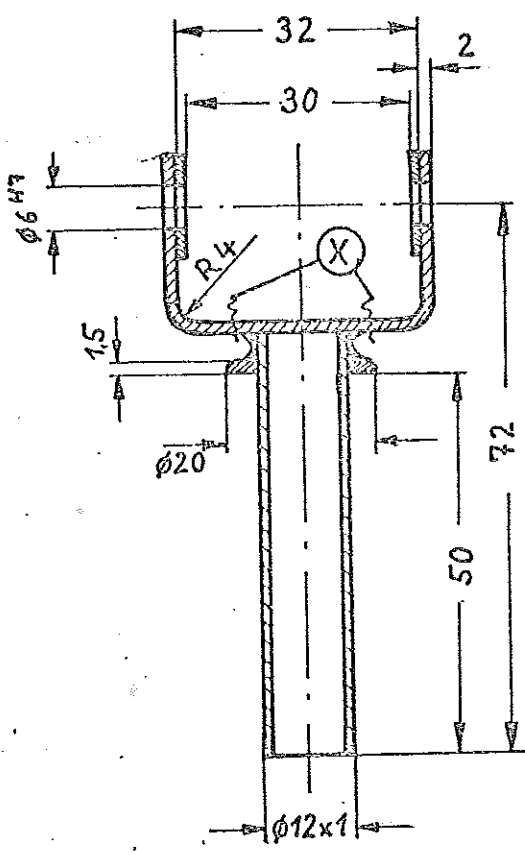
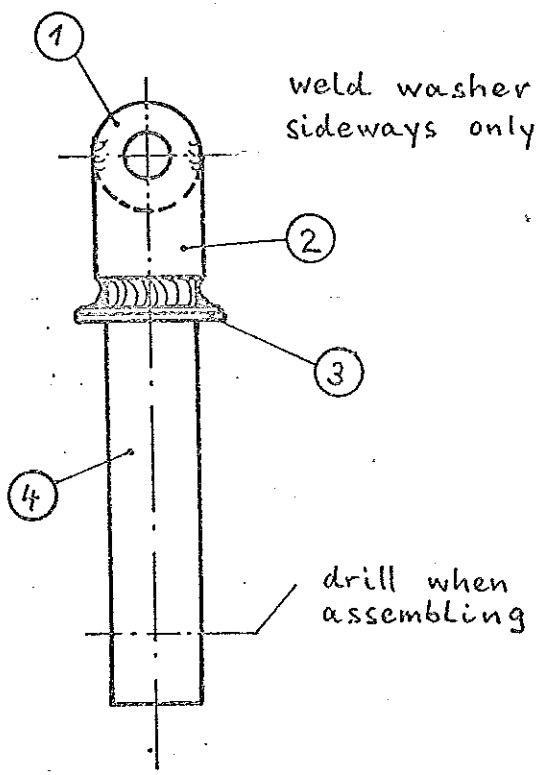
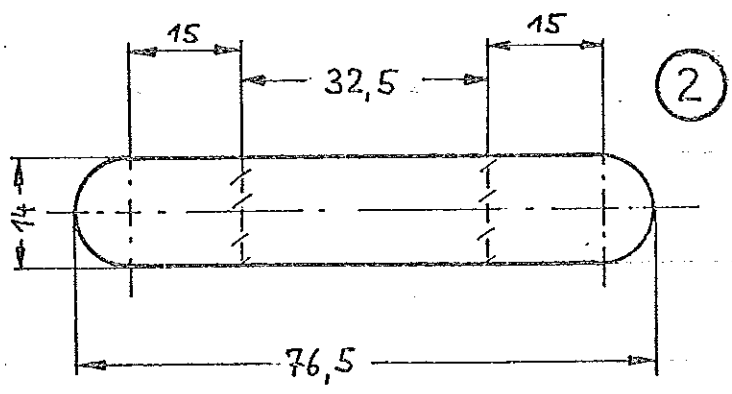
Reason: Failure of a Linkage

(X) Position of possible cracks on original Elevator Linkage

Action 2: The Elevator Linkage at the base of the stick must be replaced by a modified part in accordance with drawing No. 301-41-4/2 Replacement must in all cases be effected until November 1st 1980.

heat-treatment after welding: Tempering in controlled atmosphere
1 hour at 550°C

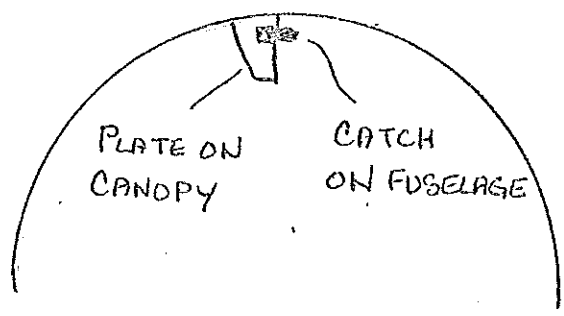
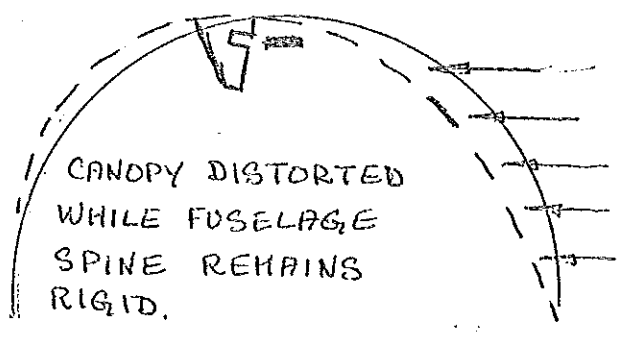
VIEWS ON REAR ARCH OF CANOPY LOOKING FORWARD

- 1.8. Canopy Locking Problems:
 1. VTC Cirrus. Canopy came adrift on winch launch when signalling "Too Fast". MOD BGA/VTC Cirrus/1/80 devised by P.R. Philpot, Blackpool & Fylde G.C. may be incorporated (sketch attached).

SUGGESTED CAUSE OF CANOPY DISENGAGEMENT
VTC CIRBUS.

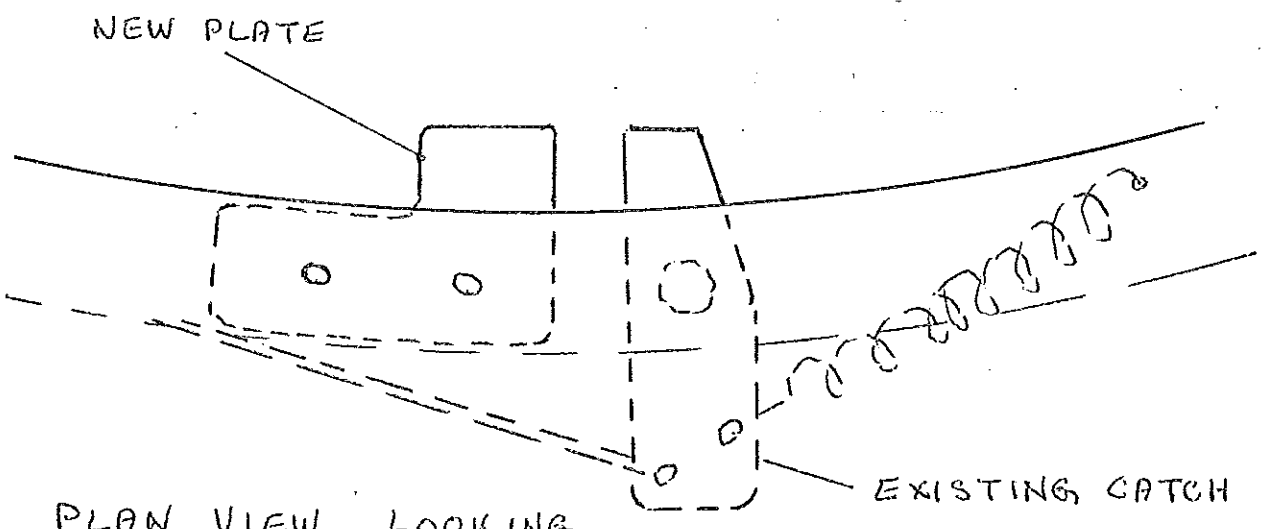
PLAN VIEW LOOKING DOWN ON TOP OF FUSELAGE

DIAGRAM SHOWING PLATE ADDED TO BGA 1835

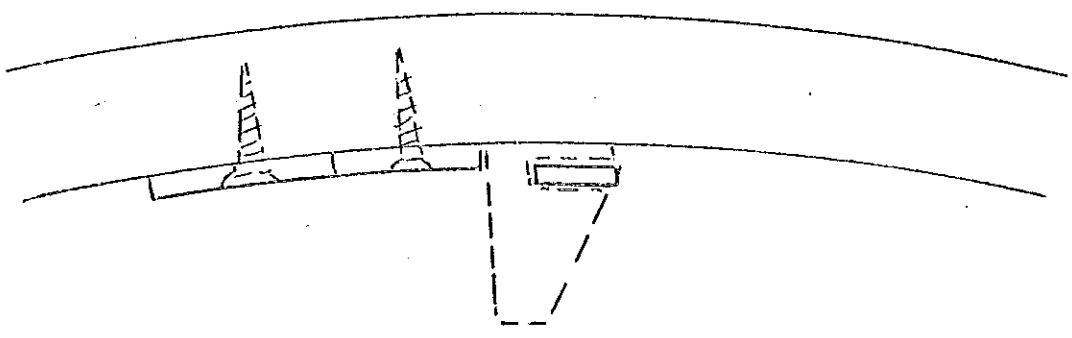
VIEW LOOKING FORWARD SHOWING PLATE ON CANOPY PREVENTED FROM MOVING Laterally, PLATE MATERIAL 12SWG, L72 AS THAT WAS READILY AVAILABLE. WILL BE CHANGED TO STEEL IF IT WEARS.

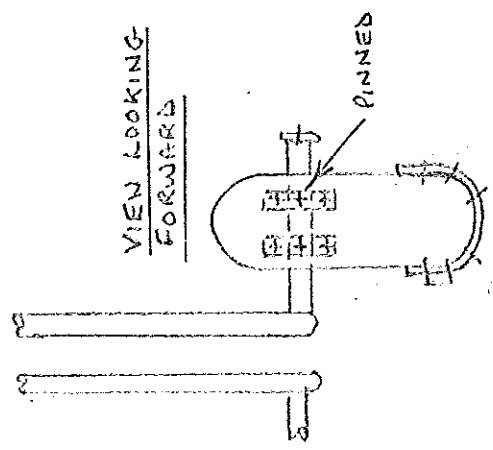
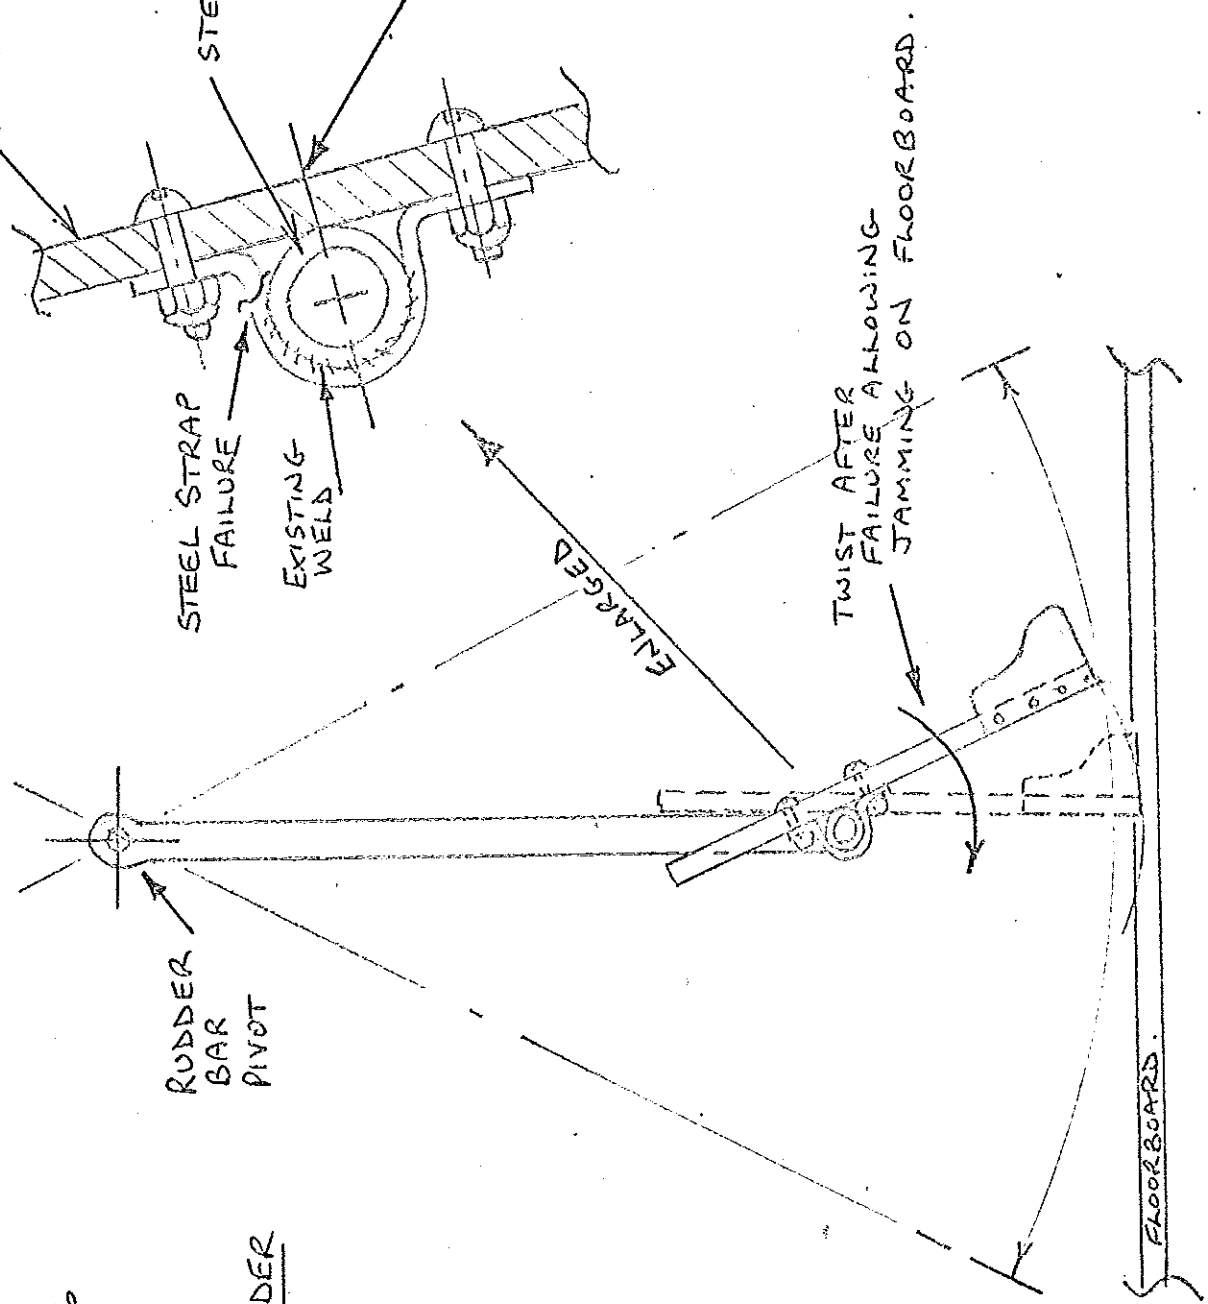
K7 - Forward Rudder Pedal Modification.

- 1.5. KA-7 Rudder Pedals Loose. Derby & Lancs modification Ref. BGA/K7/1/80 herewith provides an acceptable "fix" to a recurring problem.
 - 1.6. Standard Libelle and Libelle 201B. Elevator linkage at base of the stick - cracked. Tech Note 201-22 (herewith) applies to serial NO's 1-476 and requires replacement. (Mailed to owners).

FAILURE OF
STARBOARD RUDDER
PEDAL

MOD
PINNED BY
2 OFF 4-BA
BOLTS.
