BRITISH GLIDING ASSOCIATION

TECHNICAL COMMITTEE

TNS 4/5/81

1. AIRWORTHINESS AGGRO (Please add to 1981 Pink Pages).
  - 1.1. ASW 19/20 Aileron Hinge-Pins NOT secured. AD/81-74 (herewith) requires inspection for missing rivets.

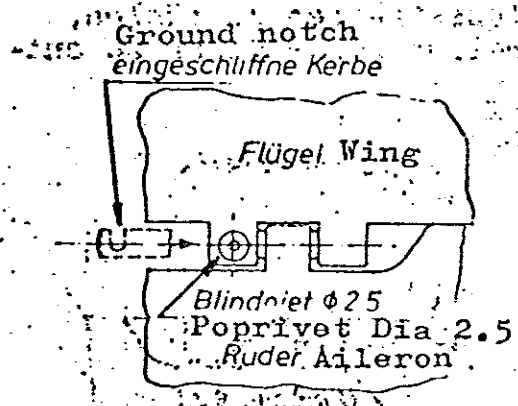
Reason:  
It may be possible that the aileron hinge shaft  
is not correctly secured.

Action and compliance:  
Unless already accomplished, check the aileron hinges  
prior to next flight after publication of this AD to  
see, whether the pop rivet securing the aileron hinge  
shaft is in its place. (see figure).  
The rivet head can be felt under the adhesive tape.  
If necessary, remove this tape to facilitate checking.

Accomplishment and log book entry:  
Action to be accomplished by an approved service  
station and to be entered in the sailplane's log.

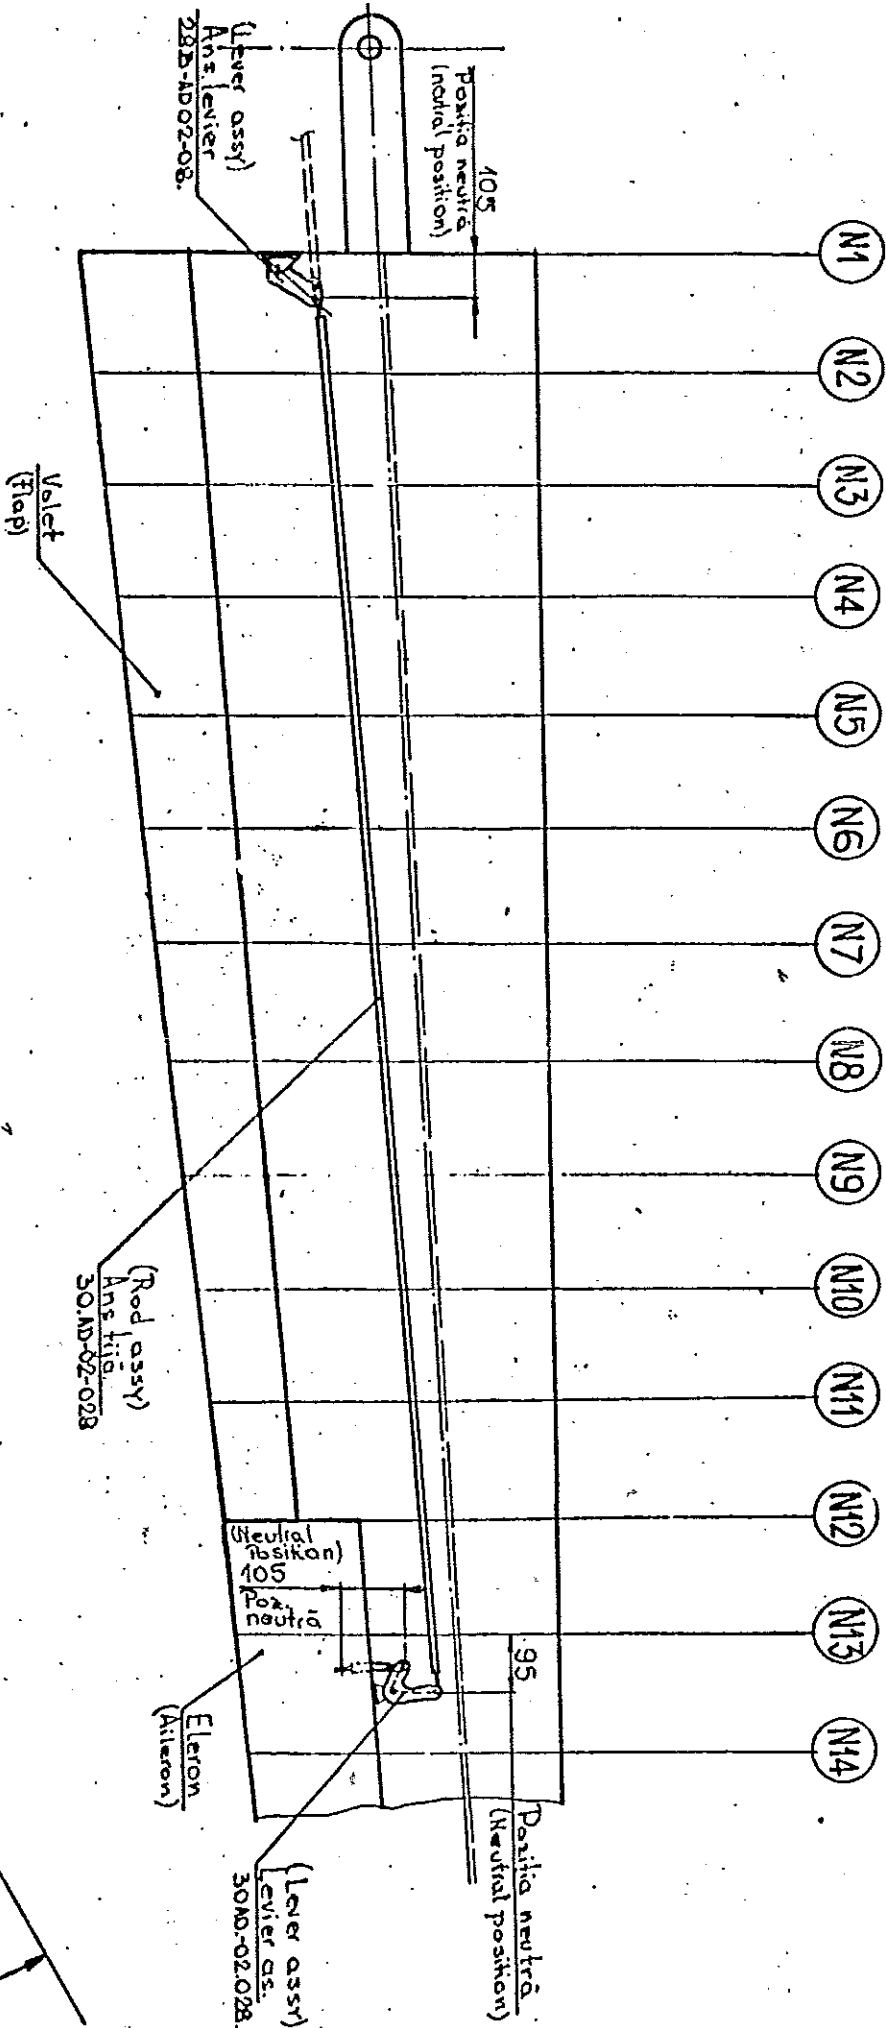
**POZITIONARE LEVIERE C-DR ELERON - Pozitia - 0°**  
 POSITIONING OF ALERON CONTROL LEVERS - 0° Position

2. GENERAL MATTERS
  - 2.1. IS-28-B2 - Inaccurate Rigging of Ailerons. Attached diagram shows up aileron  $28^{\circ} \pm 2^{\circ}$ , down aileron  $10^{\circ} \pm 2^{\circ}$ . Handling may be improved. (Gliding Federation of Australia).

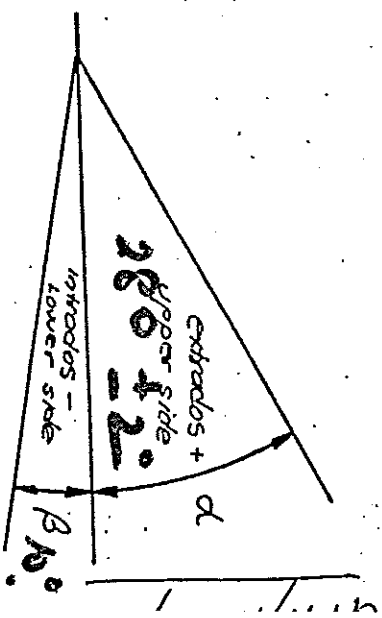
IS. 28.R.2. AILERON FIGURE

Bracarea eleranelor : +28 ± 2  
 Aileron

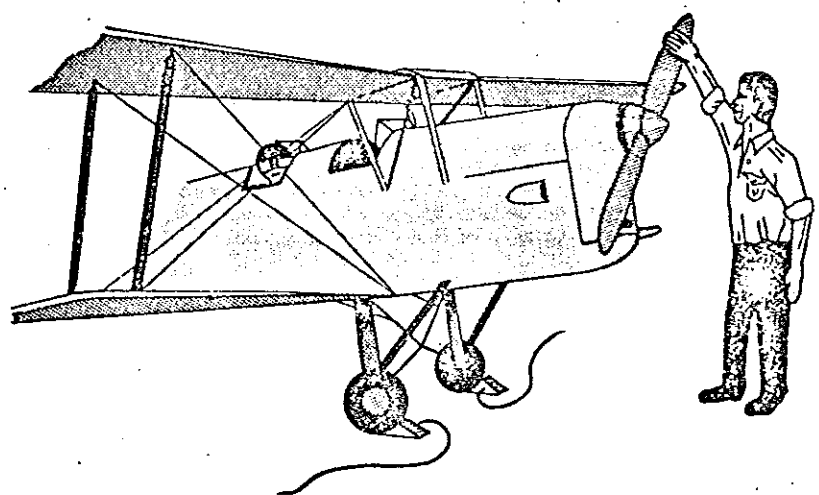
10. When swinging the propeller always move the blade downwards by pushing with the palm of the hand. Do not grip the blade with the fingers curled over the edge, since any kickback may break them or draw the body into the blade path. Follow through with the arm so that it is clear of the blade path.

11. Starting at the position shown in the Figure the propeller should be swung by moving the
  - right arm clockwise for Gipsy, Cirrus, Renault and Volkswagen engines i.e. European designed engines

- left arm anticlockwise for horizontally opposed American designed enginessmartly down and across the body turning away from the propeller and stepping away.
