BRITISH GLIDING ASSOCIATION

TECHNICAL COMMITTEE

TNS 2/3/81

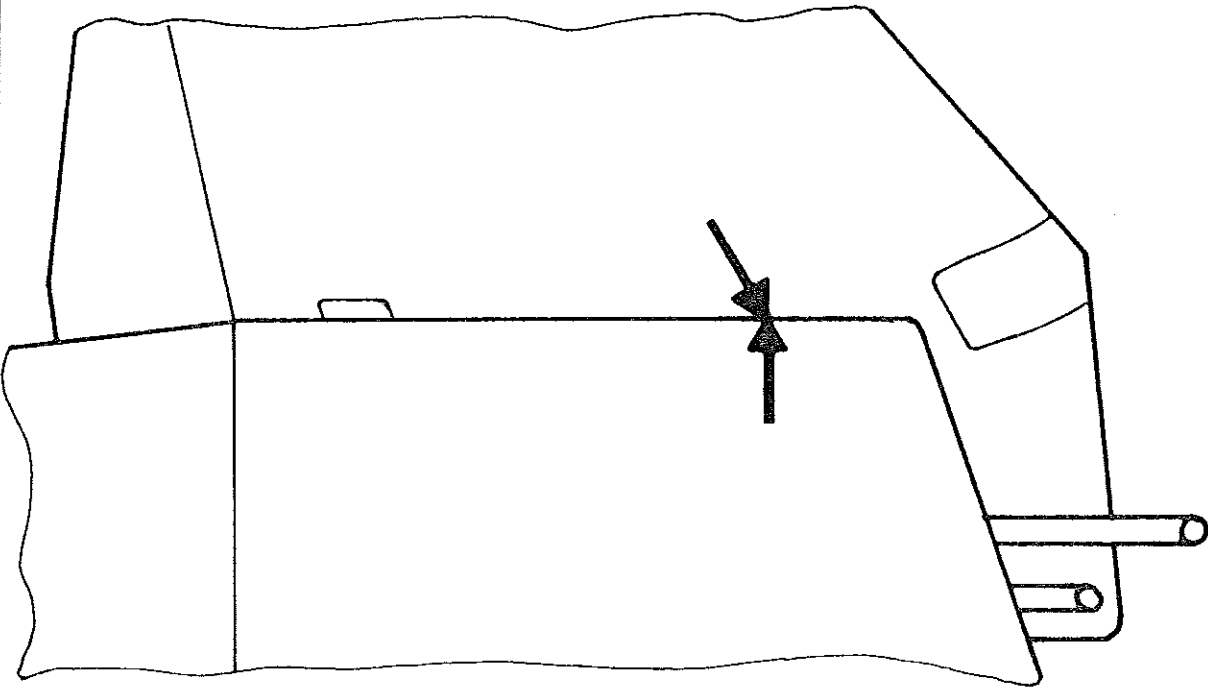
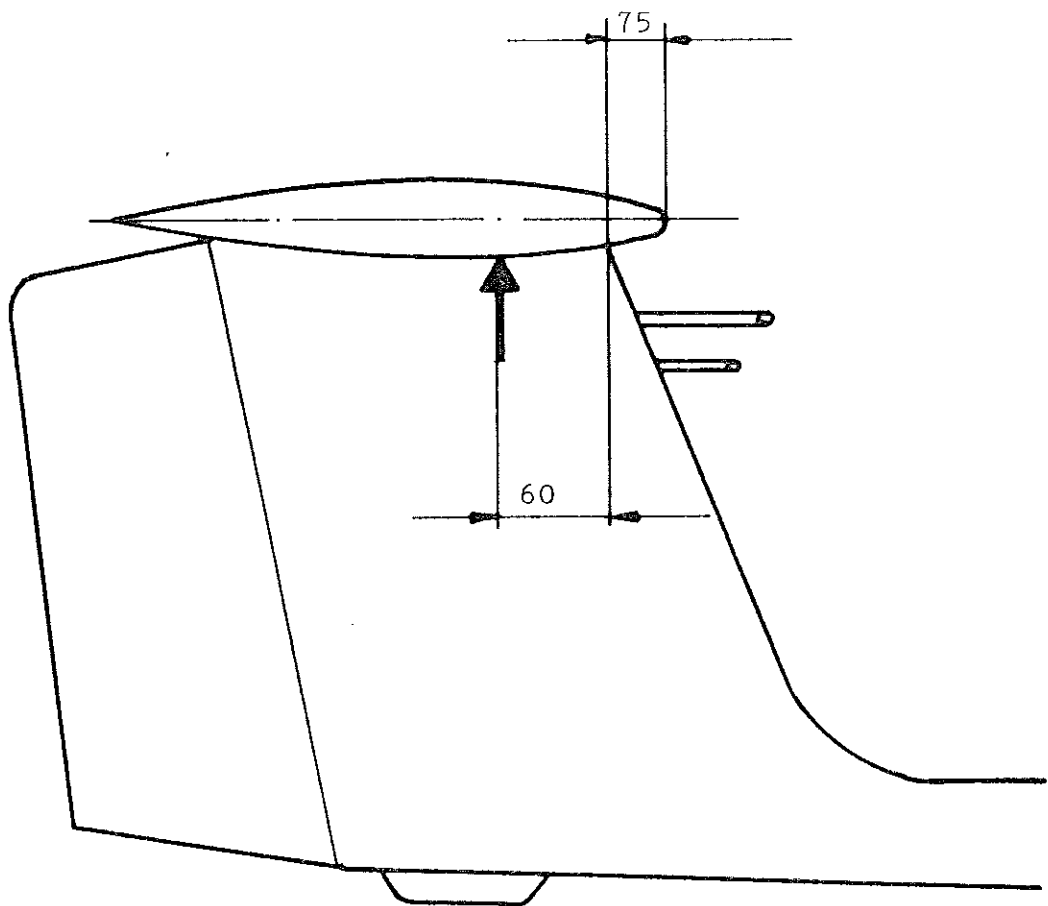
Technische Mitteilung  
TM 306-15

Subject: Marks to control the correct mounting of elevator.

Reason: This action should be taken to ensure correct markings at elevator-tabs and fin, to control correct elevator assembly-mounting.

- 1b) Provided the 4 markings at elevator and fin are still existing they must coincide after correct mounting. The former badly adhevent markings should be removed and replaced by new ones at the same position.

- 1c) Provided the 4 markings at elevator and fin are missing completely or partially, the rest of the previous marks should be removed and replaced by new markings according to construction drawing. Before applying glue make sure that the region is free of oil, grease or rest of former labels.

- 1d) To attach the new marks, it is necessary to remove the paper cover before rubbing the arrow firmly with the transparent foil. Then the foil should be carefully removed and the mark again pressed. After 24 hours the adherence is sufficiant enough to withstand application of sealing tape between stabilizer and rudder. There is no risk to remove the marking inadvertently when removing the tape.

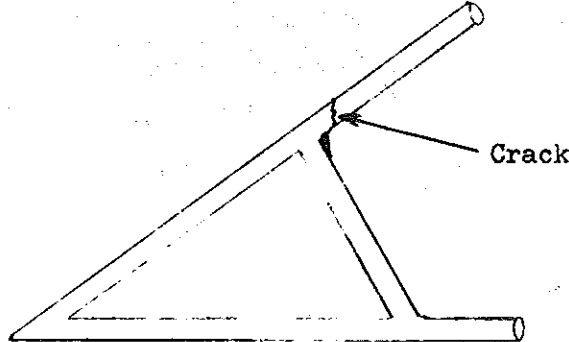
BADLY CRACKED ENGINE MOUNT

During inspection a crack was found on the left-hand engine mount. The crack emanated from the weld and had travelled approximately one third of the tube circumference. The aircraft had flown 8593 hours.

The manufacturer's Technical News Sheet No 168 calls attention to the necessity for paying particular attention to all welded joints when carrying out routine inspections of the engine mounting frames as recommended in the Maintenance and Repair Manual.

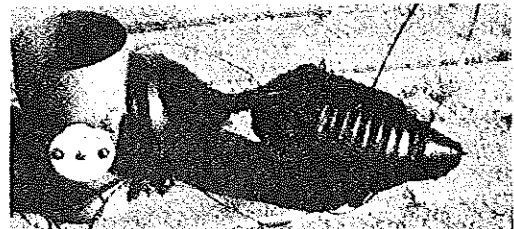
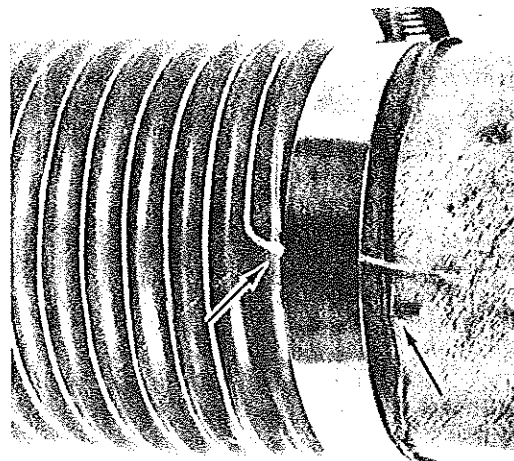
"Several incident and accident reports have been received which were attributed to the failure of the flexible air ducts installed on Cessna single-engine aircraft. Some of the reports indicated the hose assembly collapsed, resulting in loss of engine power.

"The Cessna Aircraft Company provided this photograph to illustrate how they recommend the flexible ducts be clamped. Please note that the ends of the inner reinforcing wire and the outer cord are turned 45 degrees to normal and are secured by the clamp."

"To prevent the possibility of restricting air flow through the engine air induction system, it is recommended the duct assembly be examined each 100 hours. Inspect for such duct deterioration as separation of inner lining, broken or frayed cord wrapping, evidence of hose collapsing, indication of reinforcement wire slippage, or evidence of wire not being properly bonded to the duct. Replacement of defective duct assemblies should be accomplished properly when any indication of deterioration is evident.

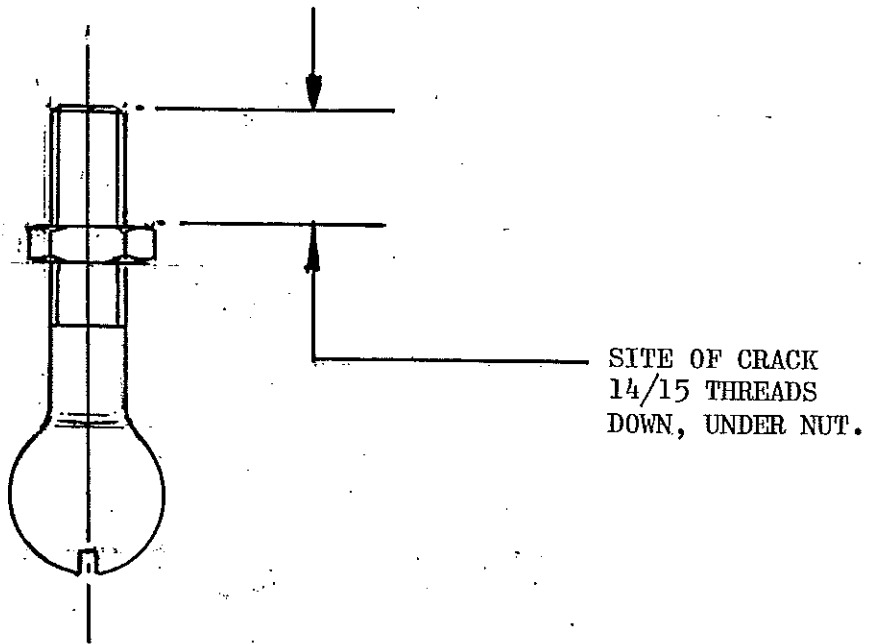
ASTIR T/P BALL.

1. AIRWORTHINESS AGGRO (Please add to 1981 pink pages).
  - 1.1. Grob Astir - Tailplane Front Ball attachment - cracked. A case of 75% cracking through the threads has been detected by Ted Henman, Dorset Gliding Club and confirmed by Non-Destructive-Testing. Reported in TNS 8/80.

CRACKED.

TAILPLANE ATTACHMENT BOLT FOUND CRACKED BETWEEN  
14 & 15 FROM START OF THREAD. THERE IS NO  
PREVIOUS HISTORY OF A GROUND LOOP ON THIS  
MACHINE.
