BRITISH GLIDING ASSOCIATION

TECHNICAL COMMITTEE

TNS 8/9/81

PART 1 (Airworthiness "AGGRO" - Please add to the 1981 Yellow Pages).

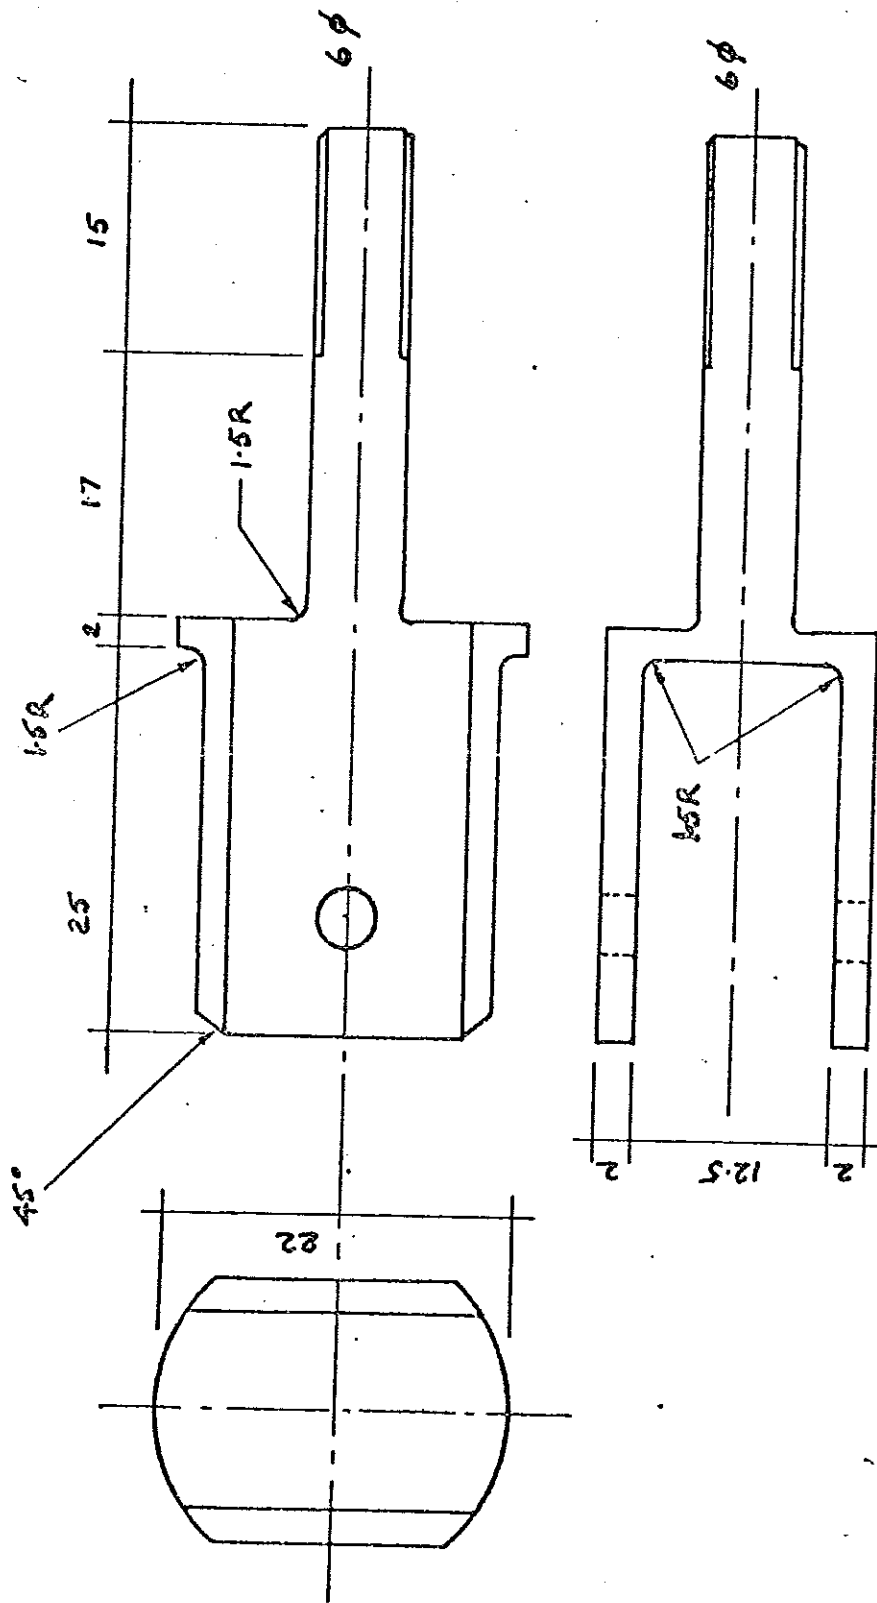
- 1.7. Bocian - Lower Rudder Hinge Failure. This item again reported by Bath & Wilts G.C. Modified hinge to DWNG MTB 060981 has been approved as BGA/Bocian/1/81. (Copy herewith).

BOCIAN LOWER
RUDDER HINGE
BRACKET

Bocian Rudder Hinge Bracket Bocian 1/81. 15/9/81.
