B.G.A. Technical Committee

TNS 10/11/12/81

TITLE <u>Kestrel Rudder Actuator Inspection</u>	T.I. No. 101/T59 Issue 1
CLASSIFICATION CAA MANDATORY	
COMPLIANCE A single inspection to be completed by 1st March 1982	
OBJECTIVE To ensure structural integrity of the rudder actuator, part number T59A-45-427	
JUSTIFICATION Cracks on the fitting have occurred, in Area 'A' shown on diagram, the cause of which cannot be established.	
APPLICABILITY All Slingsby T59A, B, C, D, E, F, G, H & J gliders including spares held in stores and all rudder assemblies pre and post Mod 25.	
CONSEQUENTIAL LIMITATIONS If cracking is found the part must be discarded immediately and scrapped.	
ACTION	
Remove the rudder in accordance with Addendum A.2.2 of the Pilots Notes. Visually examine (using a x5 magnification) the actuator for cracks especially in the area of the central weld 'A' see diagram. Should any sign of cracking be found then the existing part must be discarded and scrapped. Replace Rudder. Anotate aircraft log book showing compliance of this T.I. All findings to be reported to the undersigned.	<p><u>Inspect these areas closely</u></p>

<p>TITLE <u>T53/YS53</u></p> <p>Inspection of attachment of

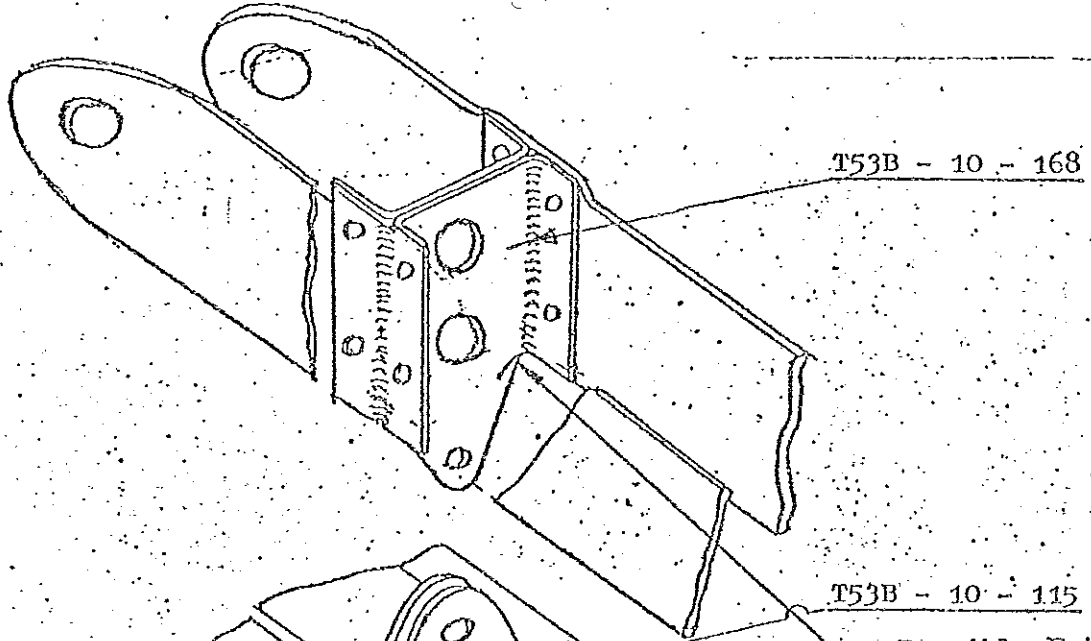
Figure 1

<p>PROCEDURE Remove glass fibre fairing No.T53B-10-1093 and wings if fitted. Using a Dye penetrant crack detection system, inspect for cracks at the corner of the fittings where the attachment flanges begin (a) the welded brackets Pt No.T53B-10-168 issue 1-4 see figure 1 page 2 which holds the rear spar member of the c/s to the fuselage frame 6 and (b) the alternative riveted bracket Pt No.T53B-10-168 issue 5. Also in a similar manner inspect the metal lugs T53B-10-115 and channel section T53-10-118 on frame 6. See Figure 2. Checking for cracks in way of rivets. If any cracks are found the aircraft is to be grounded. All findings to be reported to SEL, marked for the attention of the undersigned. New components can be obtained from SEL if required as listed above. If there are no cracks the aircraft is cleared for flight. Once the inspection has been complete the TI 100/T53 action should be recorded in the aircraft log book.</p>

T53 WING CENTRE SECTION JOINTS
TO FRAME 6

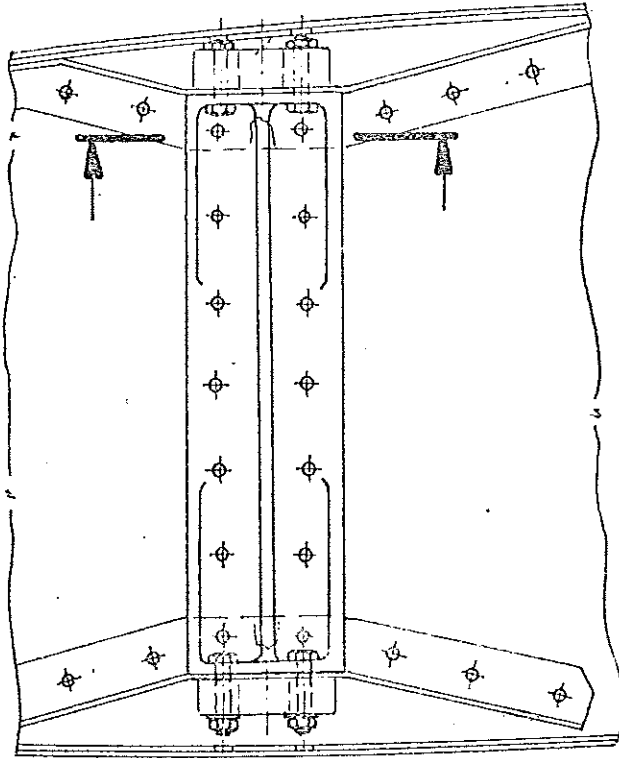
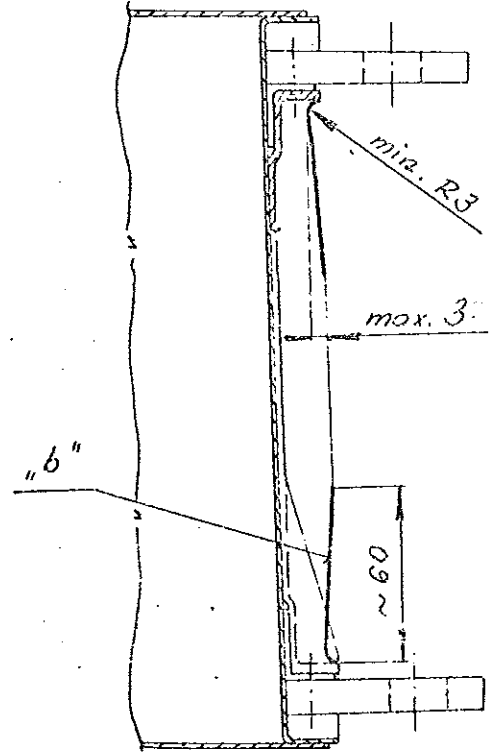
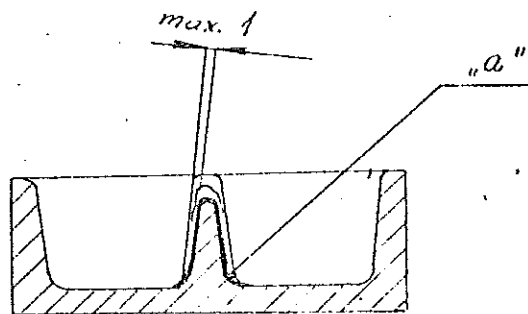
Blauk L13/048/053

- 1.2 Blanik. Wing-Root (main-spar spacer), inspection for cracks ("laps"). Bulletin L13/048 (Ref. TNS 4/5/78) has been extended to all serial numbers of Blaniks by Bulletin L13/053 dated May '81. (Extracts from L13/048 repeated herewith).

WING ROOT CRACKS.

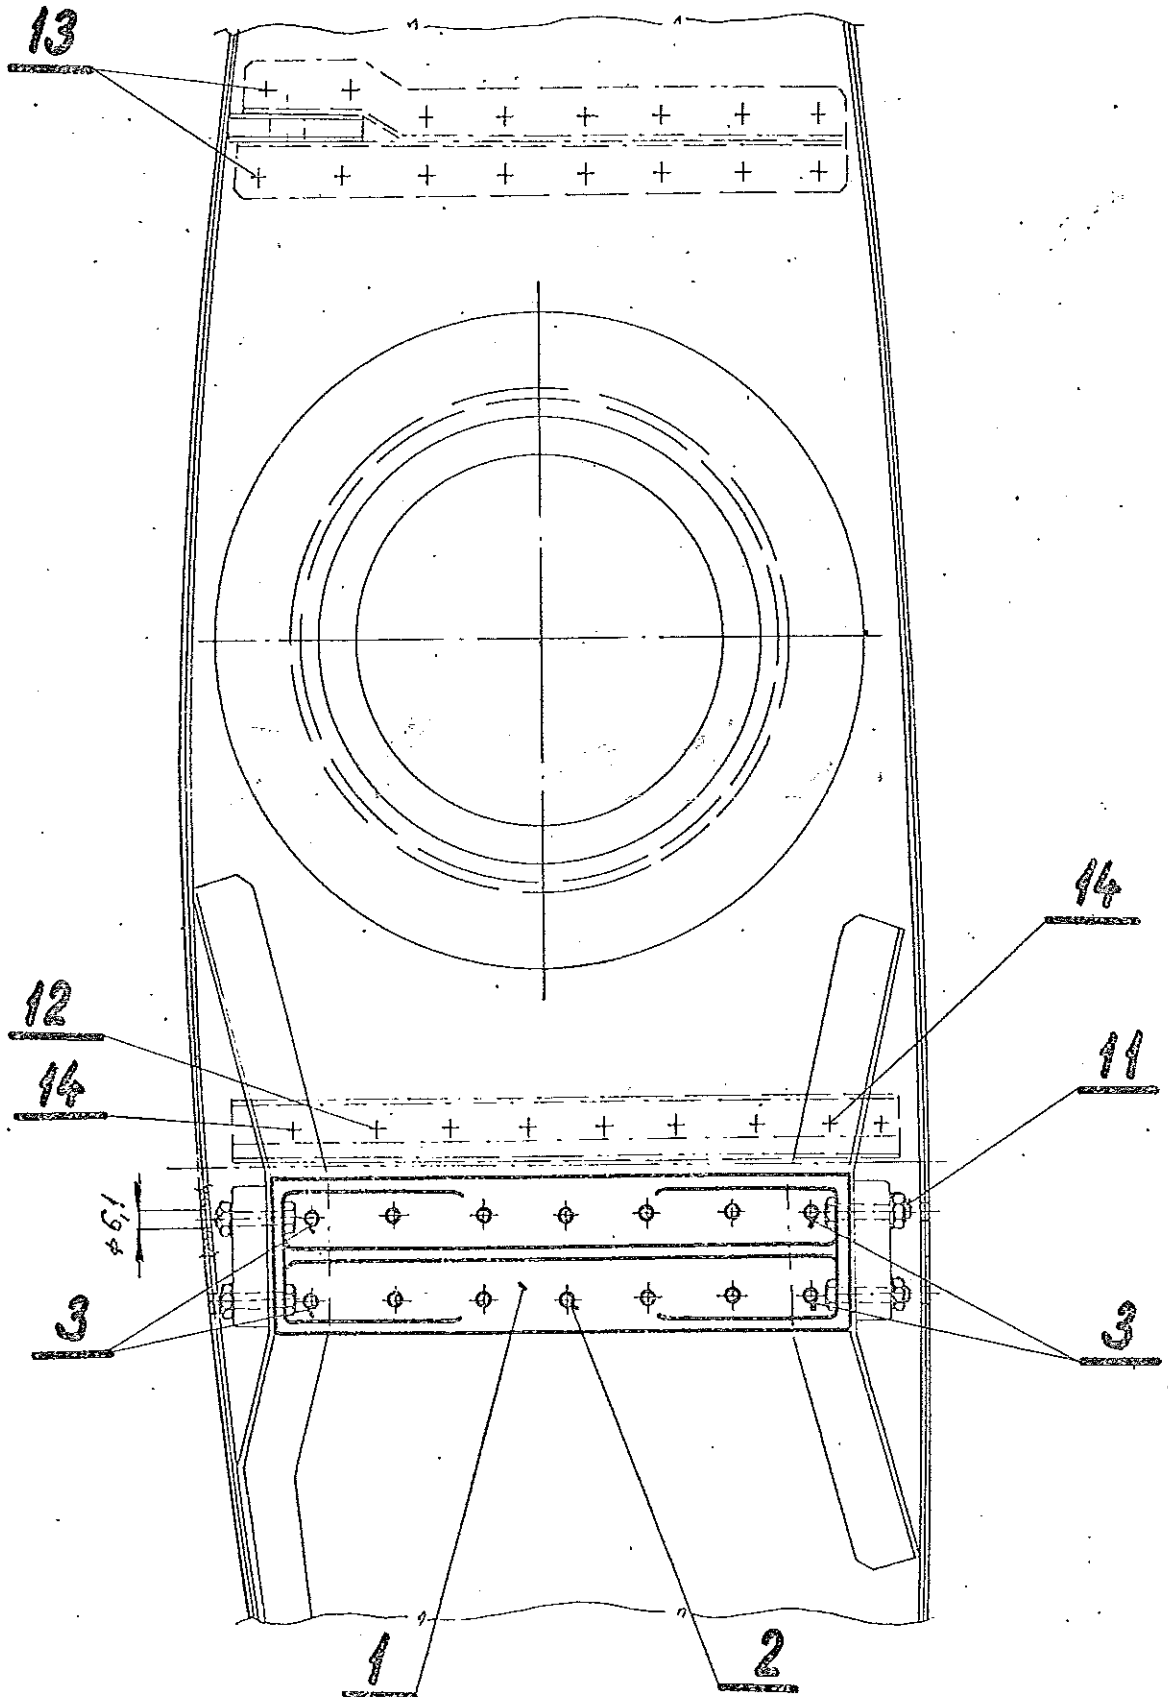
2. BLANIK L13/048/053

CRACKS at WING ROOT.
