BRITISH GLIDING ASSOCIATION

TECHNICAL COMMITTEE

TNS 6/7/81

LS4 AIR BRAKES

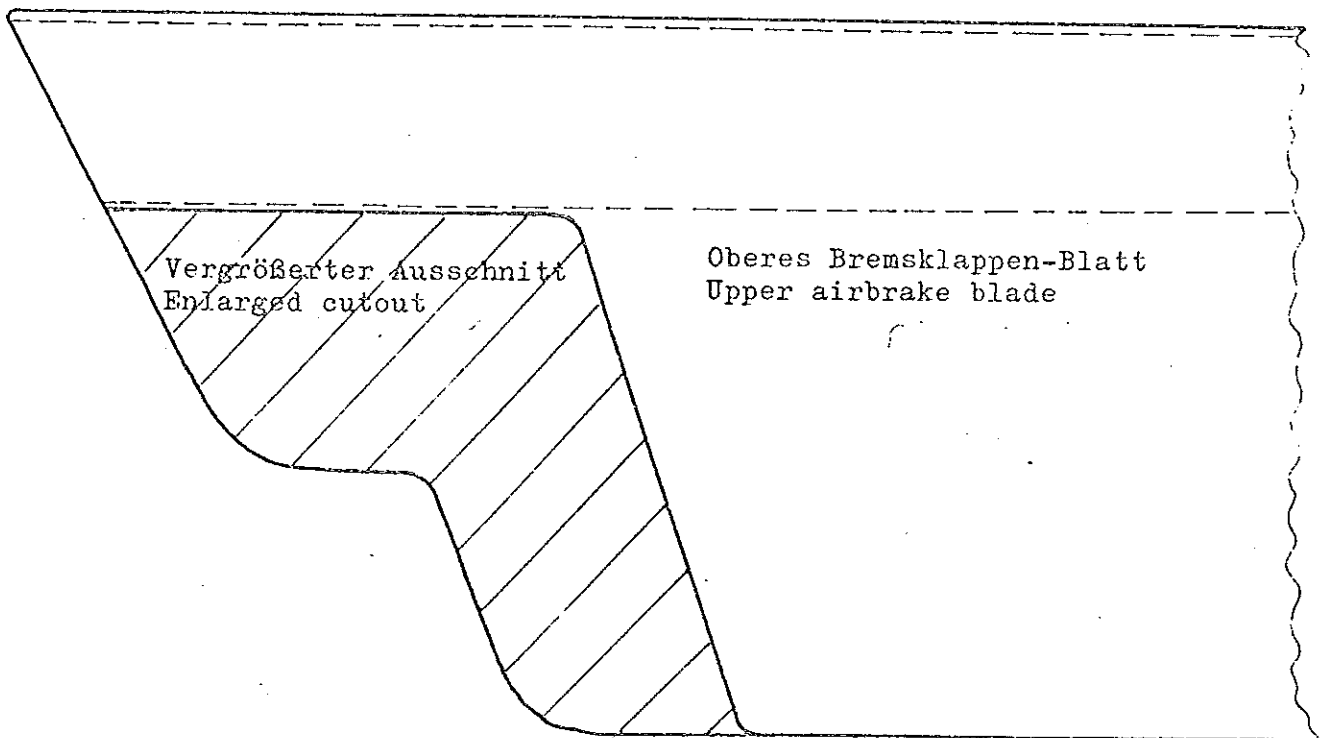
Linkes Bremsklappenblatt
Left airbrake blade

Reason : Sometimes airbrakes cannot be retracted beyond 200 km/h, because airbrake blade may interfere with the head of the drive bolt caused by manufacturing tolerances.

According to the drawing below the contour of the cutout is marked by a lead pencil and is cut out by a metal saw. The cutting edges are smoothed by a file.

Intructions : Enlarging the cutout of the upper airbrake blade on the inner side according to drawing 4005-2
