B.G.A. Technical Committee

Technical Newsheet T.N.S. 1/82

T.I. No.102/T61 Issue 1

TITLE
T61 'FALKE' (MOTOR GLIDER) FORWARD TAILPLANE BRACKET

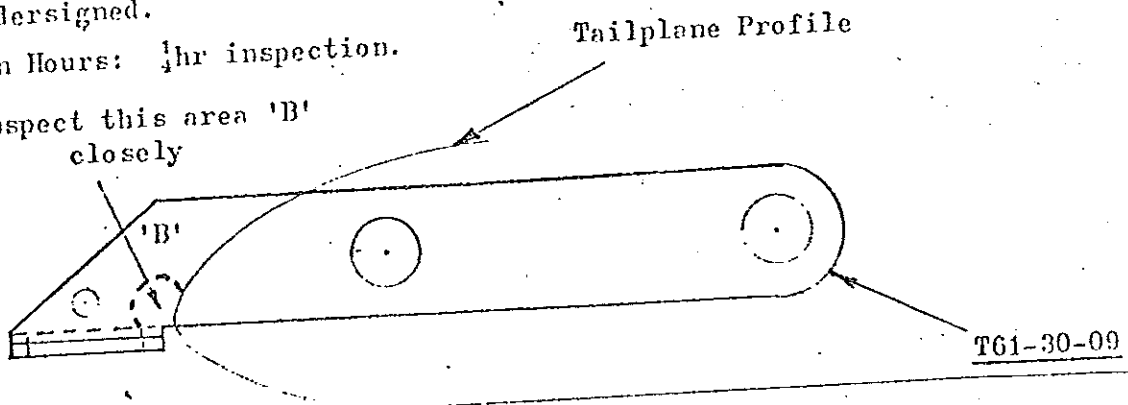
Inspect this area 'B' closely

JUSTIFICATION Cracks on the fitting have occurred in Area 'B' shown on diagram, the cause of which cannot be established.

ACTION If there is any paint on the bracket it should be completely removed. Visually examine (using a x 5 magnification) the bracket for cracks in area 'B' shown in the sketch below.
Should any sign of cracking be found then the existing part must be discarded and scrapped.
Undamaged parts may be returned to service.
Annotate aircraft log book showing compliance of this TI.
If the fitting shows any signs of damage this must be reported to the undersigned.
Man Hours: 1/2 hr inspection.

CONSEQUENTIAL LIMITATIONS
If cracking is found the part must be discarded immediately and scrapped.

PARTS REQUIRED
If inspection reveals a defective bracket, a replacement T61-30-09 Issue 4 (one off) bracket may be obtained from SEL.
