B.G.A. Technical Committee  
TNS 2/3/82

Part I     Airworthiness "aggro"     (Please add to the 1982 Blue pages).

R.B. Stratton  
Chief Technical Officer  
British Gliding Association

TNS / 3/82.AD/31-265 / JANUARY 21-82Mailed to OWNERS 23/2/82.Subject :

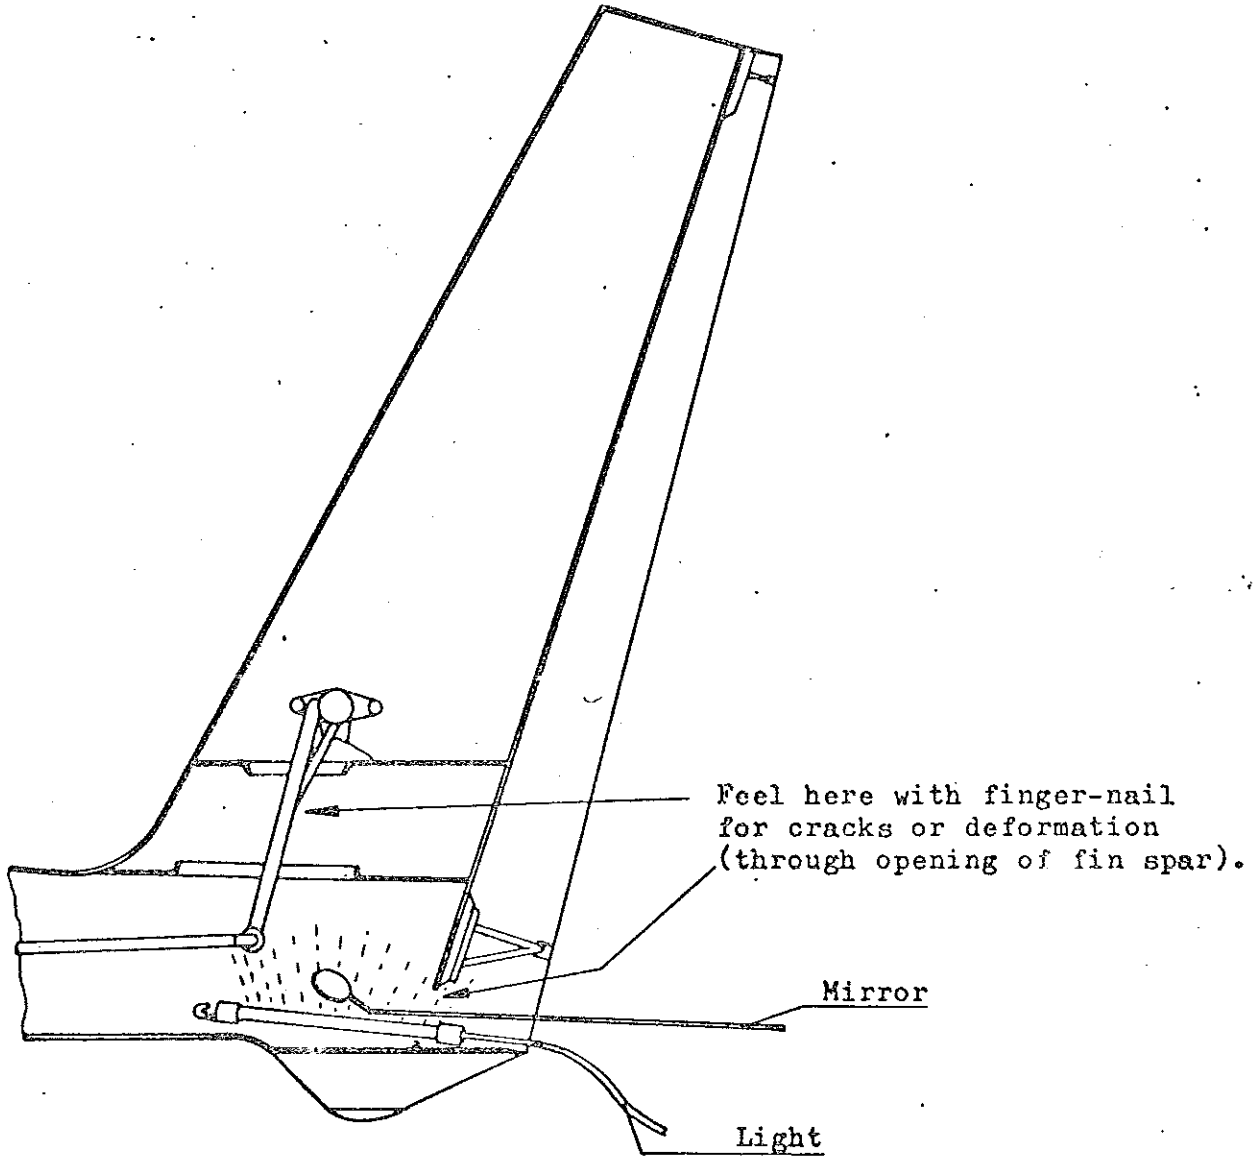
With an ASW 15 the bellcrank actuating the elevator failed in flight (see attached sketch). Luckily the pilot could save himself by parachute. An inspection of the bellcrank showed that an older crack most likely caused by a hard landing some years ago resulted in fatigue failure of the bellcrank.

1. The elevator actuator bellcrank must be inspected for cracks. To do so the rudder has to be disconnected from the fin, as the inspection is possible through a hole of the fin spar (see attached sketch). The inspection area is not directly visible. However, with the finger-nail a major crack can be felt. Smaller cracks may be found by using a mirror and a small light which is fixed to a small strip of wood or a piece of wire.  
If no cracks are found, the rudder can be rigged again to the fin and safetied.
2. If cracks are found, the bellcrank must be exchanged against a new one, i.e. a bellcrank according to drawing 151.35.1011 (showing the correction note "TM 21 dated 24-11-81"). For carrying out this job the Repair Instruction "A" for the ASW 15 is to be used.
3. A copy of the inspection report must be sent to the manufacturer.

If a new bellcrank is installed as mentioned under point 3 of the section "Instructions", it is recommended to install simultaneously the stronger plywood stiffeners of the ASW 15 B (see Repair Instruction "A").

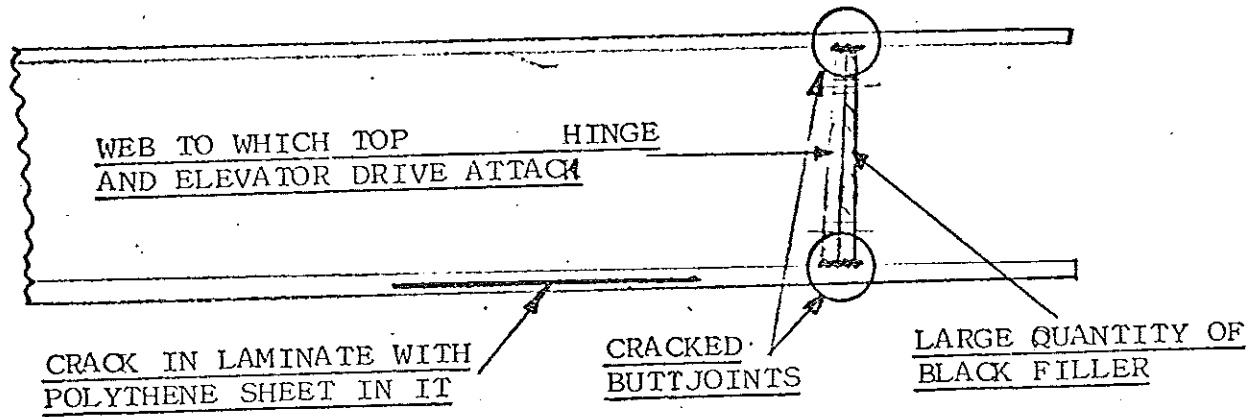
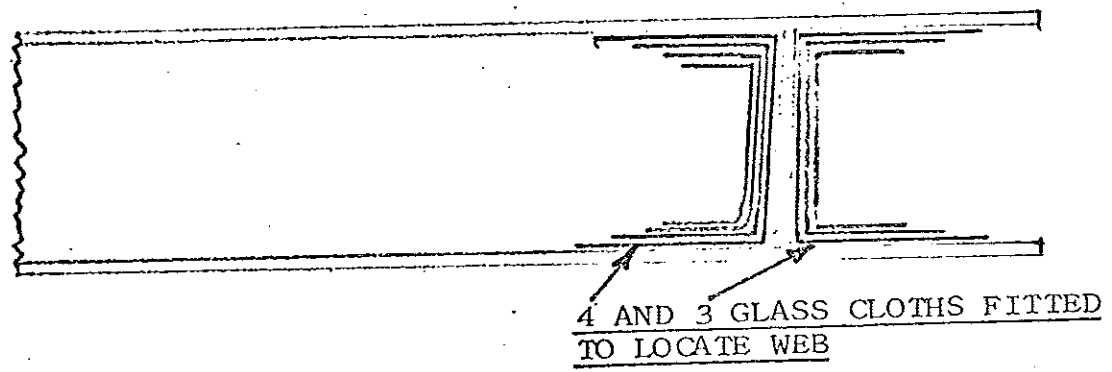
DIAGRAMATIC VIEWS LOOKING DOWN ON THE REAR TOP OF THE FIN  
BEFORE AND AFTER REPAIR

- 1.6     VEGA (T.65). Fin spar carrying Rudder hinge and elevator drive, detached from skin. (Reported by Tim Macfadyen - (Sketch attached) and reported to Slingsby Engineering).

The web to which the top rudder hinge and elevator drive are bolted was cracked from the fin sides. A quantity of filler was removed from its rear face, the area cleaned up, and 7 laminates of 10<sup>02</sup> (INTERGLASS 9215) bidirectional cloth layed on at 45°. The bolt holes were re-drilled and all was reassembled with filler to correctly position the fitting.

A 1" x 3" piece of polythene was removed from the centre of the fin laminate, see sketch. The crack was glued up with Epicort/Epicure.

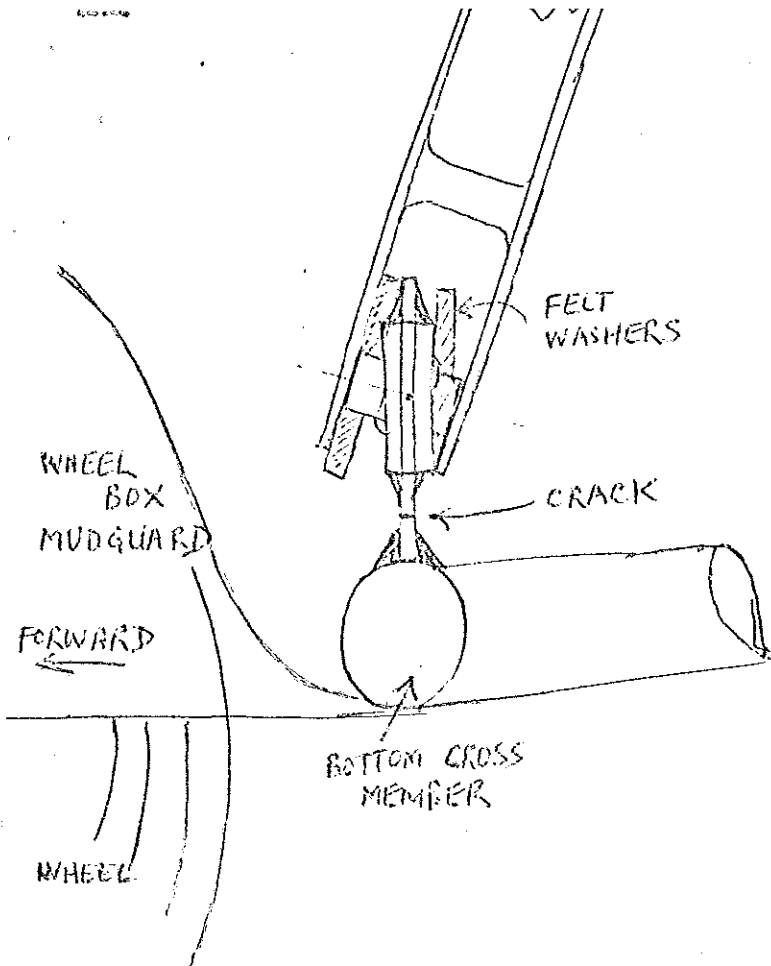
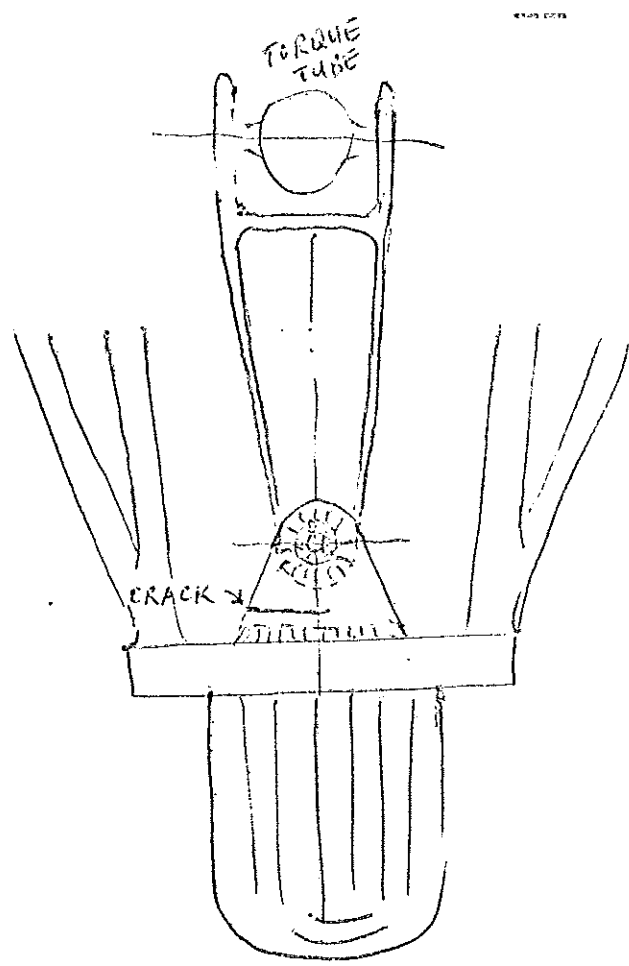
POSITION OF CRACK ON  
BEARING SUPPORT BRACKET ON FUSELAGE  
OF KA 86 BGA 2083

- 1.7     KA 8 - Control Bracket mounting in centre section (Sketch attached), cracked. Repair by Welding. (Reported by R. Jarvis S.G.C.)
- 1.8     ASW 15 & 15B. Elevator Actuator Bell-crank possible fatigue-failure in flight. Copy herewith and mailed to owners. Inspect/Replace as required.

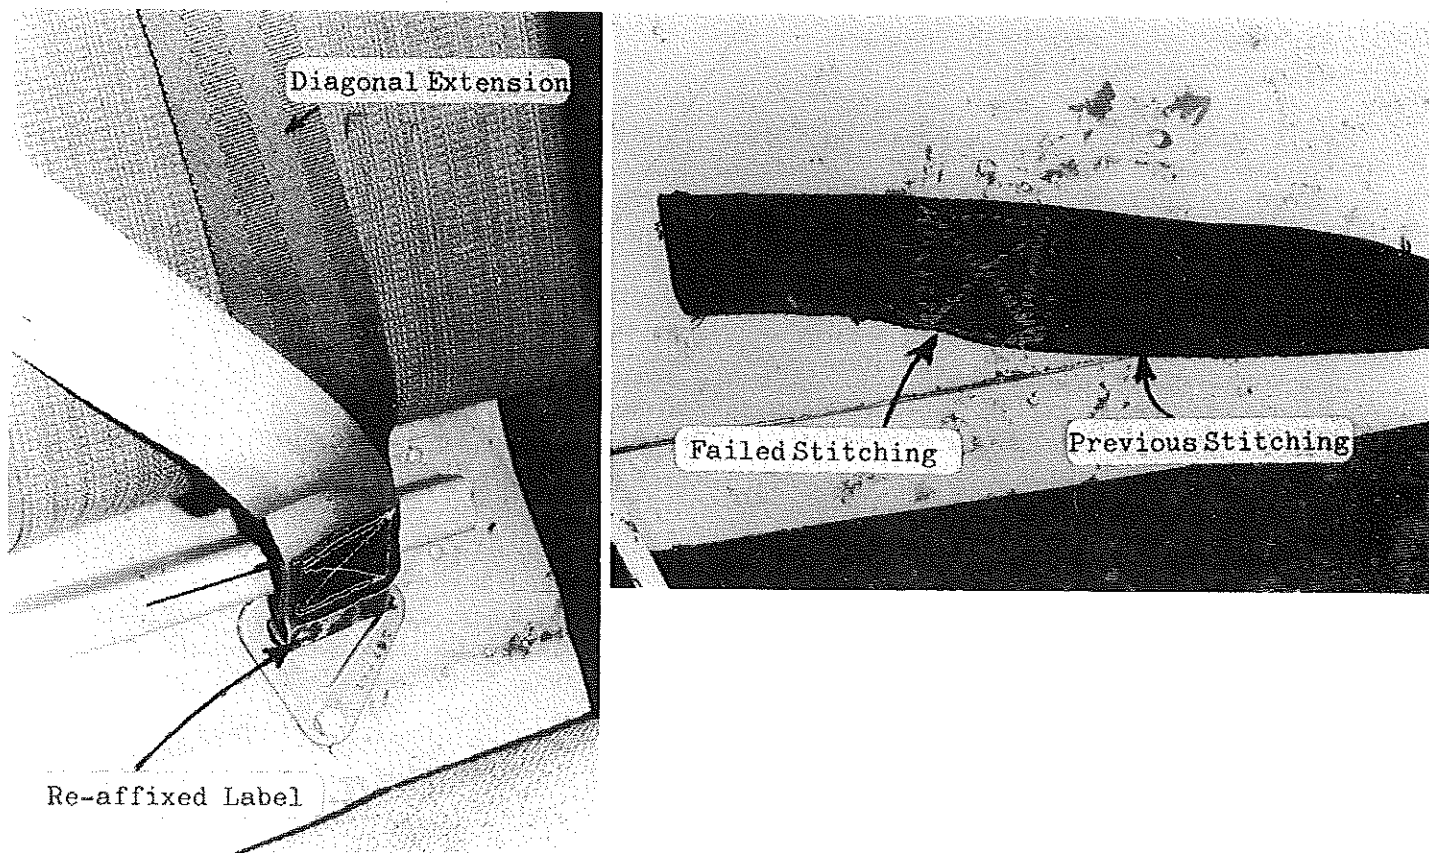
Investigation showed that the lap strap material was of a different colour from the diagonal strap. The diagonal strap had been added by firstly passing it through the airframe mounting fitting and then sewing it to the lap strap. The stitching had failed, because the thread used was weaker than that normally used for this purpose and the stitch pattern was imprecise. Nearby were signs of other stitching indicating a previous application. One of the lap strap manufacturer's labels had been re-affixed onto the end of the diagonal strap.

Any modifications of this sort are quite incorrect and if any other aircraft have been altered in this way their owners/operators should obtain and fit the proper equipment - you may only need it once but it has got to be effective.
