B.G.A. TECHNICAL COMMITTEE  
Technical Newsheet: TNS 4.5.82

PART 1                    Airworthiness "Aggro".    (Please add to 1982 Blue Pages).

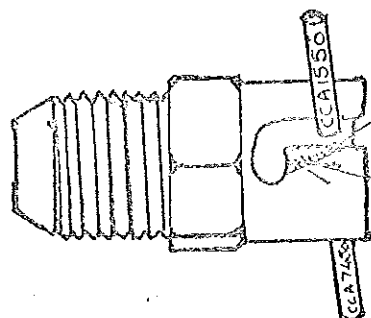
C.S.E. SERVICE BULLETIN 6/75

Investigations have proved that, in some cases, the problems have been due to the Curtis drain valve, on the bowl of the fuel filter, located between the fuel cock and the engine driven fuel pump, being inadvertently locked in the open position after carrying out a water check during a pre-flight inspection.

In order to prevent a re-occurrence of the above problem, modify all Curtis drain valves, part number CCA 1550 (Piper P/N 492-022) and CCA 7450 (Piper P/N 492-100), located between the fuel cock and the engine, as indicated in the sketch below, taking care not to damage the spring in the process.

Carefully file off shaded area of slot sufficiently to prevent the valve locking in the OPEN POSITION. Vendor part number CCA 1550 (Piper P/N 492-022) and CCA 7450 (Piper P/N 492-100).
