TNS 8/9/82

PART 1 AIRWORTHINESS "AGGRO" (please add to the 1982 Blue Pages)

To all owners -  
TN 8/9/82

SUBJECT :  
1. Elevator drive.  
2. Tail parachute.  
3. Horizontal tailplane.  
4. Amendments of the Flight and Service Manual.

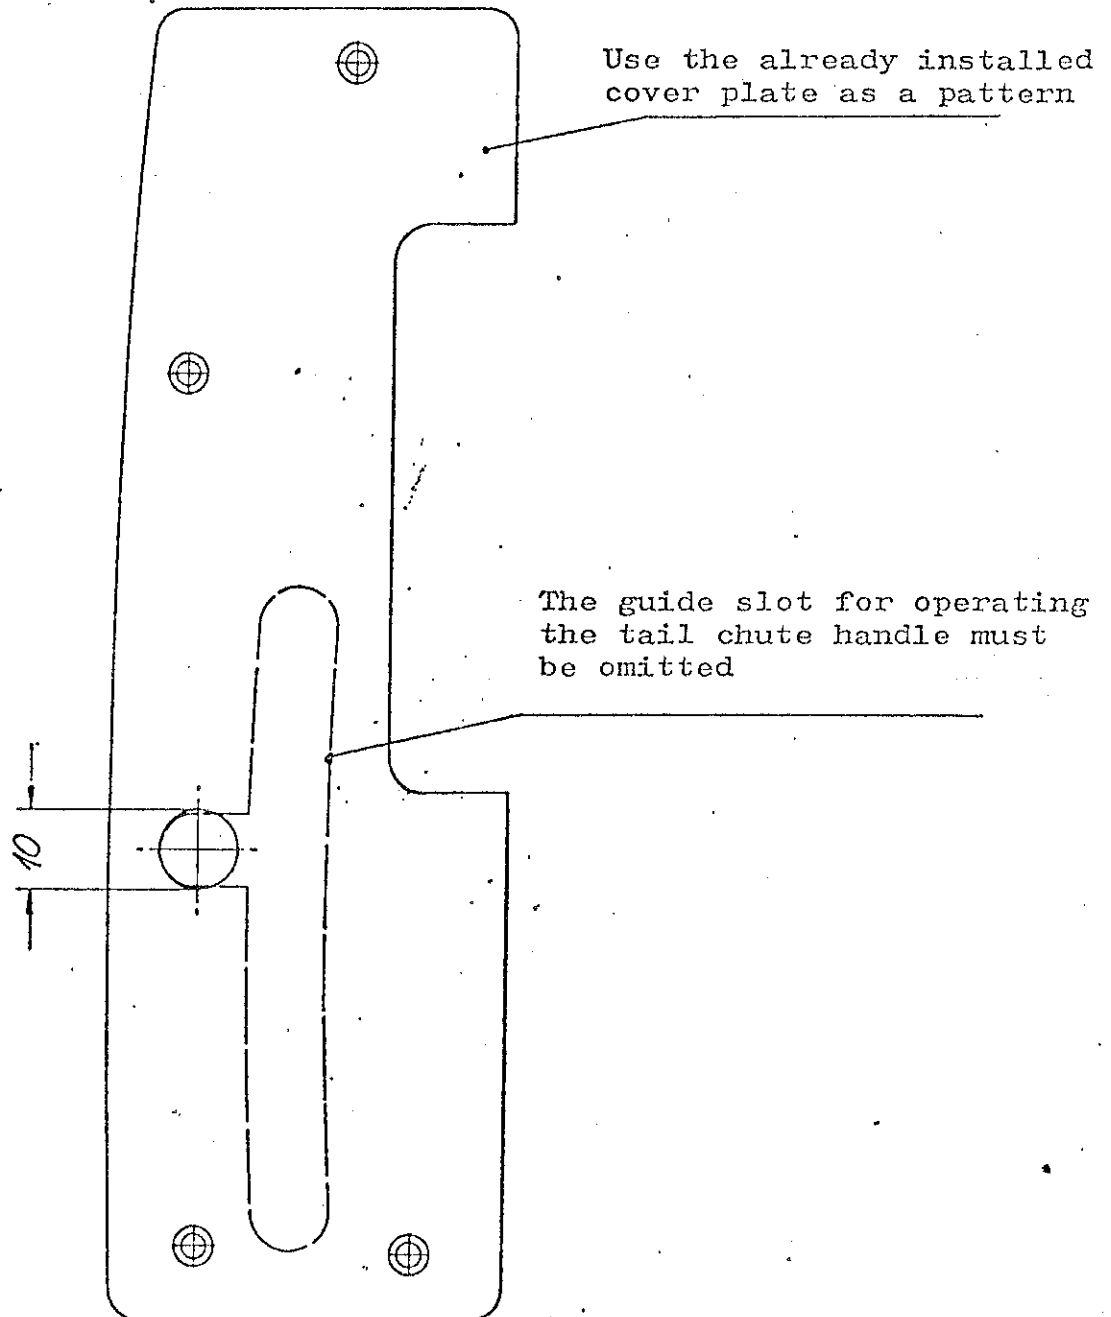
Cover plate for locking the tail parachute  
operating handle .

- a) Lock the operating handle for the tail chute in the cockpit as shown on the sketch, page 4 of this Note.
- b) Screw off the blue ball knob.
- c) Remove the reference placard for tail chute operation, if any.
- d) Check the tail chute box for a drainage hole (dia 6 mm).
- e) Amendments of the Flight and Service Manual:

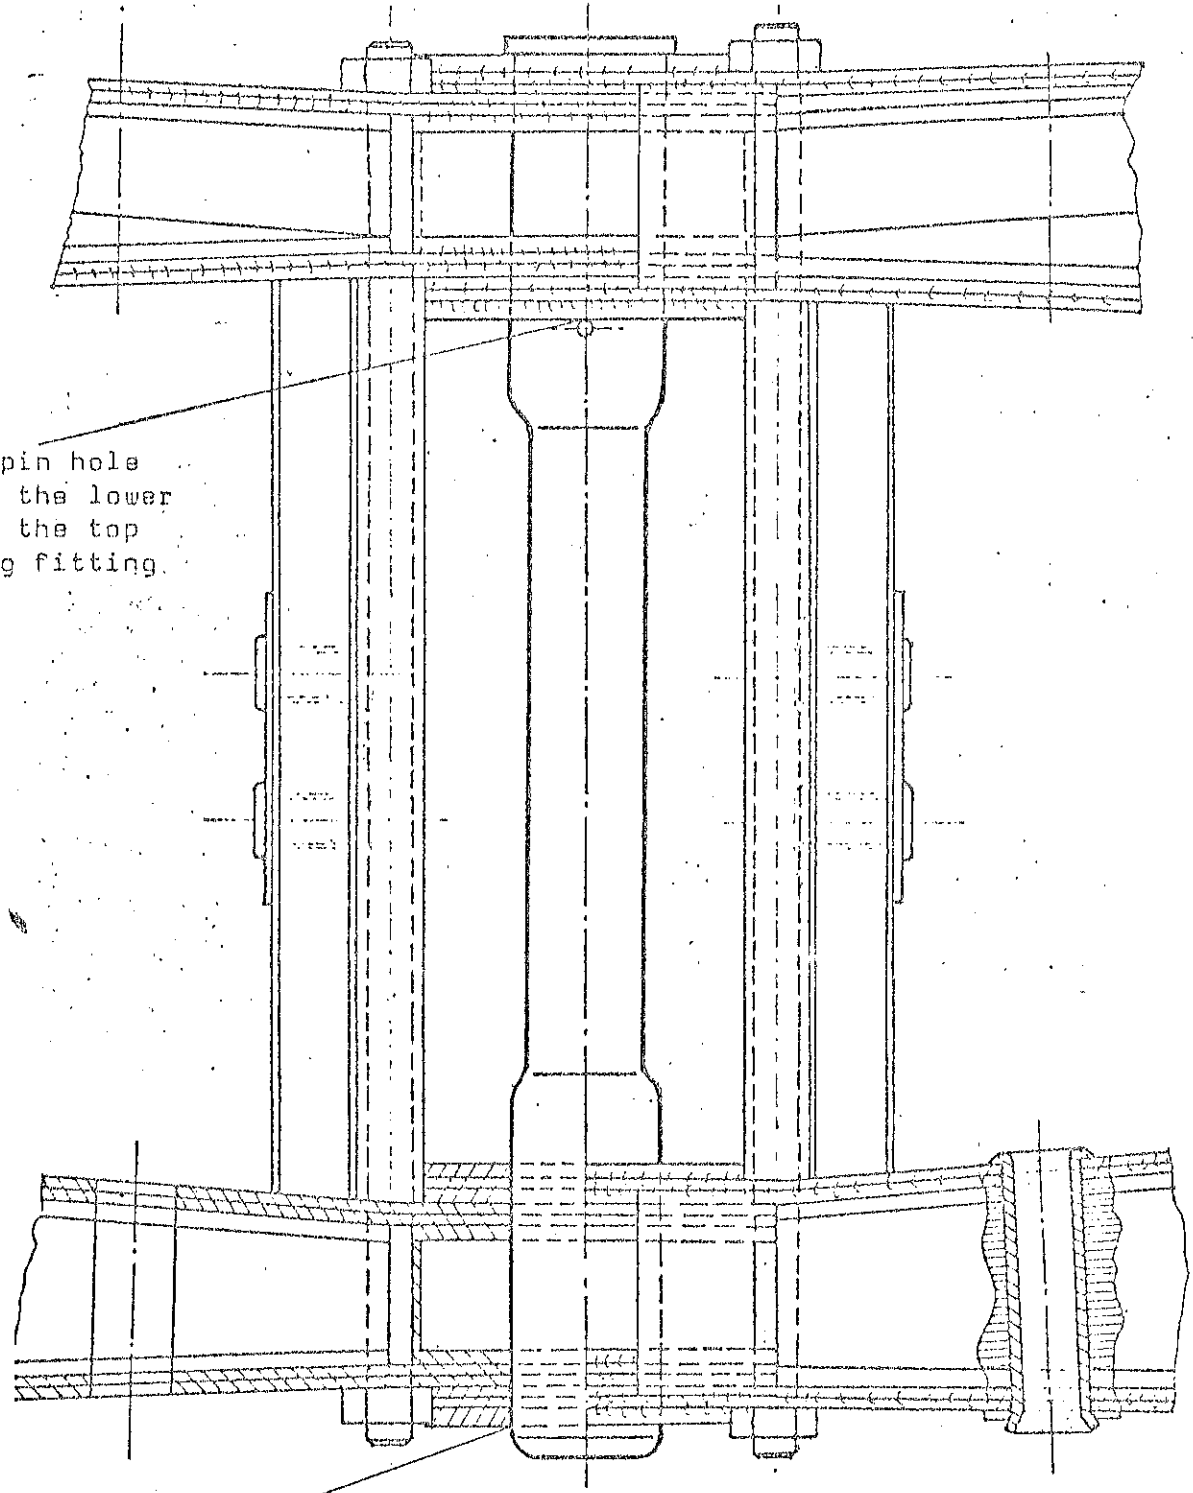
1. It must be checked that the main rigging pin is fully through the bottom lug fitting. With the main rigging pin pulled fully upwards by means of the tee handle, such that the 2.5 mm safety pin is hard against the lower face of the top boom lug fitting, inspect the amount of plain portion of main pin shank protruding below the port bottom boom lug fitting (Wings imburdened). If difficulty in the inspection is encountered when the Motorglider is assembled due to poor access, the wings must be removed and port wing inspected. Certainly upon the following assembly the inspection must be made again (when necessary, by help of a mirror and a handlamp).  
Should no plain shank be visible protruding below the port bottom lug fitting, according to 1., the aircraft shall not fly until the cause has been established, and rectified. For that, contact the manufacturer Fa. Scheibe Flugzeugbau.

Safety pin hole  
against the lower  
face of the top  
boom lug fitting.

Plain portion of the main  
rigging pin must protude below  
port bottom boom lug fitting

2. Normally the main rigging pin has one safety pin hole. If more than one safety pin hole exists the aircraft must not be flown until the correct hole has been established, and the redundant hole made unusable (flush rivet)

If the inspection according to 1., shows that the main rigging pin is not fully through the bottom lug fitting with the plain portion, the first thing is to check that, with the main rigging pin fully down, another safety pin hole could be made, so that the plain portion is through the bottom lug fitting. Another thing to check is that the female lug fittings has not been splayed through a wrong assembly. In case the fittings must be straightened and a new inspection according to 1., must be made, contact Fa. Scheibe Flugzeugbau.
