BRITISH GLIDING ASSOCIATION

Technical Newsheet. TNS 11/82

<b>TITLE</b> T65 'VEGA' Central Elevator Hinge on Tailplane, Elevator Tongue & Pivot Bearings for Elevator Rocker Arm.	<b>T.I.No.</b> 104/T65 Iss.1
<b>CLASSIFICATION</b> C.A.A. Mandatory	
<b>COMPLIANCE</b> Inspection to be carried out before the next flight unless LTO 'Elevator & Canopy Jettison Mechanism', 20th August has been carried out.	
<b>OBJECTIVE</b> To ensure structural integrity of the central elevator hinge on tailplane elevator drive tongue and to inspect the pivot bearings for the elevator rocker arm assy. Also to reinforce central elevator hinge on tailplane.	
<b>JUSTIFICATION</b> Cracking and a lack of stiffness has occurred in the area 'A' (Fig 1), the cause of which is attributable to heavy landings and/or excessive bearing loads during elevator assembly.	
<b>APPLICABILITY</b>  All Slingsby T65A, C, D gliders, including spare tailplane/elevators expanding on CAA Airworthiness Directive No.008-08-82. (LTO 'Elevator & Canopy Jettison Mechanism', 20th August).

TITLE		T65 'VEGA' Canopy Jettison Mechanism	T.I. No. 105/T65
CLASSIFICATION C.A.A. Mandatory			
COMPLIANCE Inspection to be carried out before next fl

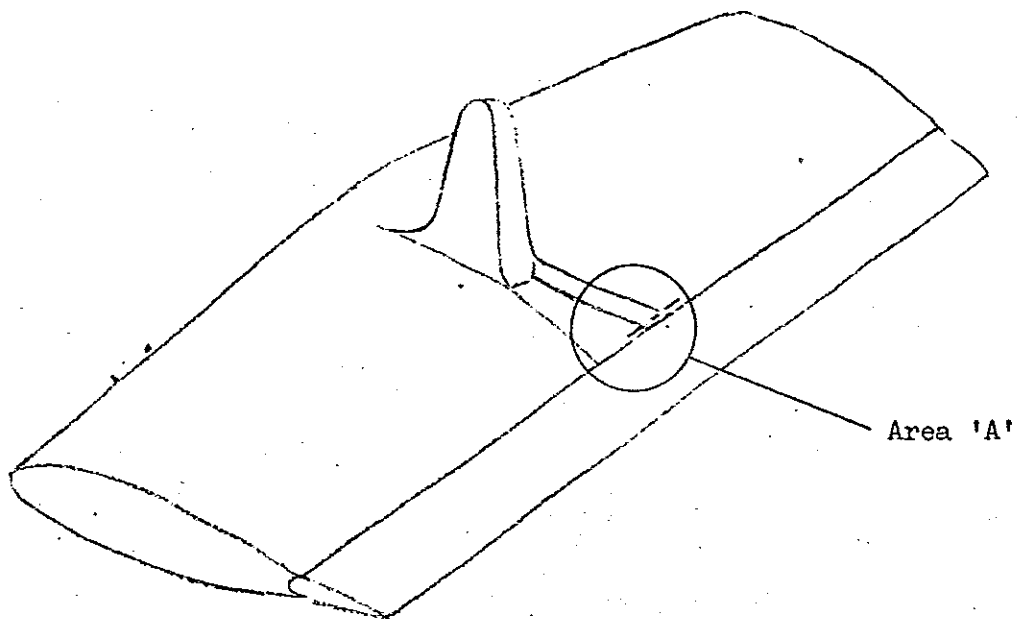
FIG 1 Area of Cracking on Vega T-Plane

1.3 Inspect the tailplane centre hinge pin mounting rib at the section just forward of the hinge pin as detailed in Fig 6. If cracks or damage are found a repair entailing the fitting of a new 'reinforced' rib will be required. The repair scheme is detailed in Section 4 and should be undertaken by S.A.L. or an approved repair shop. If the section does not show signs of cracking a reinforcement cloth will be required as detailed in Section 5. Alternative means of repair for minor cracking may be carried out with the agreement of SAL.  <u>Note</u> - Use Epikote 162/Epikure 113 resin system throughout.	
<b>ISSUED BY:</b>  <div style="text-align: center; font-size: 1.5em; font-family: cursive;">B Mellors</div>	<b>Date</b> 22nd Sept 82
for and on behalf of <b>SLINGSBY ENGINEERING LIMITED</b> <small>Kirkbymoorside, York YO6 6EZ, England. Tel. 0751 31751 Telex 57911</small>	<b>Page</b> 1 of 6

<b>CONSEQUENTIAL LIMITATIONS</b>  If cracking is found on the tailplane central hinge the repair will require a new central tailplane rib (T65A-30-15) which must be fitted by S.A.L. or an approved repair shop before next flight.	
<b>ACTION</b> - Inspection to be carried out as follows :

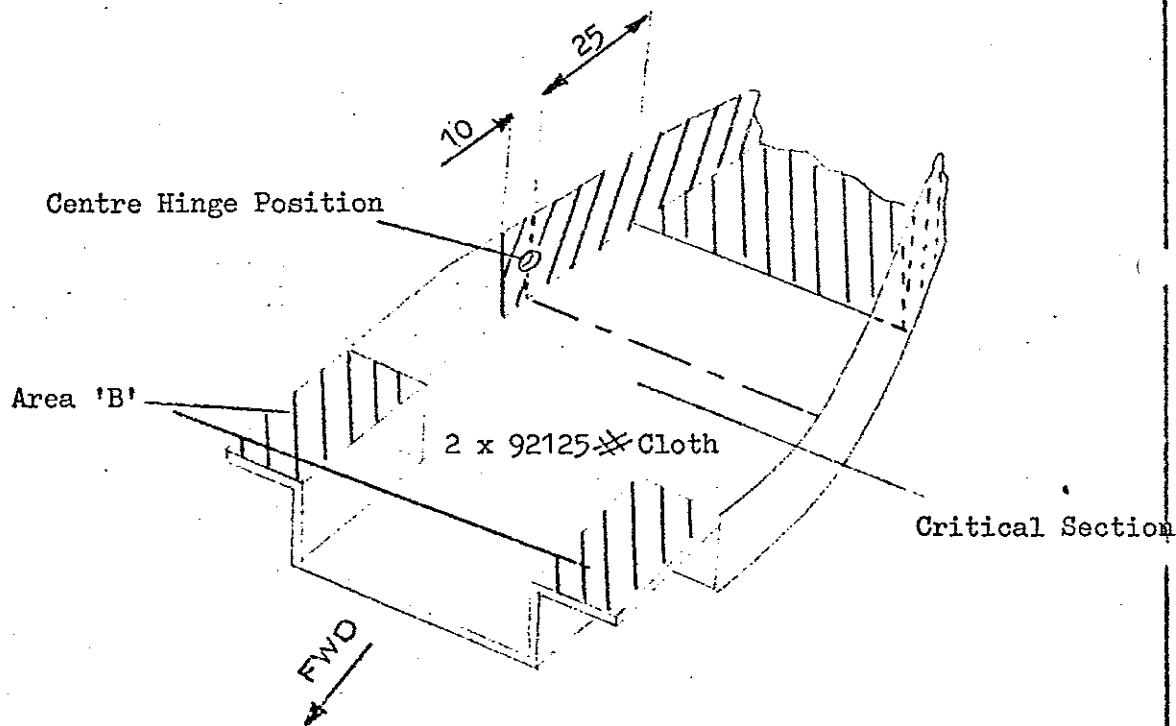
FIG 2 Reinforcement of Elevator-Tongue

Only layup cloth on the inside of the tongue on the area NOT shaded.

- 2.1 Rectification of lack of stiffness of the elevator tongue will be as follows :-
- (a) Remove the tailplane/elevator assembly from the aircraft.
  - (b) With the elevator removed from the tailplane, abrade the tongue of the elevator over the area detailed in Fig 2.

- (c) Layup 2 layers of woven roving cloth (2 x 92125~~XX~~) over the area detailed in Fig 2.
- 3.1 If the pivot bearing 04 DU 04 is worn it may be replaced as follows (refer Fig 3).

- (j) When fitting the tailplane elevator assembly ensure the elevator tongue seats correctly on the actuator. If there is a clearance between the tongue and actuator the tongue must be built up in the Area 'B' detailed in Fig 2. If there is a foul between the tongue and actuator, the tongue must be trimmed (refer Area 'B' Fig 2) to seat properly on the actuator. Build up the cloth under the flanges and around the web to compensate for any cloth removed.

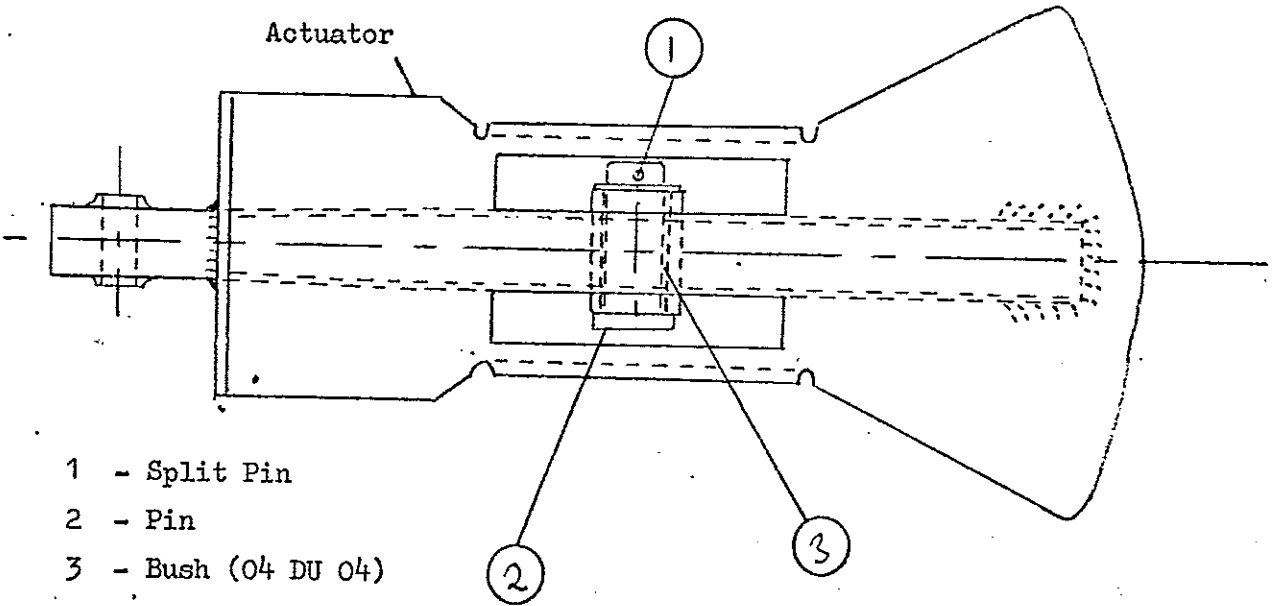
FIG 3 Actuator Pivot Bearing

1.2 Inspect the pivot bearings (04 DU 04) for the elevator rocker arm assembly, on the top of the fin for wear. Any wear found in excess of 0.01" in the fwd & aft direction must be rectified before further flight. Fitting of the bearing is detailed in Section 3.

- (a) Remove the tailplane/elevator assembly from the aircraft.
  - (b) Remove the split pin (Item 1) and washer from the central hinge of the actuator (located on top of fin).

- (c) Remove pin (Item 2).
  - (d) Disconnect the pushrod on the fwd end of the actuator (similar to above).
  - (e) Drift the bush from the elevator actuator assembly and replace with new bush (04 DU 04), available from S.A.L.

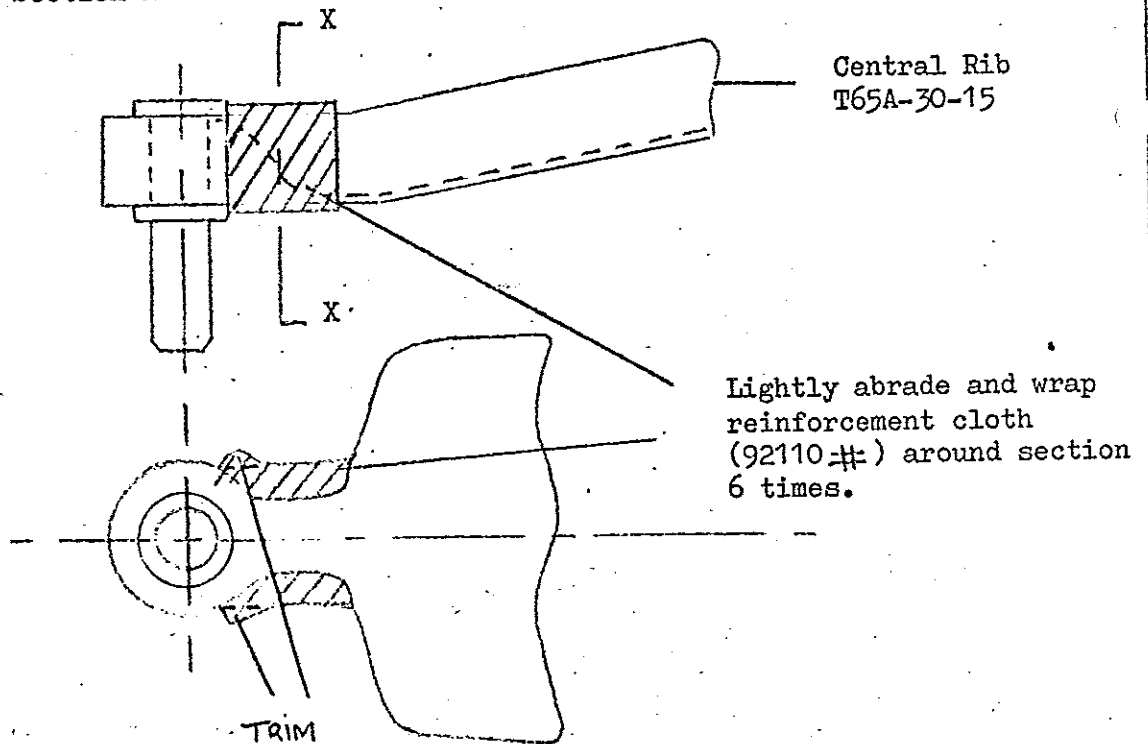
FIG 6 Reinforcement Cloth on the Centre Tailplane Hinge

Inspect Section X-X

- (k) Cure for 8 hours at 56°C.
- 5.1 If the central elevator hinge on the tailplane is not cracked, reinforcement will be added as follows :-
- (a) Remove the tailplane/elevator assembly from the aircraft.

- (b) When the elevator is removed from the tailplane, lightly abrade the area shown in Fig 6.
- (c) Wrap a 10mm strip of 92110# woven roving cloth 6 times around the area detailed.

- (d) When cured trim any rough edges.
- (e) Trim the elevator cutout to enable maximum deflection of the elevator  
+24° ± 1° 30'  
-16.5°
- (Note - the cutout may now be visible when full deflection of the elevator is applied.)

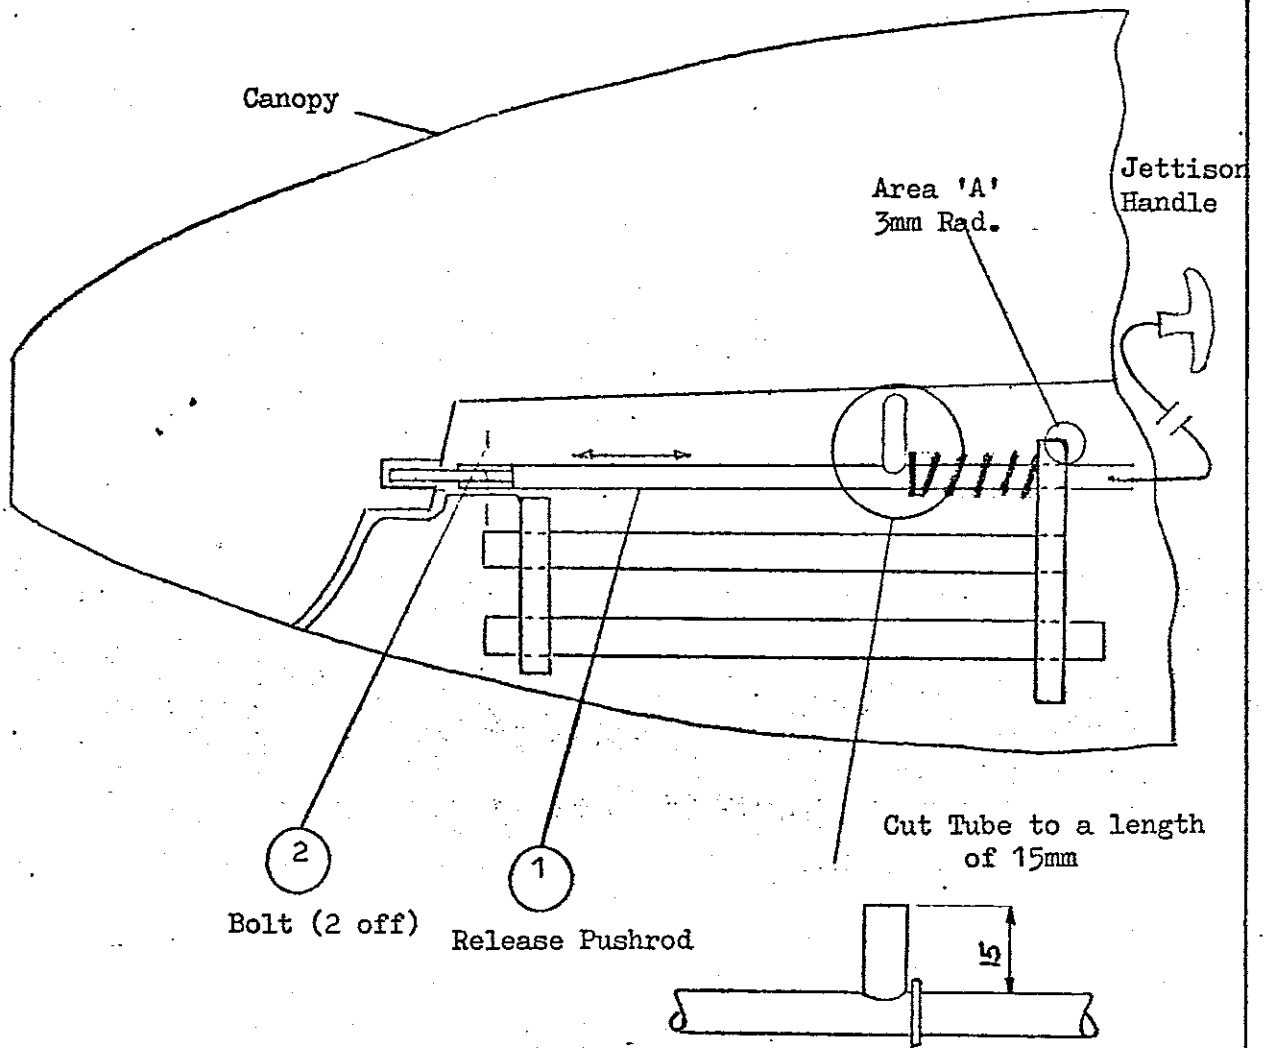
FIG 1 T65 Canopy Jettison Mechanism

1.1	Remove the canopy from the fuselage.		
1.2	Ensure the two bolts (indicated in Fig 1, Item 2) are tight.		
1.3	Inspect the front portion of the release pushrod (Fig 1, Item 1) and ensure the pushrod is not bent. The release pushrod should slide easily through the guides by pulling on the canopy jettison handle.

2.	Before further flight modify, and check the operation of the canopy release mechanism as follows :-		
2.1	Cut the tube on the release pushrod to a height of 15mm (refer Fig 1).

2.2	Paint a white line on the canopy arm marking the position of the tube (Fig 1) on the release pushrod in the locked position.		
PARTS REQUIRED			
ISSUED BY:		Date 22 Sept 82	
for and on behalf of		Page 1 of 4	
<p align="center"><b>SLINGSBY ENGINEERING LIMITED</b> Kirkbymoorside, York YO6 6EZ, England. Tel. 0751 31751 Telex 57911</p>

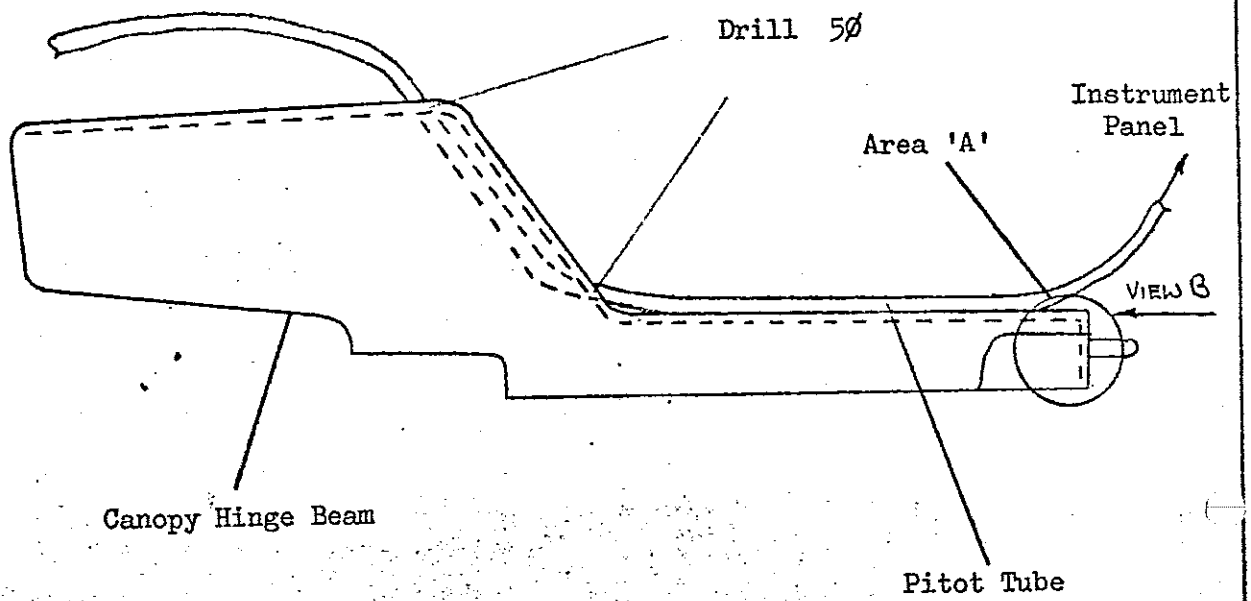
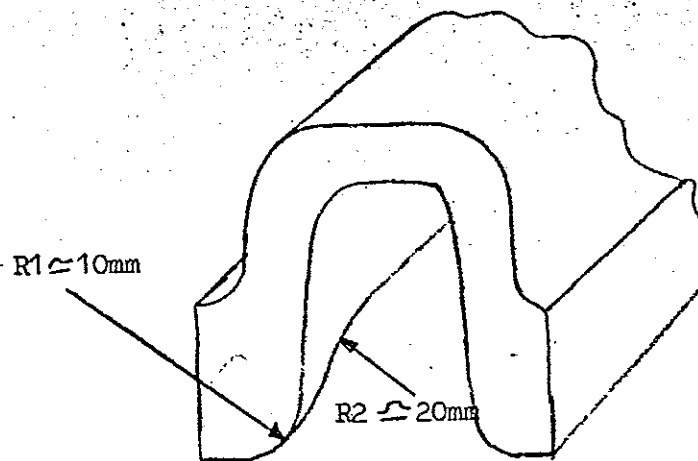
FIG 3

1.4	Inspect the pitot tube for damage where the tube is routed under the channel sectioned arm of the canopy. If damage is apparent replace the pitot tube and re-route the tube on the outer surface of the channel securing the tube as previously (refer Fig 3).

Radius the corners (R1 & R2)

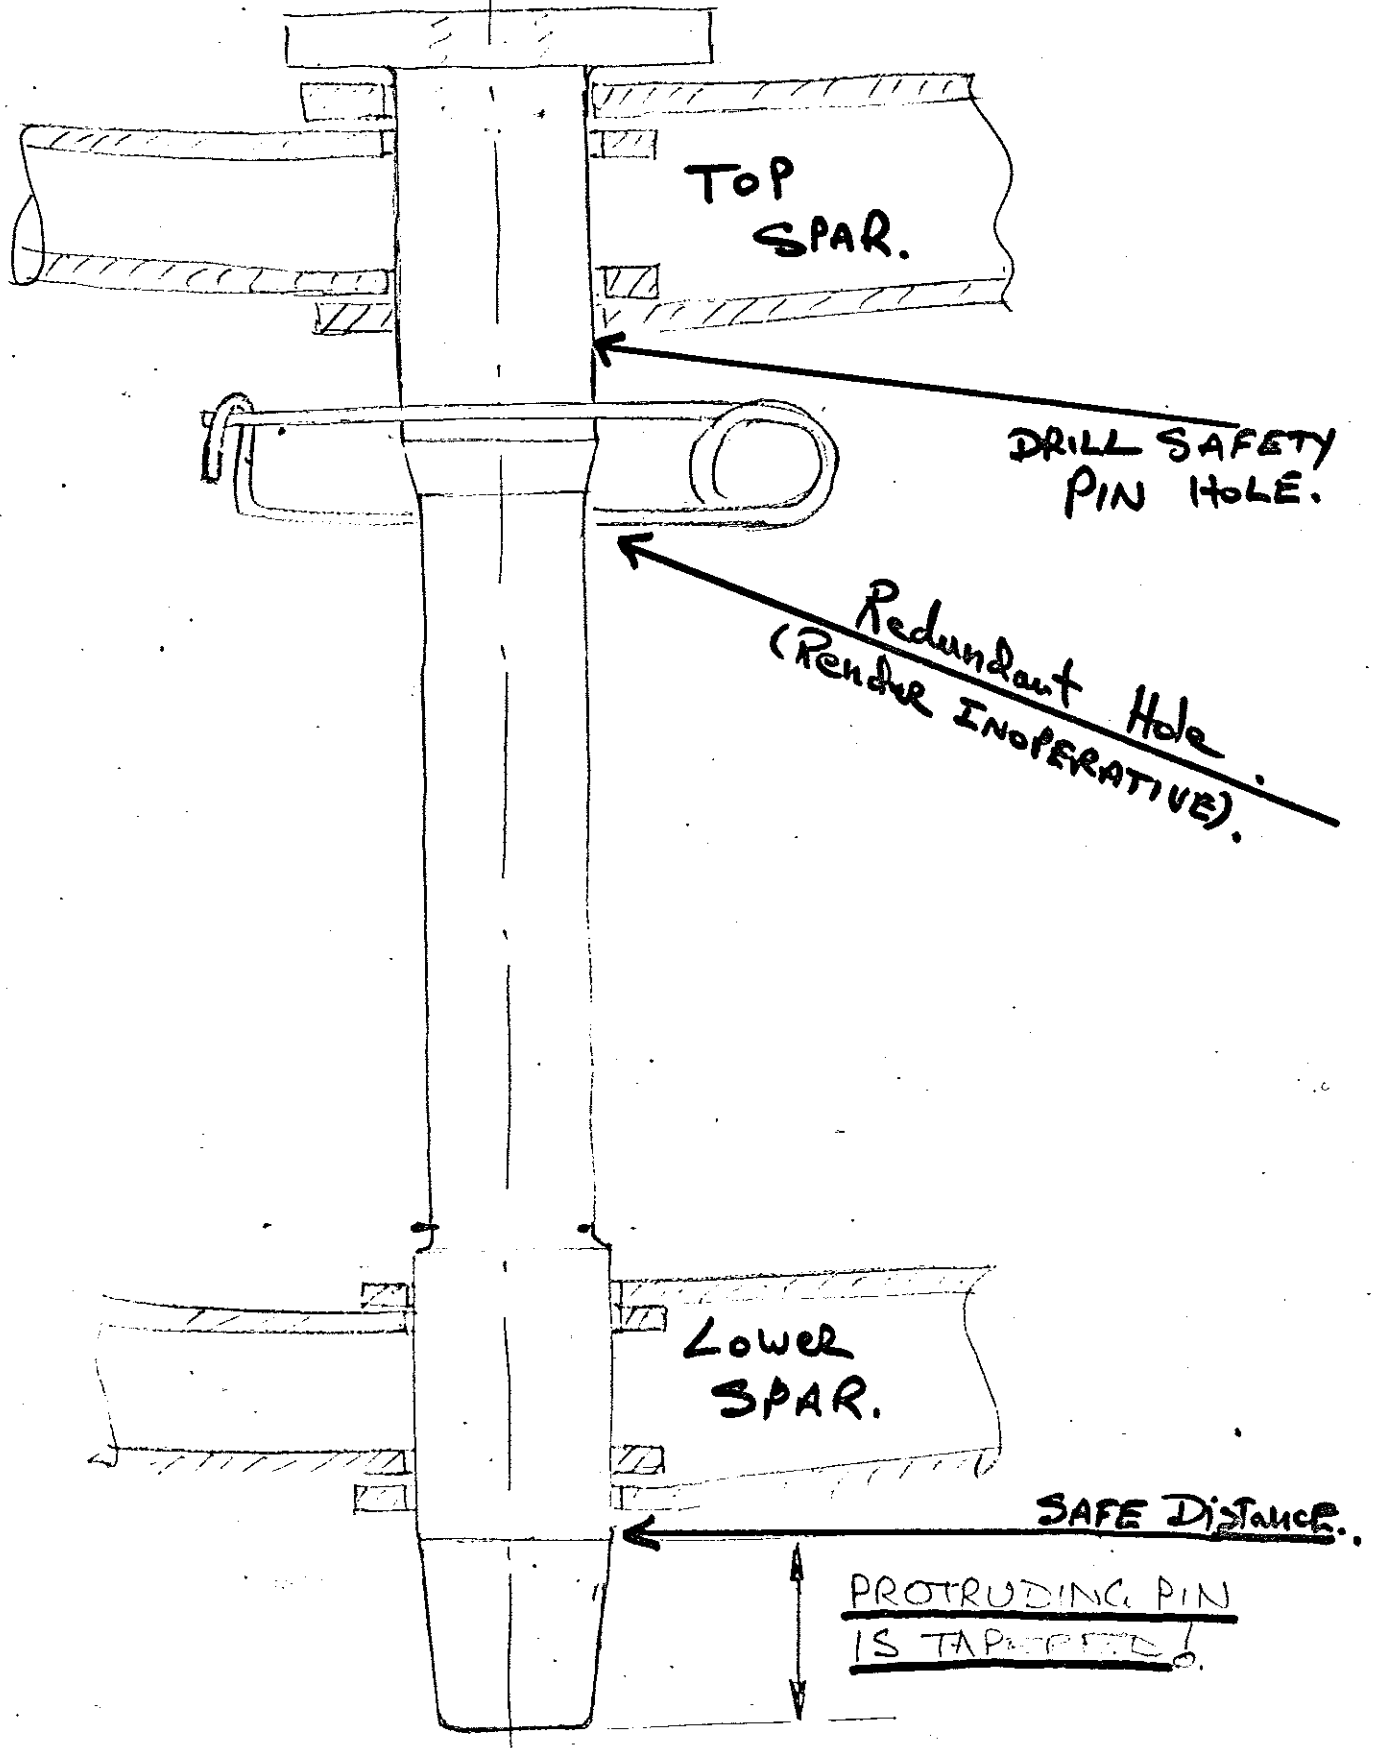
MAIN WING PIN.

- 1.4 KAB - Seat Back structure may impair Escape by Parachute. The attached Note was circulated to all owners by BGA on 12/10/82.
- 1.5 Bergfalk Series (and other Scheibe designs?) MAIN WING PIN Retention. (Ref. attached sketch). To ensure that main wing pin remains fully engaged in lower spar fittings, and that the parallel portion protrudes a safe distance, the safety-pin hole may have to be drilled closer to the top spar fittings. The redundant hole must then be rendered inoperative. (Reported by Chris Batty - Cotswold Gliding Club.)

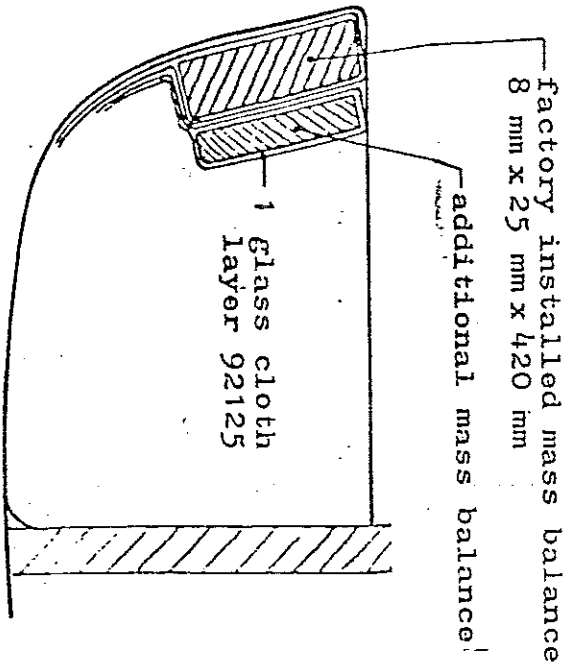
Additional mass balance on the rudder nose

- 1.3 Cirrus Series. Rudder Mass Balance. Cirrus Service Manual Revision of pages 27 and 28 (herewith), amplifies the requirements of T1 265-6 referred to in TNS 8/9/82. (Correction T1 265-6 was mailed only to VTC Cirrus owners by BGA on 8/9/82, because of the flutter/VNE speed restrictions implied therein). The revision permits increased ballast to restore the parachute facility.

① If the values for the rudder are exceeded, the tail parachute must be removed, or an additional mass balance (lead strip) must be attached to the already factory installed mass balance on the lower part of the rudder nose. (See page 28).
