TNS 12/82

PART 1 AIRWORTHINESS "AGGRO" (These items will be included in the 1983 list).

From:	Subject <b>GROB TWIN ASTIR SPEED - BRAKE</b>	Date:
To:		Reply Address:

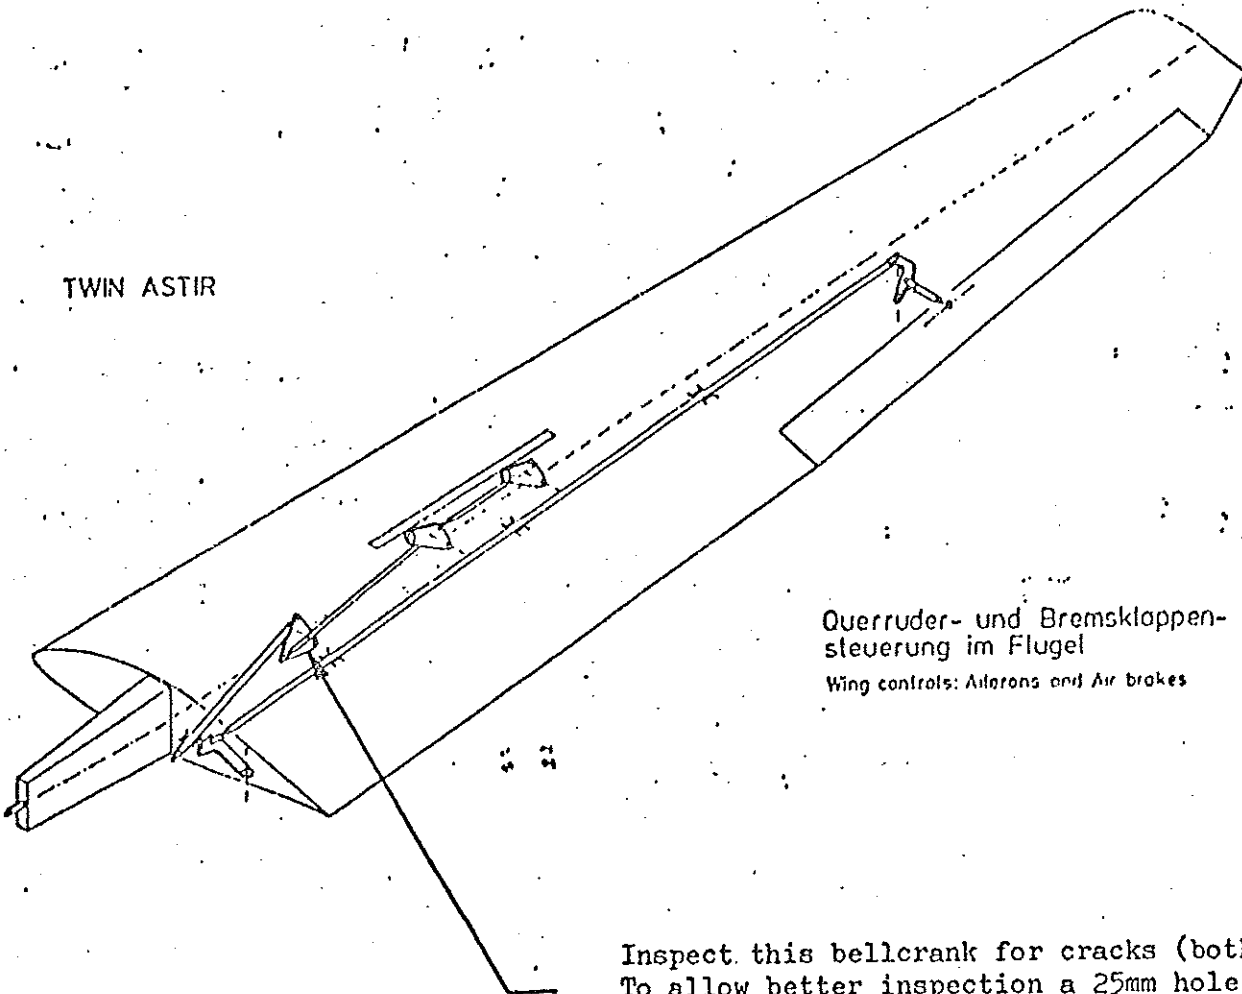
- 1.7. T.49 CAPSTAN Rudder bottom hinge badly corroded by water entering open ended tube. (Report by P. Kingsford, Kent Gliding Club).
- 1.8. GROB TWIN ASTIR Speed-Brake Control bellcrank (Ref. sketch attached) - cracked. Inspect and rectify as required. (Reported by G.F.A. Australia).

Inspect this bellcrank for cracks (both wings). To allow better inspection a 25mm hole may be cut in the wing lower skin. The edges of the hole to be sealed with epoxy and the hole covered with a "contact" patch. This hole will be repaired, or converted into an inspection panel, when the bellcrank is finally replaced.
