TECHNICAL NEWSHEET

TNS 3/4/83

TNS 8/4/83

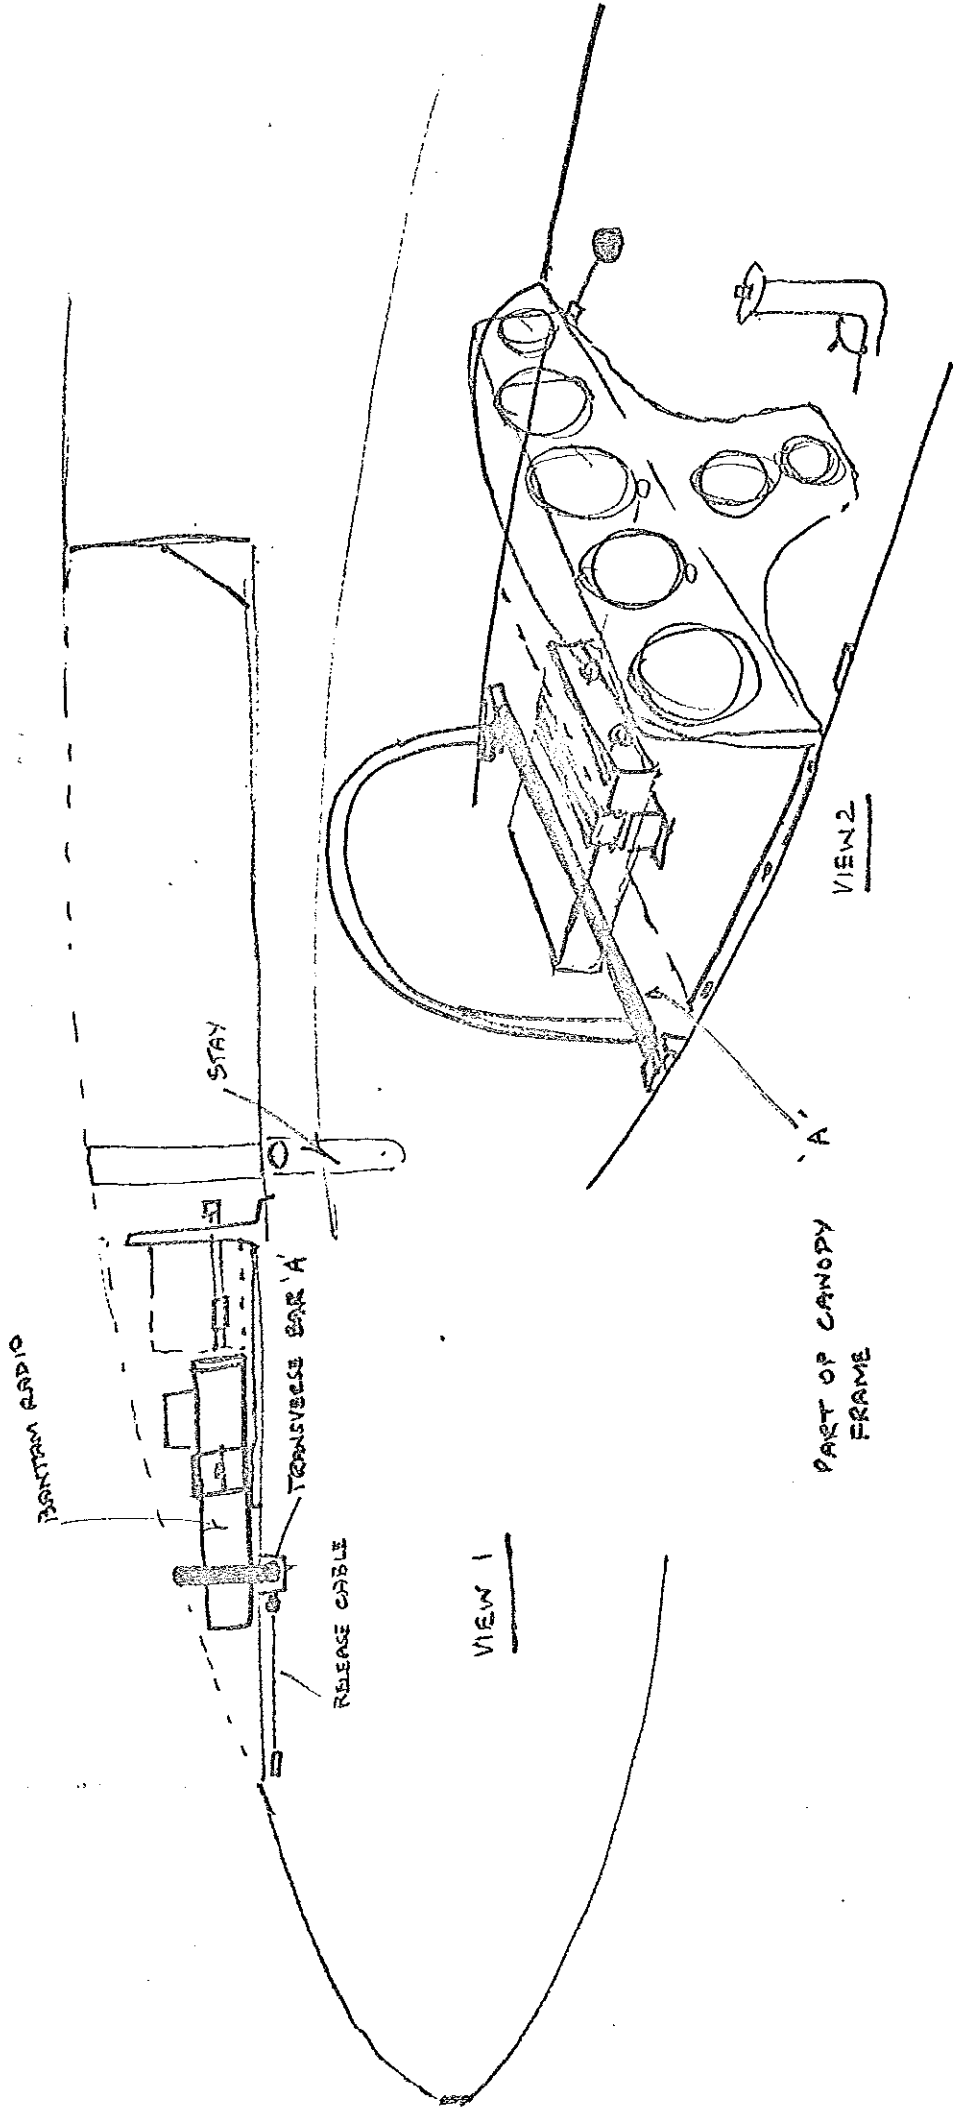
MOSQUITO - 2244

- 1.2. Radio Installation renders Conopy Jettison inoperative. The attached sketch of Pye Bantam installation in a 'Mosquito' may be typical of other installations. (Reported by Jim Riddoch, N. Weald.)

Radio Installation For Mosquito Canopy Jettison.

CANOPY JETTISON - DETAIL VIEW 1 & 2.

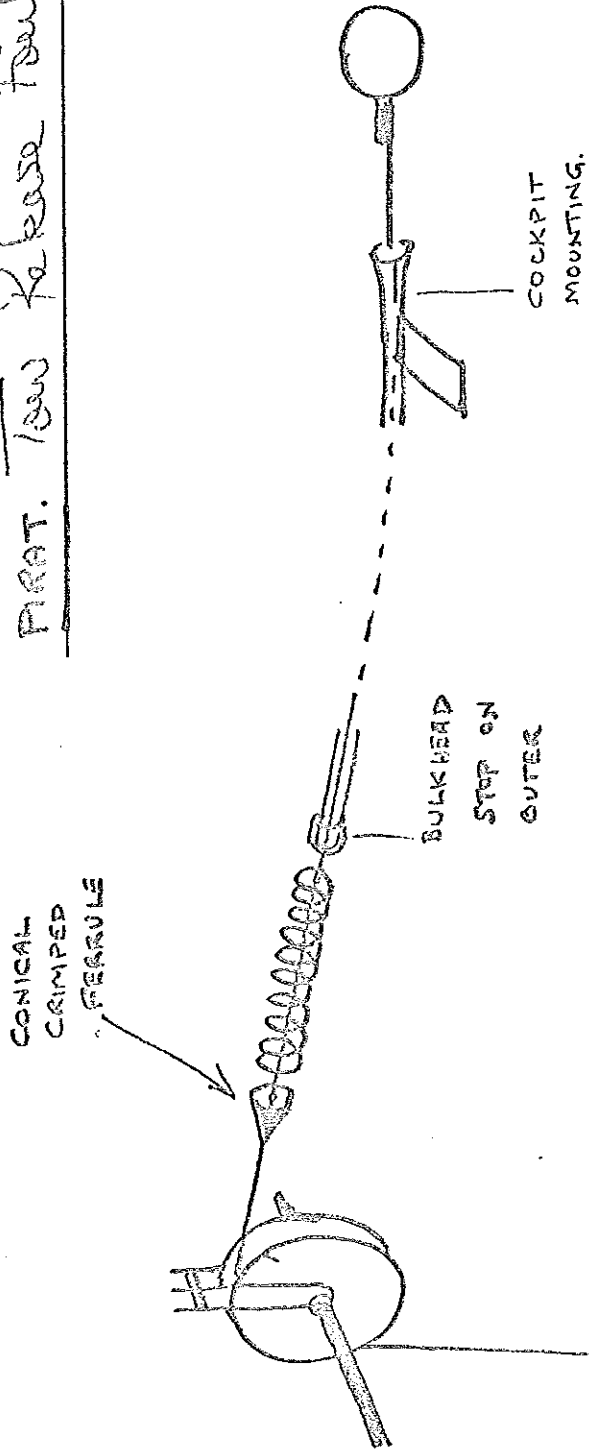
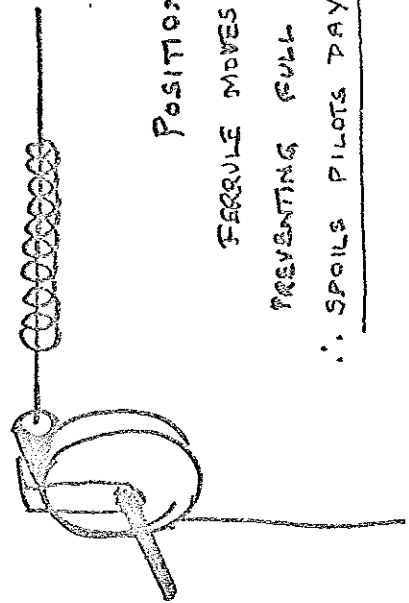
PARAT. Tow Release Fowl.

- 1.3. Pirat Tow Release, intermittent failure. The attached sketch demonstrates how a ferrule on the release cable can foul in the pulley assembly. (Reported by Jim Riddoch).

POSITION OF FERRULE AFTER OPERATE AND RELEASE :-

FERRULE MOVES ALONG CABLE AND STAYS CABLE IN PULLEY, SOMETIMES PREVENTING FULL CLOSURE OF OTFUR ; OR PREVENTING RELEASE ( WIRE LAUNCH ) :-

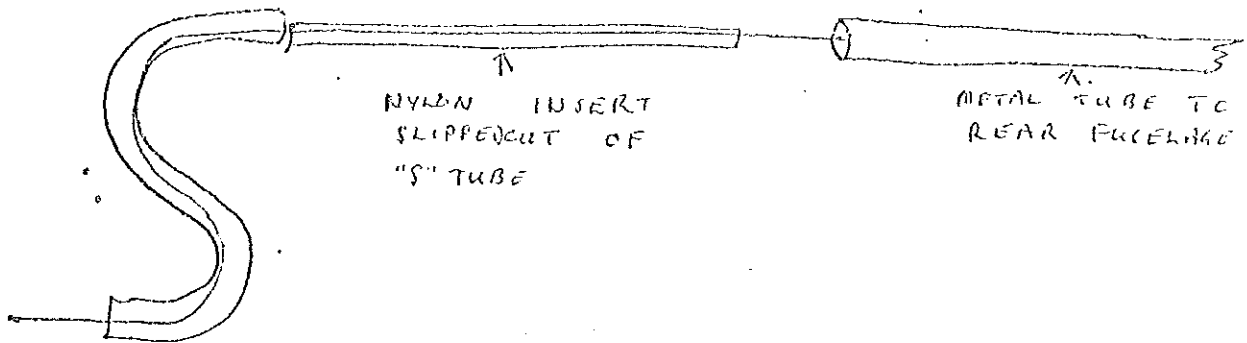
- 1.4. ASK 21. Rudder Pedal Jamming. The attached sketch shows how the nylon tube insert in the rudder pedal assembly can become detached and restrict the rudder travel (Reported by Mynd). Re-secure the nylon tube as required.

During the pre-take off checks it was discovered that the nylon tube insert, in the front rudder pedal 'S' tube had slipped out onto the exposed cable, thus preventing full pedal movement.

This problem may only get noticed when the pedals are adjusted fully backward (i.e. short pilots beware)

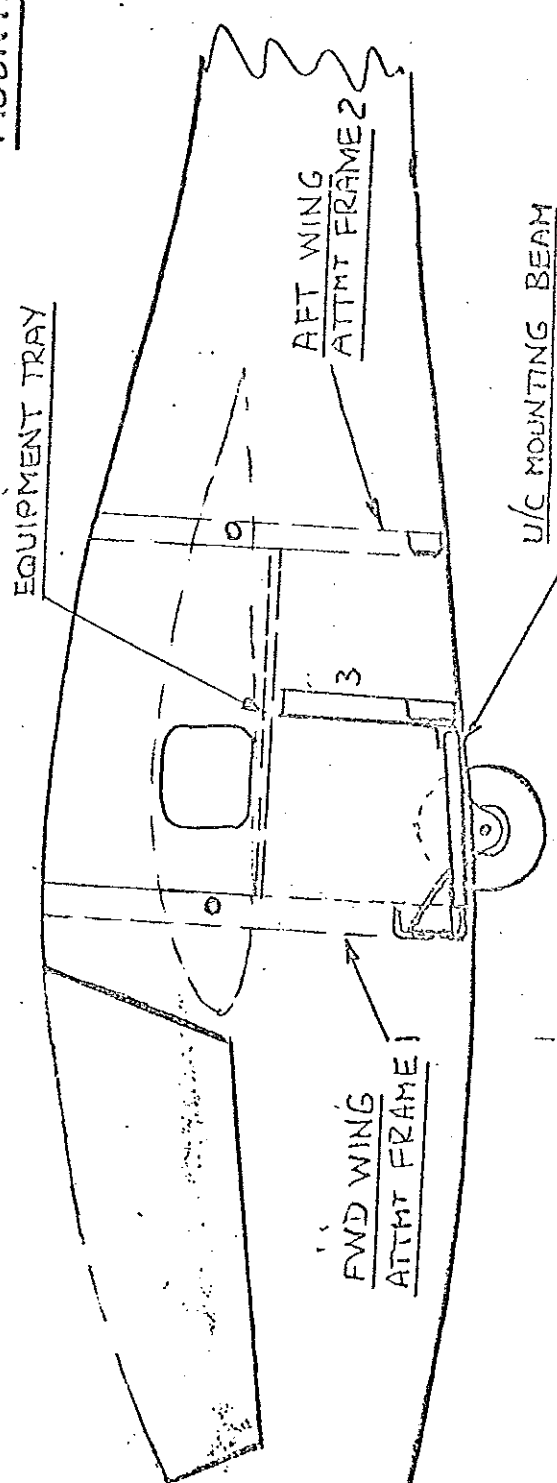
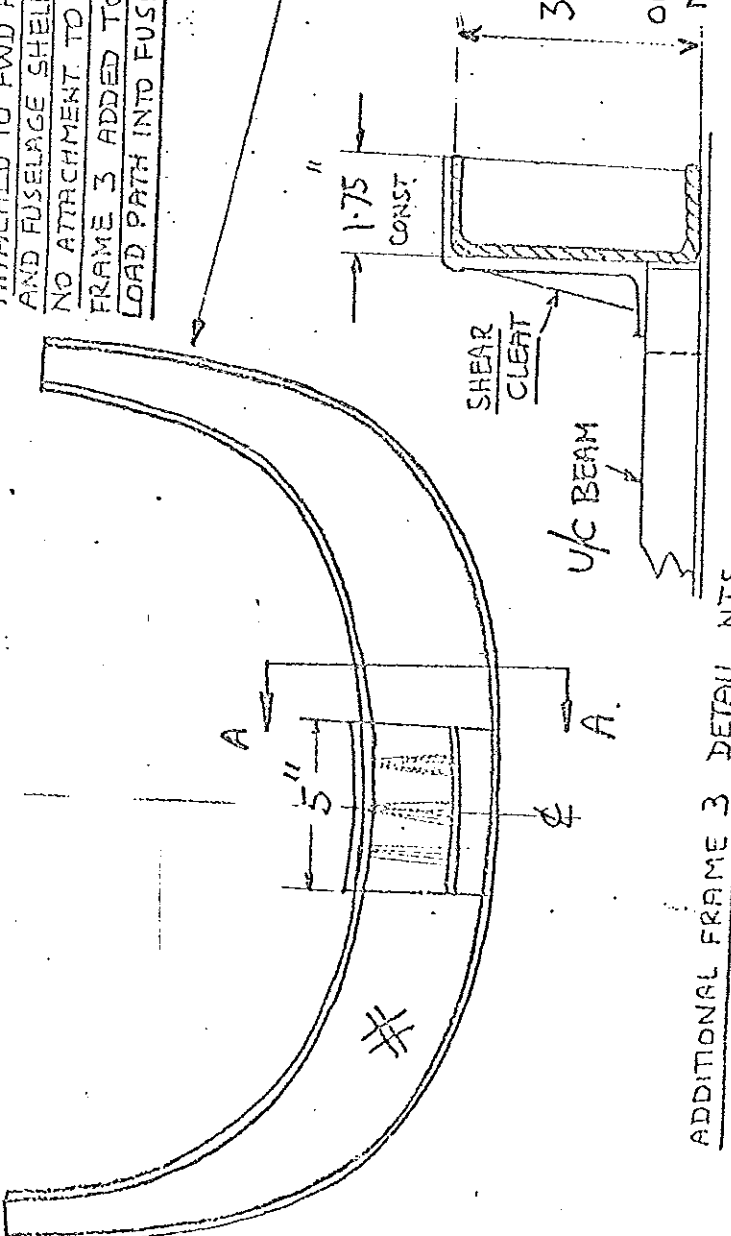
GROB G102 MK3. MODIFICATION TO FIXED WHEEL MOUNTING STRUCTURE

U/C MOUNTING BEAM  
ATTACHED TO FWD FRAME 1  
AND FUSELAGE SHELL. NOTE  
NO ATTACHMENT TO AFT FRAME 2  
FRAME 3 ADDED TO PROVIDE  
LOAD PATH INTO FUSELAGE SHELL

FRAME LAY UP. 5 LAMS INTERGLAS 92125 (t=0.08)  
± 45° CORNERS REINFORCED WITH 6 ROWINGS  
SILENKA 051-2400 TEX. SHEAR CLEAT  
5 LAMS 92125 0°-50° LAMINATE WITH  
EPICOTE 162 - EPICURE 113 RESIN SYSTEM.

ADDITIONAL FRAME 3 DETAIL NTS.

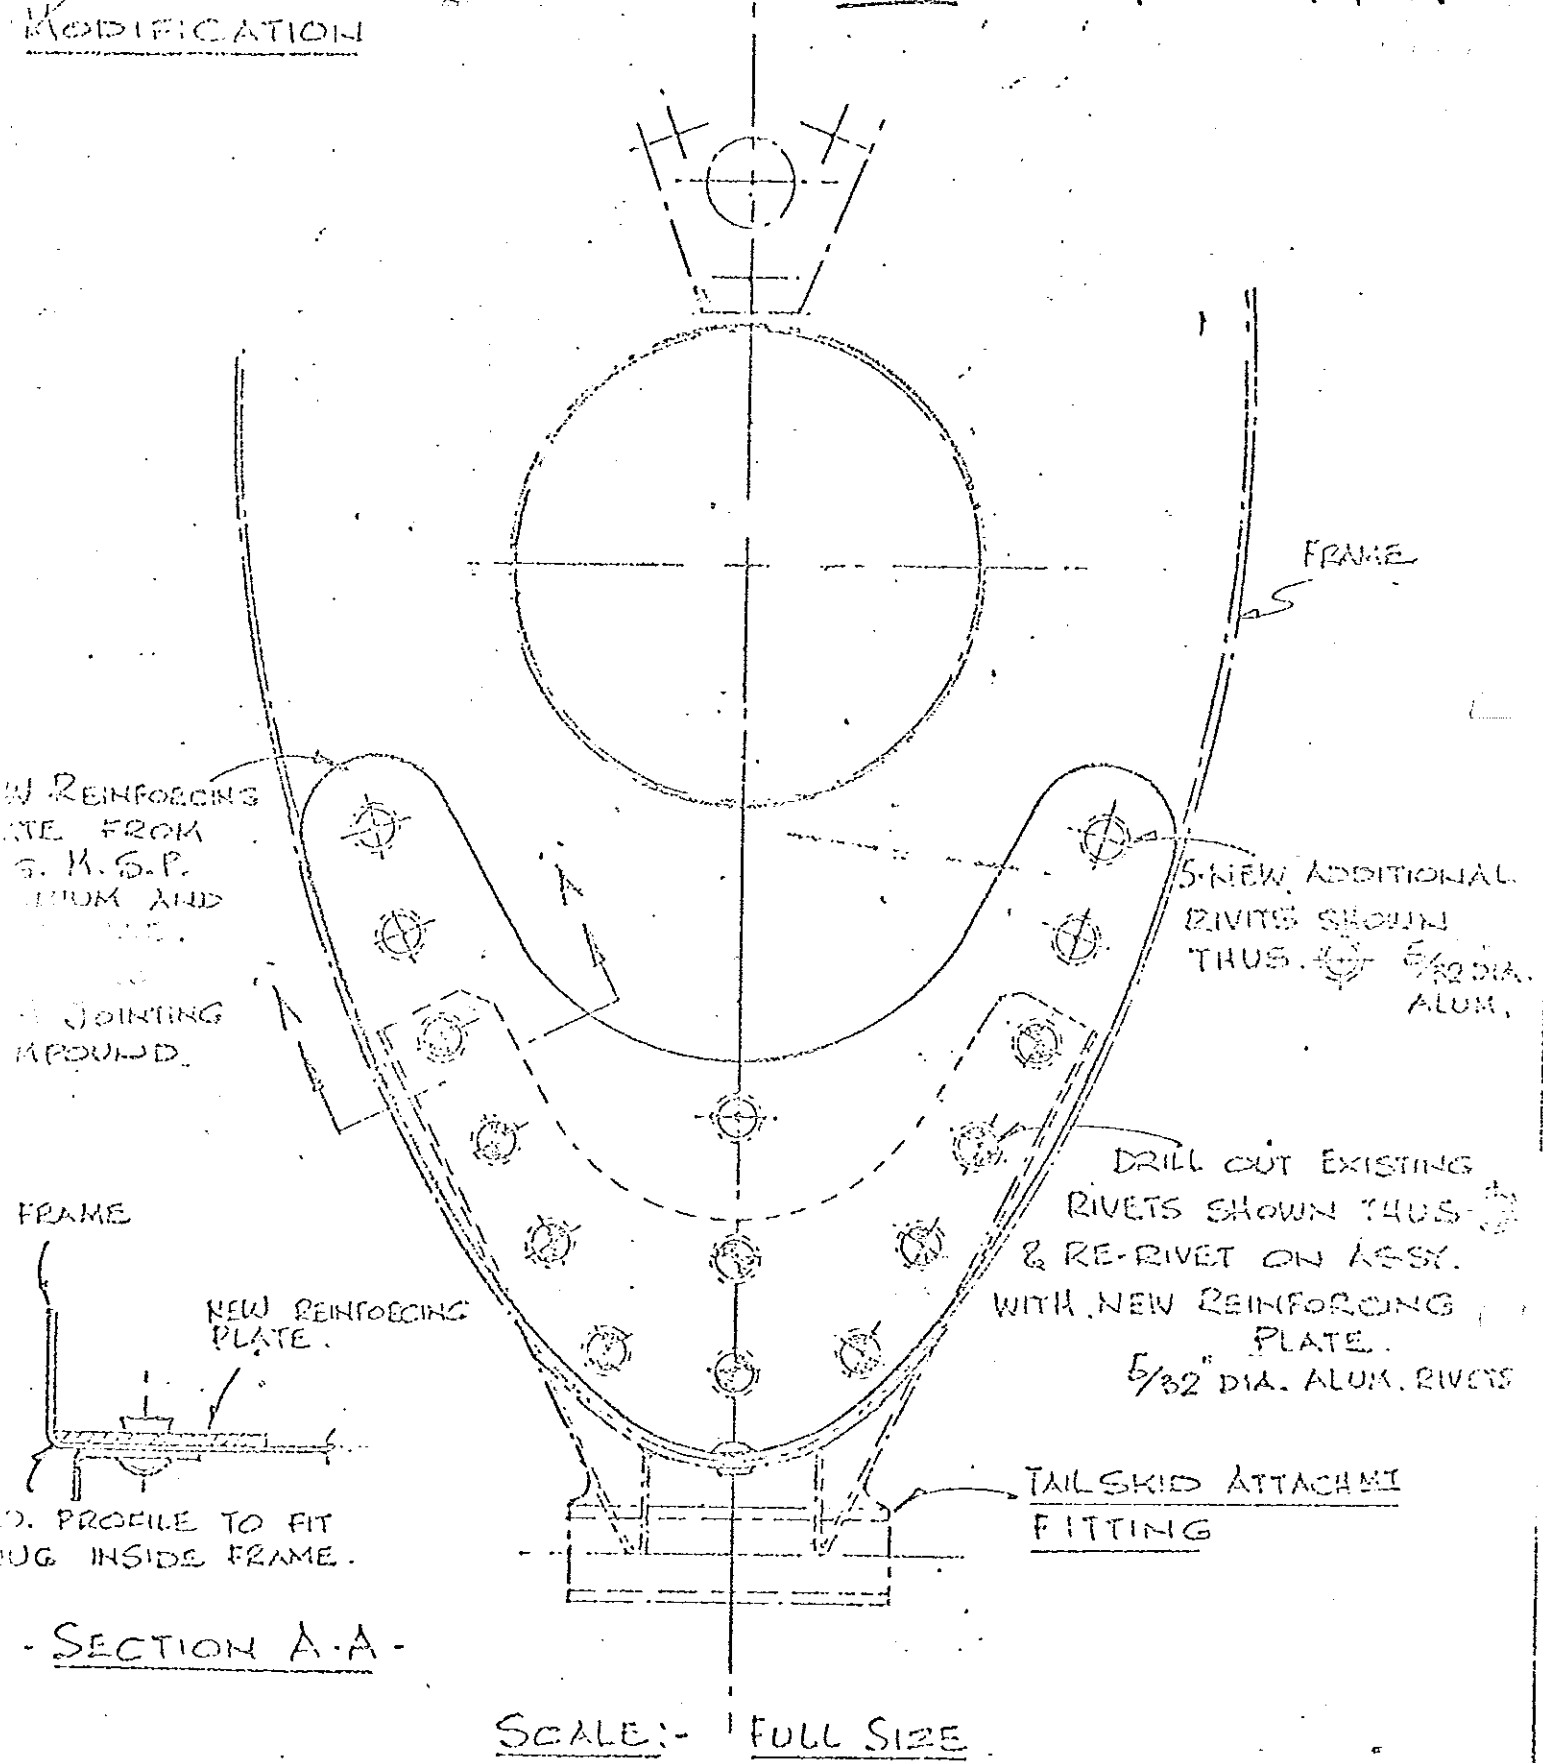
MOD BGA/Blank/1/88

DETAIL OF REINFORCING PLATE AT FUSELAGE  
FRAME TAILSKID ATTACHMENT FITTING ON  
BLANK SAILPLANE
