B.G.A. TECHNICAL COMMITTEE

TECHNICAL NEWSHEET

TNS 5/6/83

PART 1 AIRWORTHINESS 'AGGRO' Please add to the 1983 Pink Pages

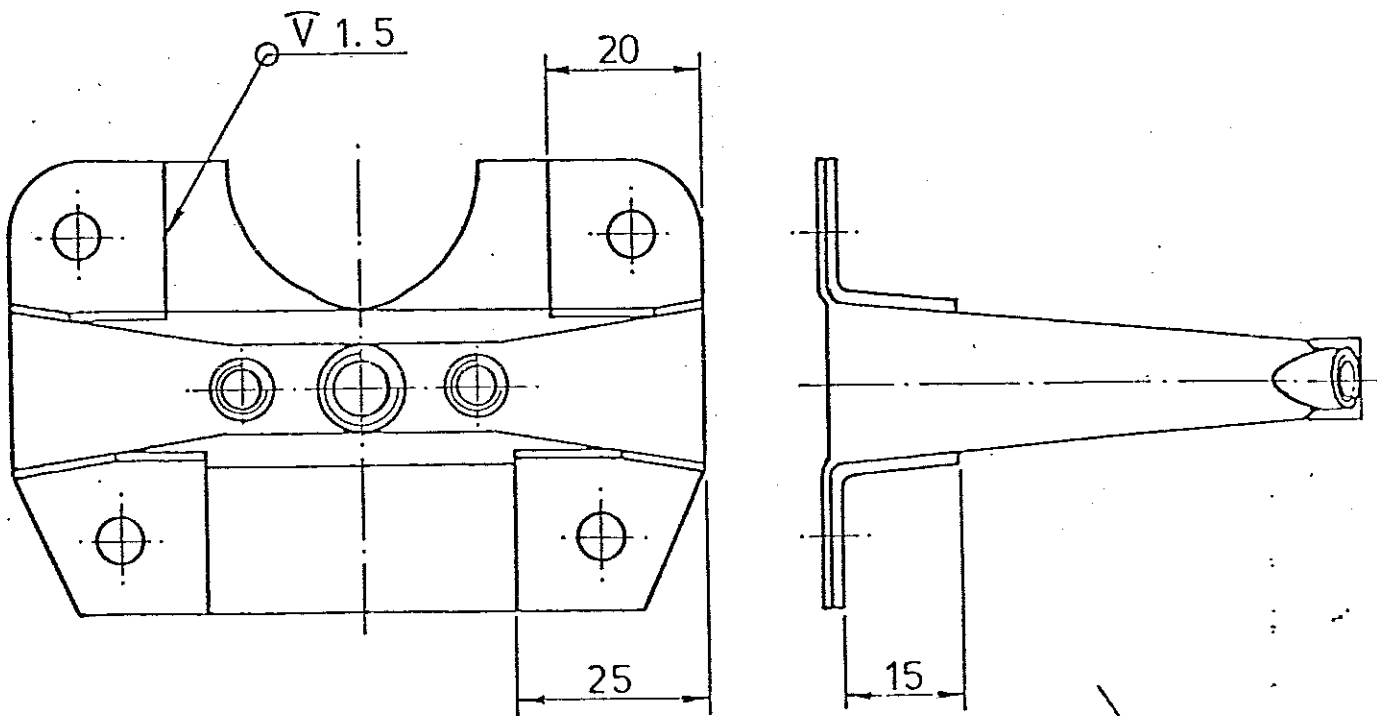
DESCRIPTION Due to a too small bending radius of the hinge bracket suspension flange, fractures have been found on the corners of the hinge suspension flange. The vibration caused by a hard rubber tail dolly wheel may in some cases assist in the formation of the fracture. It is possible that when the fractures get large enough the bottom hinge could peel off and jam the rudder control.

- cadmium, yellow colour
 - zinc, clear
- 3) Make and weld the bracings on the suspension flange according to the drawing. NOTE! Weldings can be done only by a person who has an aircraft welding licence. Before assembling the hinge bracket has to be sand blasted, the attaching holes has to be drilled and the whole bracket has to be coated (cadmium or zinc) and painted.

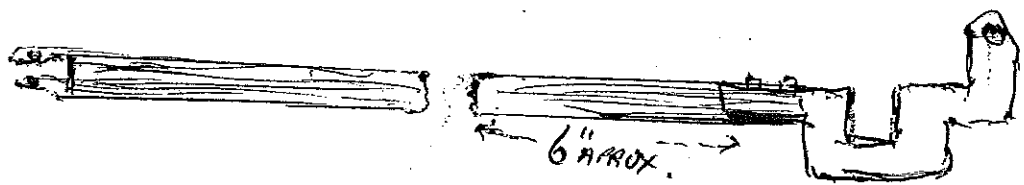
DAMAGE TO ELEVATOR
PUSH ROD DRIVE K6

- 1.7. KA6/KA6 CR ELEVATOR DRIVE PUSH-ROD DAMAGED, probably due to incorrect alignment whilst rigging. Inspect as required, in accordance with sketch herewith. (reported by Essex & Suffolk G.C.)

COULD APPLY TO K6CR AS WELL RB

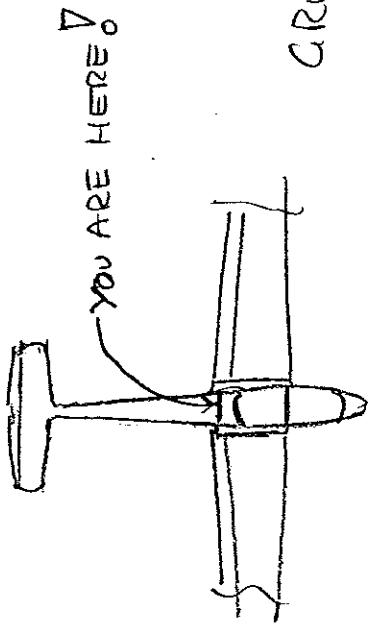
VIEW LOOKING AFT ON FLAP DRIVE TORQUE TUBES ASSY.

After the event the g.r.p. moulding which provides the flap torque shaft bearing was found to be almost completely detached from the inside of the fuselage. The resulting flexibility provided enormous flap backlash. On dismantling the mechanism the double row self aligning bearing at the end of the L.H. torque tube was found to be disrupted as shown in sketch.

The L.H. flap drive bearing has received a substantial overload in the inwards direction to cause the outer ring to spring over the ball array. This load can only be reacted by the g.r.p. moulding carrying the centre bearing in a direction which will "unpeel" it from the fuselage wall. It is suggested that the L.H. wing was entered to the fuselage with the flap in a different position to that of the cockpit lever. The flap drive spigot then abutted the slotted end of the torque tube instead of entering the slot. The resulting end load disrupted the bearing and dismounted the g.r.p. bearing housing.

G.R.P. BEARING HOUSING DETACHED FROM FUSELAGE SIDE WALL.

THIS BRG. FOUND TO HAVE BEEN DISRUPTED THUS.

1. That owners be alerted to the risk of damage during rigging.
2. That inspectors be made aware of the possibility that such damage could exist.
