B.G.A. Technical Committee

Technical Newsheet

TNS 1:2:83

PART 1: Airworthiness Aggro

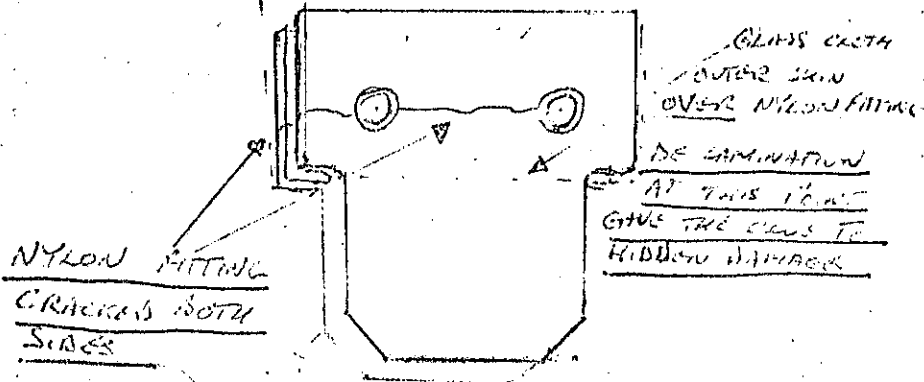
VEGA.

- 1.1 T.65 Vega. Tailplane front tongue spigot cracked - (sketch attached). (Reported by Martin Breen, and reported by him to S.E.L.)
- 1.2 KA2 Elevator "D" box glue failure etc., (sketch attached). Reported by Martyn Davies. KA2's should be inspected throughout for glue deterioration.

TAIL PLANE TAILING
WITH CARBON CORE
HAD GLASS CLOTH
OVER SKIN.

ON THIS OCCASION THE CARBON FIBER CORE
WAS UNDAUNTED

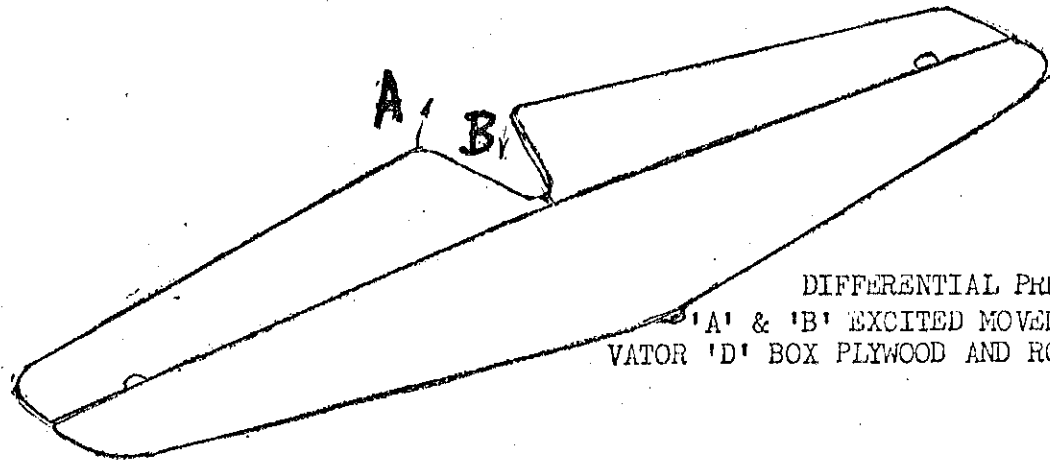
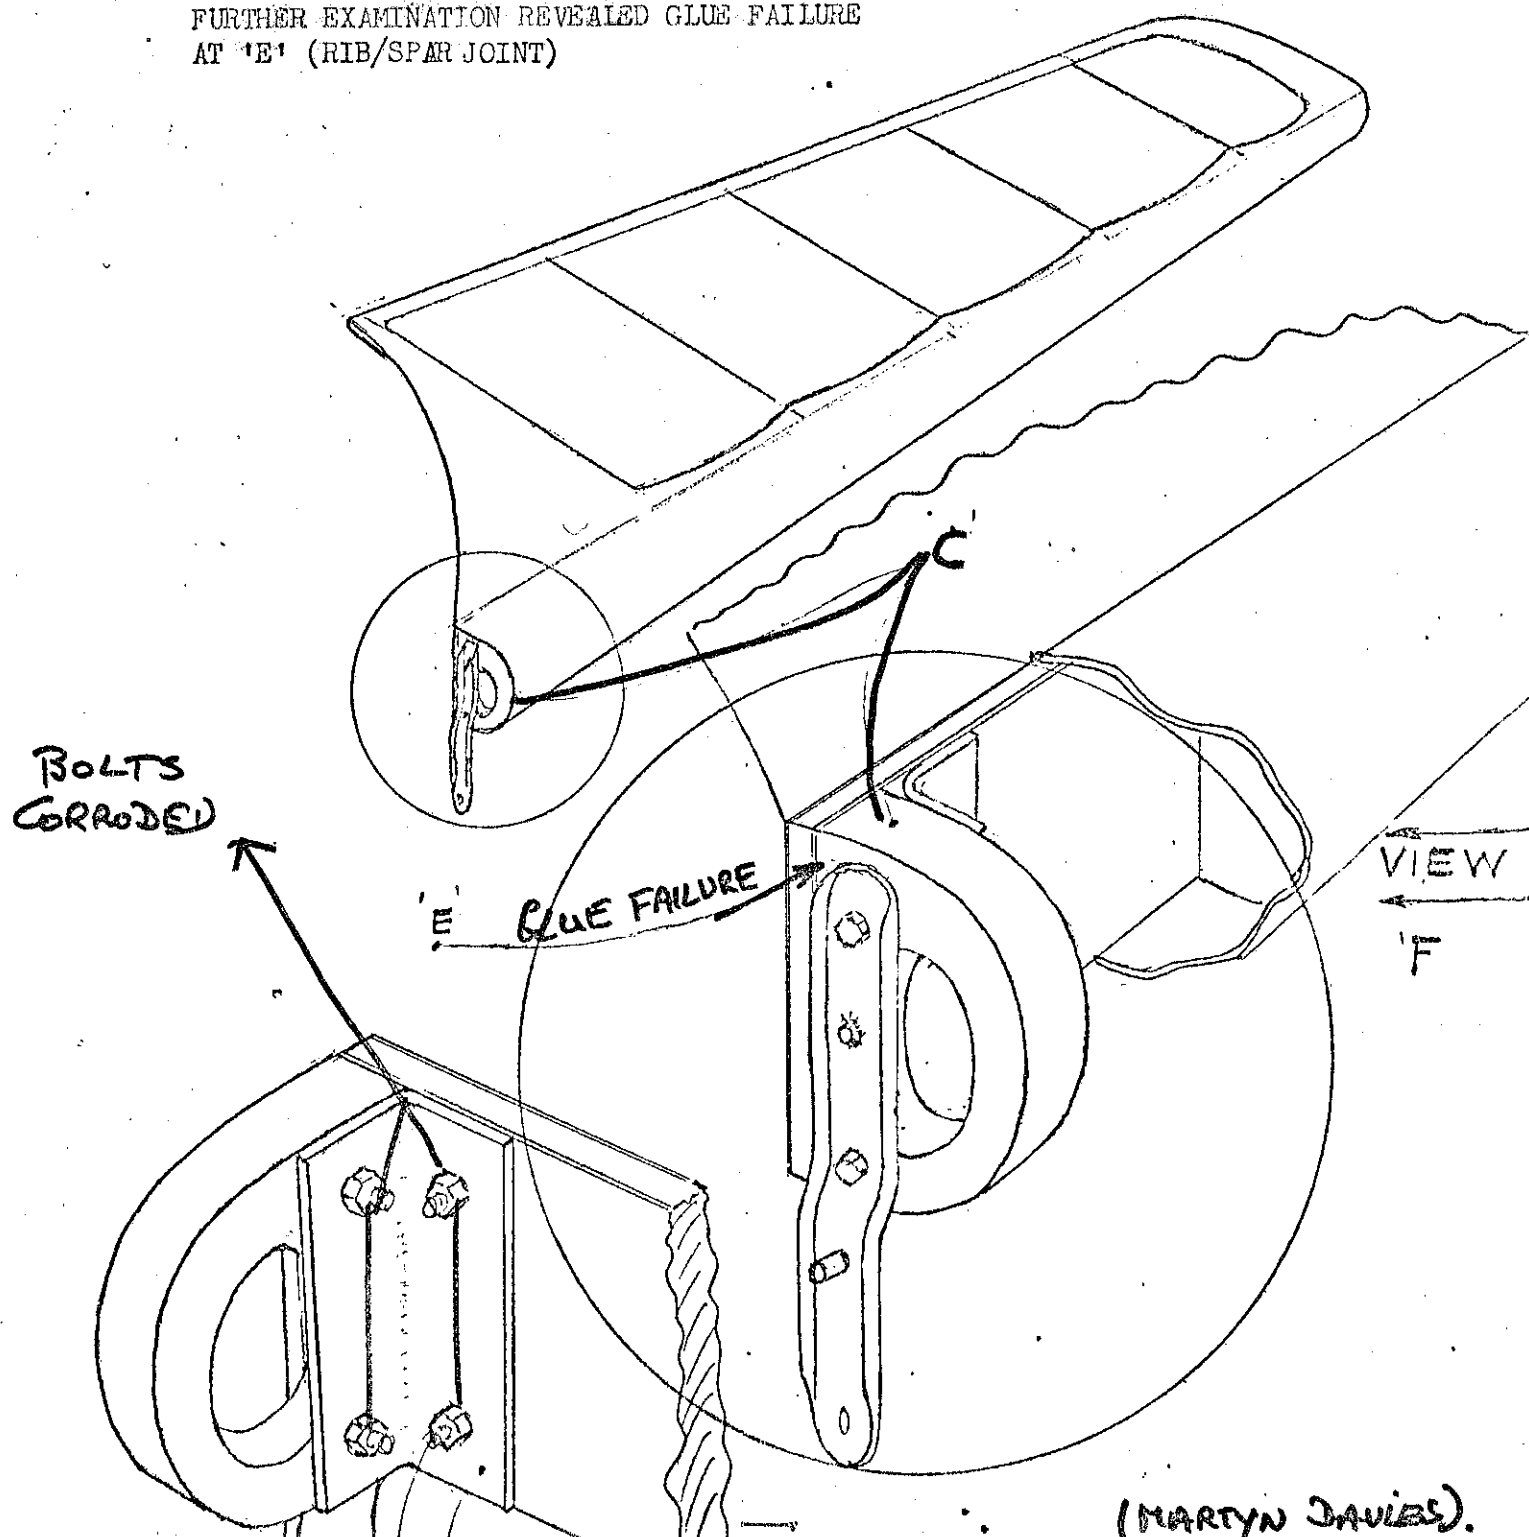
ELEVATORS

DIFFERENTIAL PRESSURE APPLIED AT 'A' & 'B' EXCITED MOVEMENT BETWEEN ELEVATOR 'D' BOX PLYWOOD AND ROOT RIB. (SEE 'C'.)

EXAMINATION REVEALED GLUE FAILURE AT 'C'.

FURTHER EXAMINATION REVEALED GLUE FAILURE AT 'E' (RIB/SPAR JOINT)

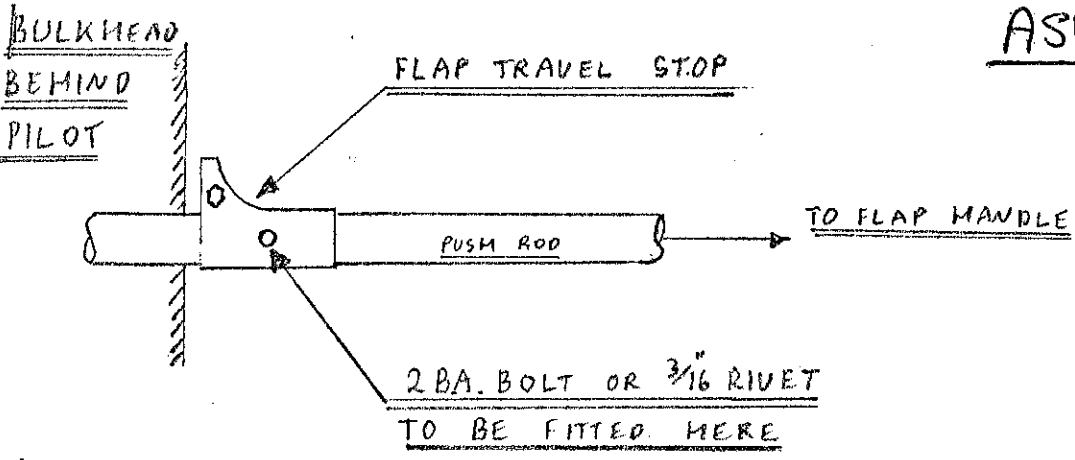
ASW 20 FLAP STOP.

- 1.5 ASW 20. Flap Push-Rod Stop. The flap travel stop on some ASW 20's may not be positively located and may slip. Later models are rivetted (or bolted). Early models should be modified as per sketch attached. (Reported by Tim MacFadyen.)

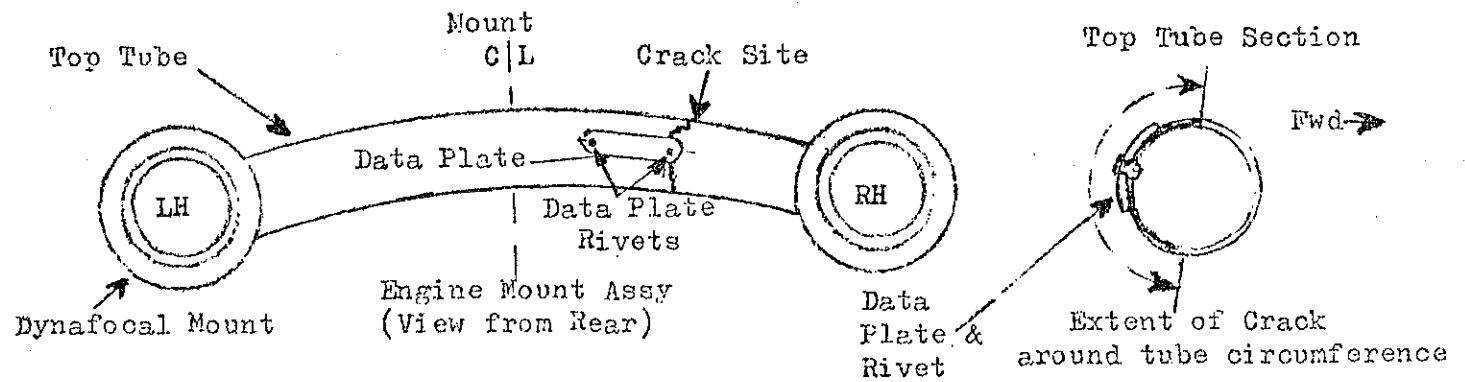
5. CRACKED ENGINE MOUNTS

The top centre engine mount tube was found badly cracked (over about 50% of the tube circumference) at the right-hand data plate rivet hole. The mount had been satisfactory at the last check one month previously. It had been fitted 1485 hours previously in response to SOCATA Letter AV/TB No 879/78 of 10 January 1979. The aircraft is used for glider towing, and averages about seven tow cycles per flying hour, so the mount has been subjected to over 10,000 cycles. Another Rallye 180T has twice suffered the same cracking through a data plate rivet hole at 164 and 1543 hours. The reporter suggests that the plate should be attached with adhesive.

CAA Comment:
 On 31 December 1982 the CAA is publishing CAA AD 006-11-82 applicable to MS 892 A/E and MS 893 A/E aircraft. Inspection of the area will be required within 10 hours and thereafter every 50 hours.

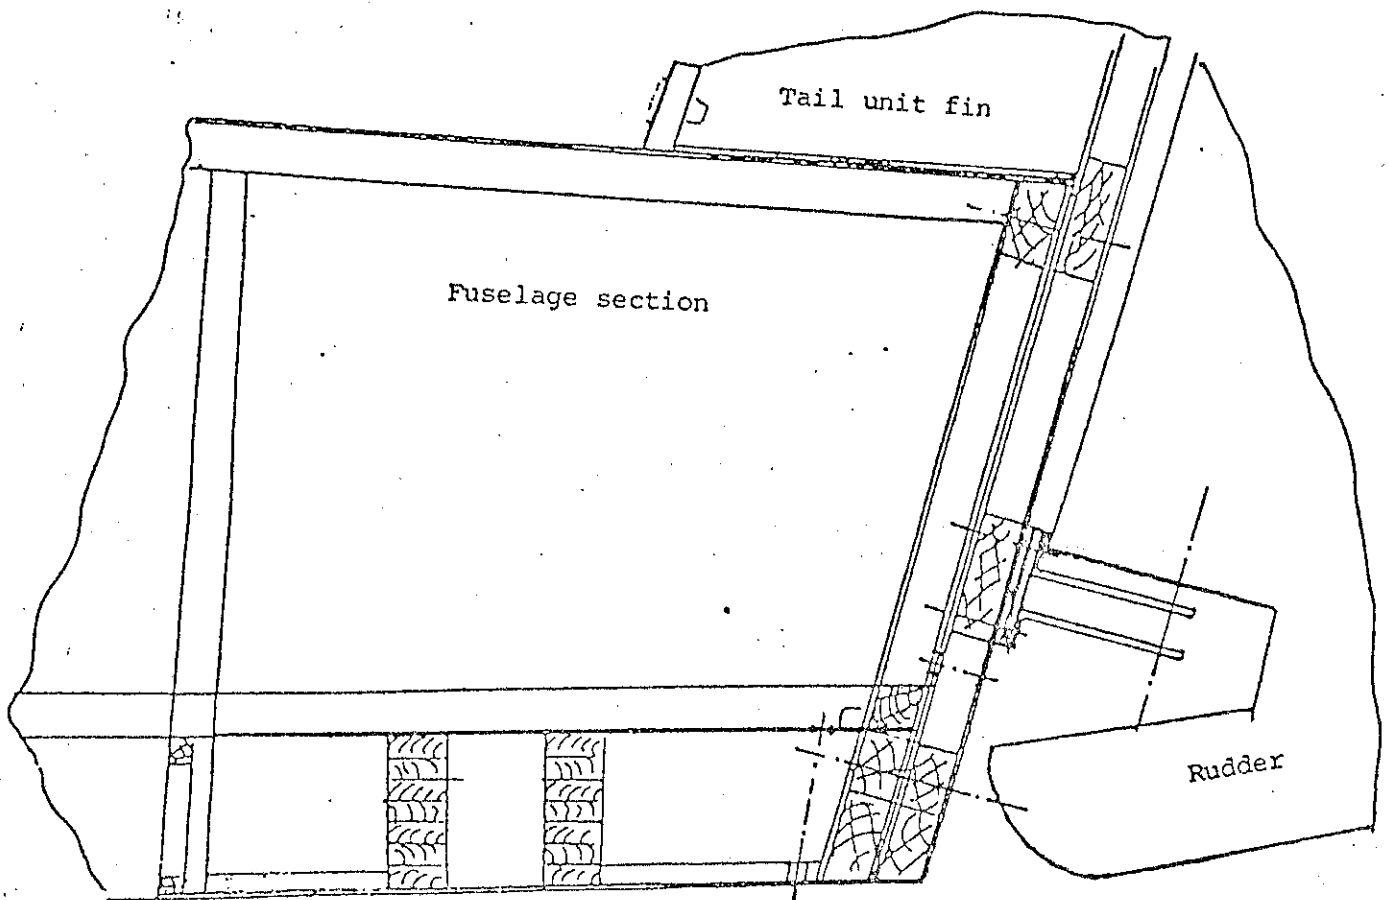
Course of events: During a large-scale repair to an RF5 the underside of the fin crossbeam was noticed to be rotting. This rotting was due to the effect of dampness. Presumably water penetrated into the fin crossbeam over the fuselage section and through the drill-hole for the cable to the navigation light.

Drill hole for navigation light.

- 2 Drainage holes in fuselage section bored at the time near the underbrace. Note: Drill holes must pass through the outer casing and the inner floor.

- Steps:
1. Examination of the interior condition of the fuselage for damage to the inner preserving agents and to the plywood parts.
 2. Examination of the opening to the drainage hole and the position of the hole in the tail skid. (see sketch). If necessary, new drainage holes should be drilled.

3. If damage to the preserving agents or to the plywood has occurred in the fuselage, and/or the drainage hole is faulty, an examination of the interior condition of the tail unit fin will be necessary. For this purpose, the rudder will be dismantled and the planking of the fin cross beam in the area shown on the sketch will be opened up in a circular area of about 30mm. If no damage to the wood is discovered, the area can be doubled over with 1.5 mm plywood after renewing the interior preserving agent. For this purpose, clean surfaces of varnish and preserving agent and glue on the plywood part(s) with AERODUX 185.

Cover the repaired area with preserving agent and varnish.
Re-assemble the rudder with new nuts.
Examine the functioning of the controls.
