## British Gliding Association

### B.G.A. Technical Committee Technical Newsheet

TNS 7:8:83

#### Part 1. Airworthiness "Aggro" (please add to the 1983 pink pages)

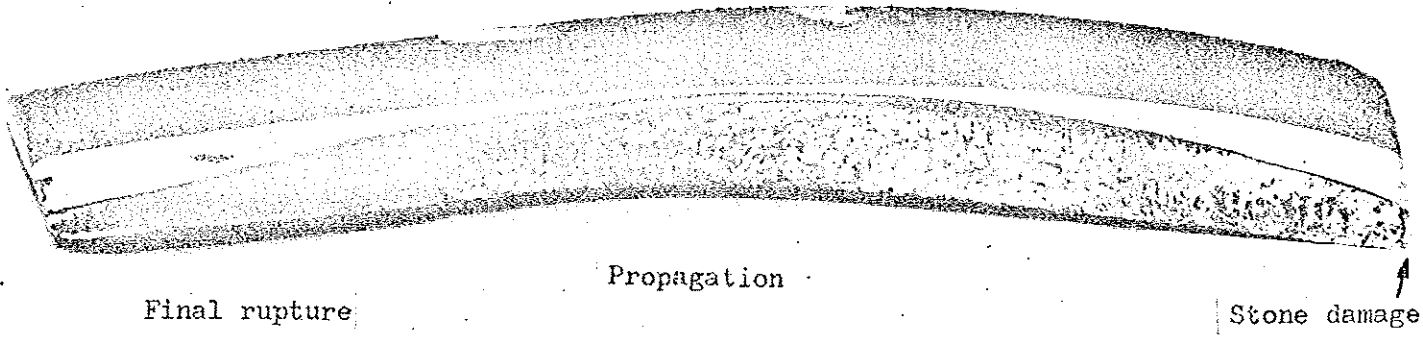
21. Issue 3/83 - Item 14 Piper PA28R - 200 Cherokee  
Part of Propeller Blade Broke Off

Laboratory examination showed that the blade had failed due to high cycle fatigue through  $\frac{3}{4}$  of the blade section before final rupture. The fatigue originated at a notch (only 0.050" deep, slightly more than the thickness of a halfpenny) in the leading edge of the blade which displayed bruising typical of stone damage. The

blade leading edge contained other stone damage. The combination of this engine and propeller are known to result in high blade stresses in the 2100-2350 rpm band. A warning in the Pilot's Operating Handbook prohibits continuous operation in this rpm band which is also identified by colour coding on the engine rpm indicator (see also Hartzell Bulletin 89). We have heard of two cases on foreign registered aircraft where a similar engine/propeller combination also resulted in blade failures about 4 inches from the tip.

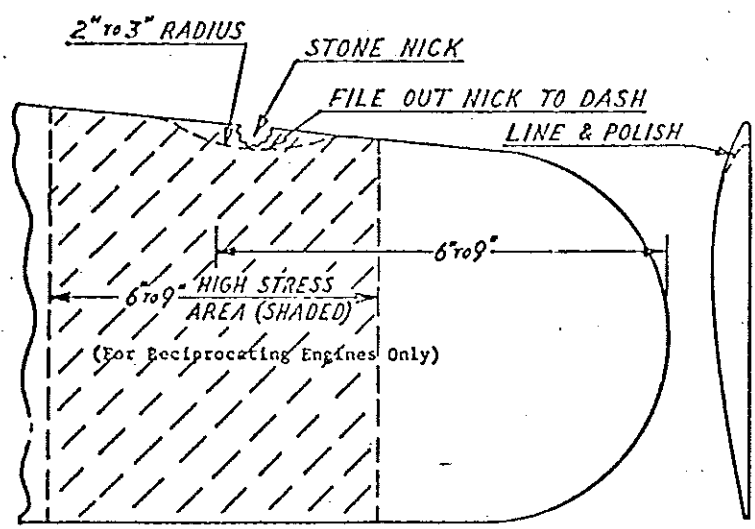
In December 1954 (Revised in February 1969) Hartzell Service Bulletin No 31 'Avoidance of Propeller Tip Failures - General Maintenance Procedures' was issued applicable to all metal propellers. The diagram below was included:-

It was also stated that "a small nick at the point of peak stress may be as detrimental from the fatigue standpoint as a large nick. A quick inspection for cracks at the critical area should be included in the pre-flight inspection".

Care of propellers is covered by Airworthiness Notice No 55 'Routine Maintenance of Propeller Blades'.
