B.G.A. Technical Committee
Technical Newsheet TNS 1/2/84

PART 1 AIRWORTHINESS "AGGRO" the 1984 "Yellow Pages" herewith, replace last year's Pink Pages, which should be scrapped!

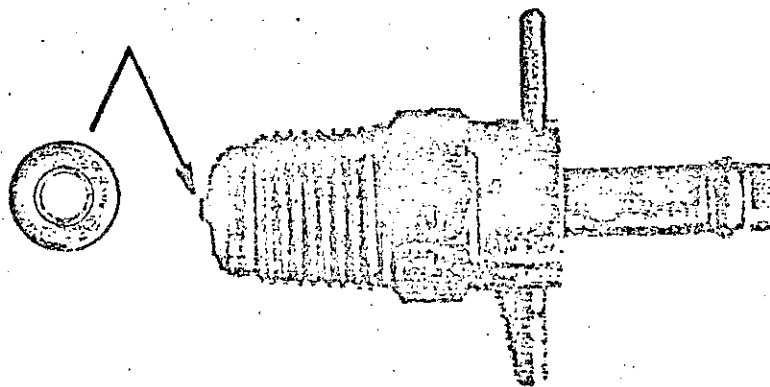
A new sump quick-drain valve Part No. 61879-2 was collected from the stores. The end-cap was found to be detached, such that only the 'O' ring held the valve together. If the 'O' ring were to fail or roll out of its slot, the centre of the valve would fall out under spring pressure allowing the oil to drain from the sump. The Curtis CCB-37000 valve is fitted to most Lycoming engines.

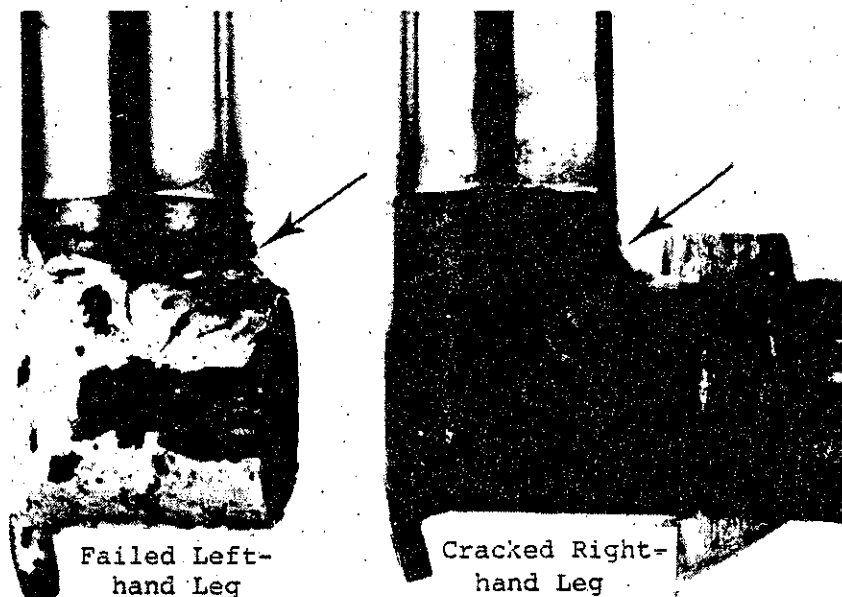
Failure of the landing gear leg occurred near the weld between the bottom of the leg and the stub-axle. The left-hand wheel, axle and part of the leg detached on landing. Examination of the right-hand leg showed that it was cracked half way through in similar fashion. Laboratory examination confirmed that the crack had been present for some time and was a result of fatigue from landing and taxiing loads. (The welding process produces an adverse change of material microstructure in an area that by its design is subject to high stress levels.

The affected area is underneath the rubber gaiter and cannot be seen during a pre-flight check. All owners/operators would be well advised to check this area regularly, particularly if operating from a rough surface.

Because of the high duty cycle of take-offs and landings, often from rough airfields, there is a risk of undercarriage failures. In particular those types which depend upon hinge-bolts (and related attachment tugs, welded to the airframe structure), require frequent inspection and/or replacement. (Includes Auster Variants, Piper Cub series and Citabria type undercarriage systems).
