B.G.A. TECHNICAL COMMITTEE

TECHNICAL NEWSHEET

TNS 3/4/84

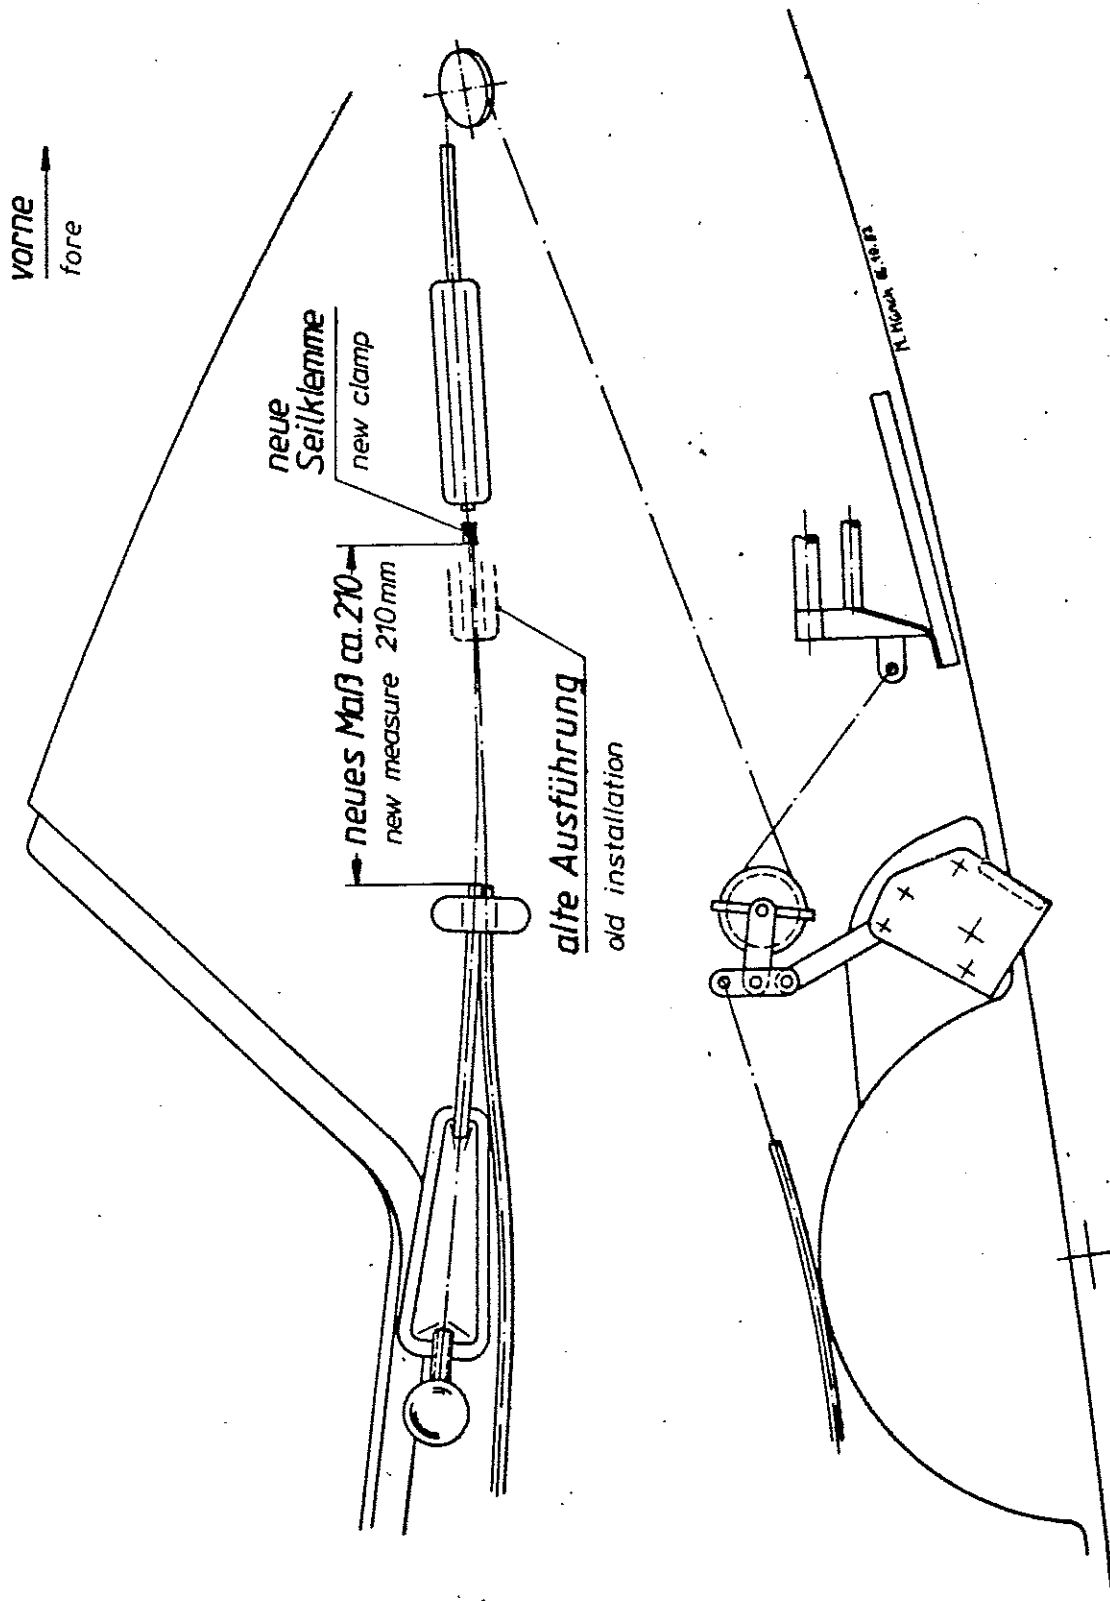
Reason: It has been found that in course of time the tow release cable is prone to create loops. Because these loops are relatively short, they lead to strong bending loads on the cable, mainly at the binding clamp.

- Action:
1. On receipt of this Technical Note check immediately the tow release cable for possible cracks at the junction clamp.
  2. According to the drawing on sheet 2 of this Technical Note the tow release cable must be installed new. It is very important that possibly developing loops do not create strong bending loads on the clamp. The loops form preferably if one knob is forward and the other behind. The new arrangement of the tow release cable shall lead to larger loops forming larger radii and thus bringing about lower bending stresses of the cable at the clamp.
  3. Page 43 of the Maintenance Manual must be exchanged against page 43 a.

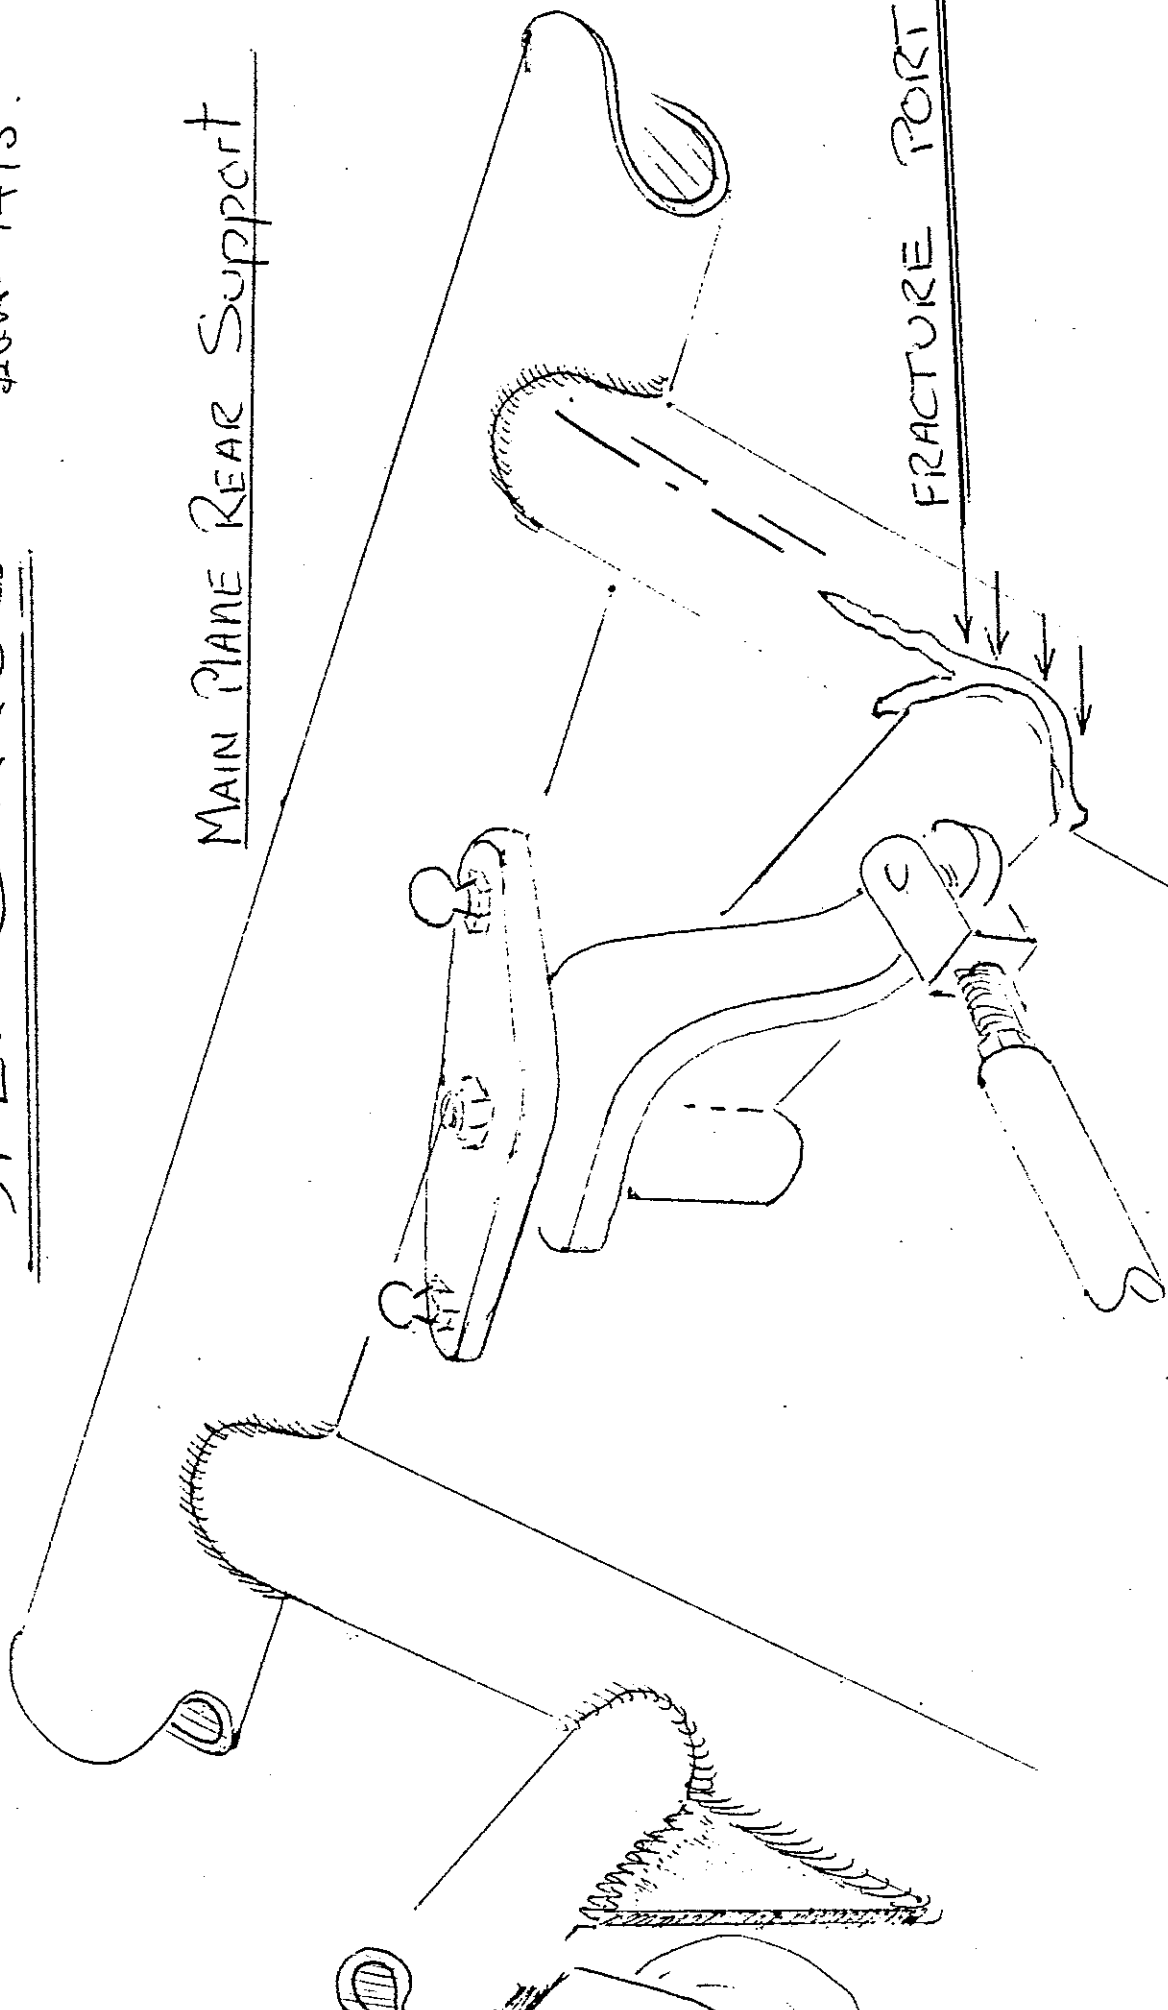
MAIN PLANE REAR SUPPORT

- 1.1 OPEN CIRRUS Cracks in centre-section tubular structure, probably arising from ground-loop damage? (sketch attached). Inspect as required. (Reported by J. Clarke).
- 1.2. ASK 21 Cable Release Fairlead to be modified to Tech. Note 10 (attached) to avoid bending loads in the cable which may induce failure.
- 1.3. KA.2B Heavy Landing Damage induced cracks in "D" box and trailing edge structures. Remove sufficient fabric to allow proper inspection for both primary and secondary structural damage. (Reported by J.M. Scott).
- 1.4. IS.28 M2A (Motor Glider) C.A.A. Foreign Airworthiness Directives (Vol III) make the following service bulletins mandatory:-

FRACTURE PORT SIDE

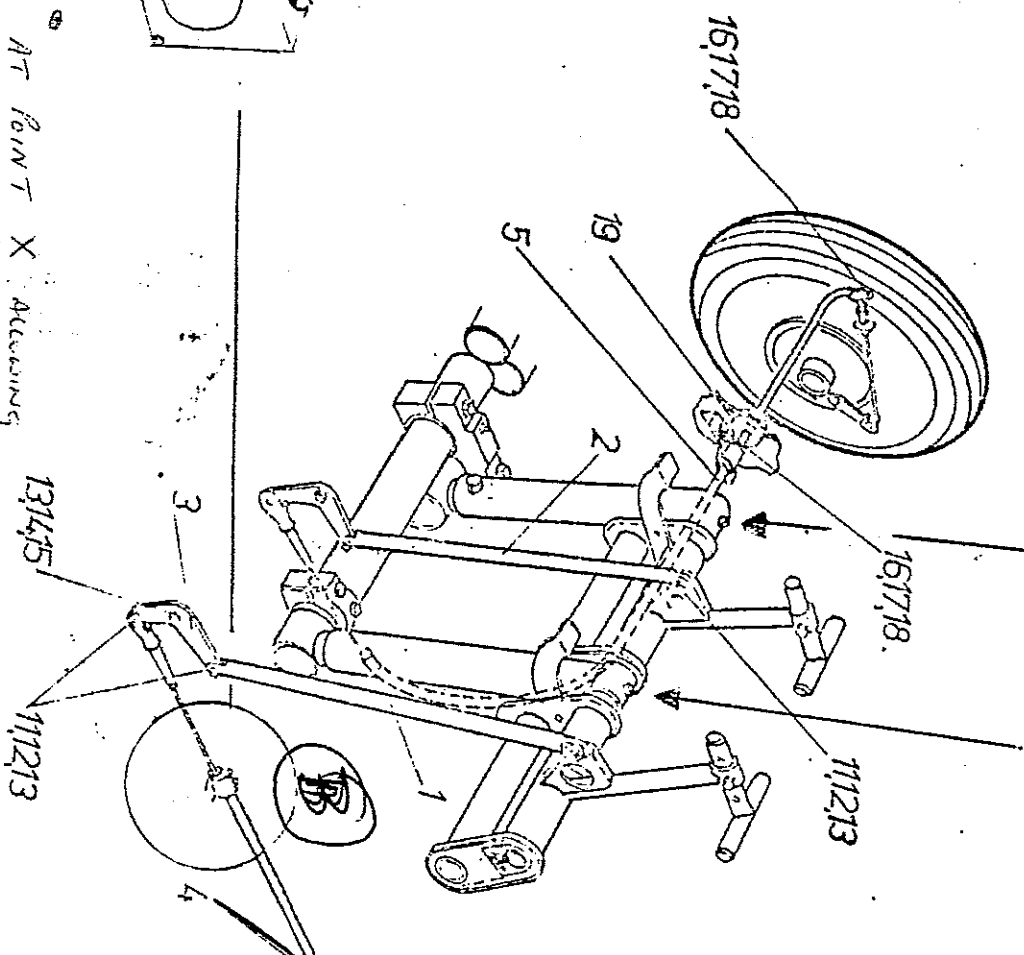
IS 2842

- 1.5. IS.28.M2 (Series) Defects reported to B.G.A./C.A.A.
  - a) Flap lever fouls floor in 5° position.
  - b) Airbrake micro-switch insecure
  - c) Landing gear selector lever centre bolt ripping the debris guard (cockpit)
  - d) Canopy flexes and jumps out of the guide rails.
  - e) Rudder pedal attachments to horizontal shaft by single rivet, prone to shearing.
  - f) Brake malfunction due to failure of flexible cable attachment bracket (sketch attached).

BRACKET COLLAPSED AT POINT X ALLOWING

EFFECTIVE LENGTHENING OF OUTER BRAKE CASSE (ITEM 4)  
LEVER (ITEM 3) HAD EXCESSIVE TRAVEL ALLOWING BRAKE  
PEDAL TO GO OVER CENTRE AND GEOMETRICALLY LOCK BRAKE

(B) Brake cable bracket failure,

Kent Motor-Gliding Club have proposed modifications which have been passed by B.G.A. to both C.A.A. and to B.Ae. Weybridge.
- 1.6. Tug Main Gear Failure (Bellanca Scout) Welded repair to "U" bolt failed. Extract from G.A.S.I.L. 2/84 attached.
- 1.7. MORANE SAULNIER RALLYE (All variants) C.A.A. additional airworthiness directive 002-02-84 dated 3.2.84 and referring to service bulletin 133/2 (1981) requires special anti-corrosion inspections.
- 1.8. OPEN CIRRUS - Rudder Cables dislodged from rollers, forward of adjustment bar under footwell - (cables damaged), with pedals set fully forward, spring tension was inadequate. (Reported by J. Clarke).
- 1.9. LS.1 (Series) Weight & Mass Balance of Control Surfaces Maintenance Manual revisions dated 2/1/84 give current tolerances to prevent flutter. Copies from Rolladen Schneider Flugzeugbau GmbH or U.K. agents.

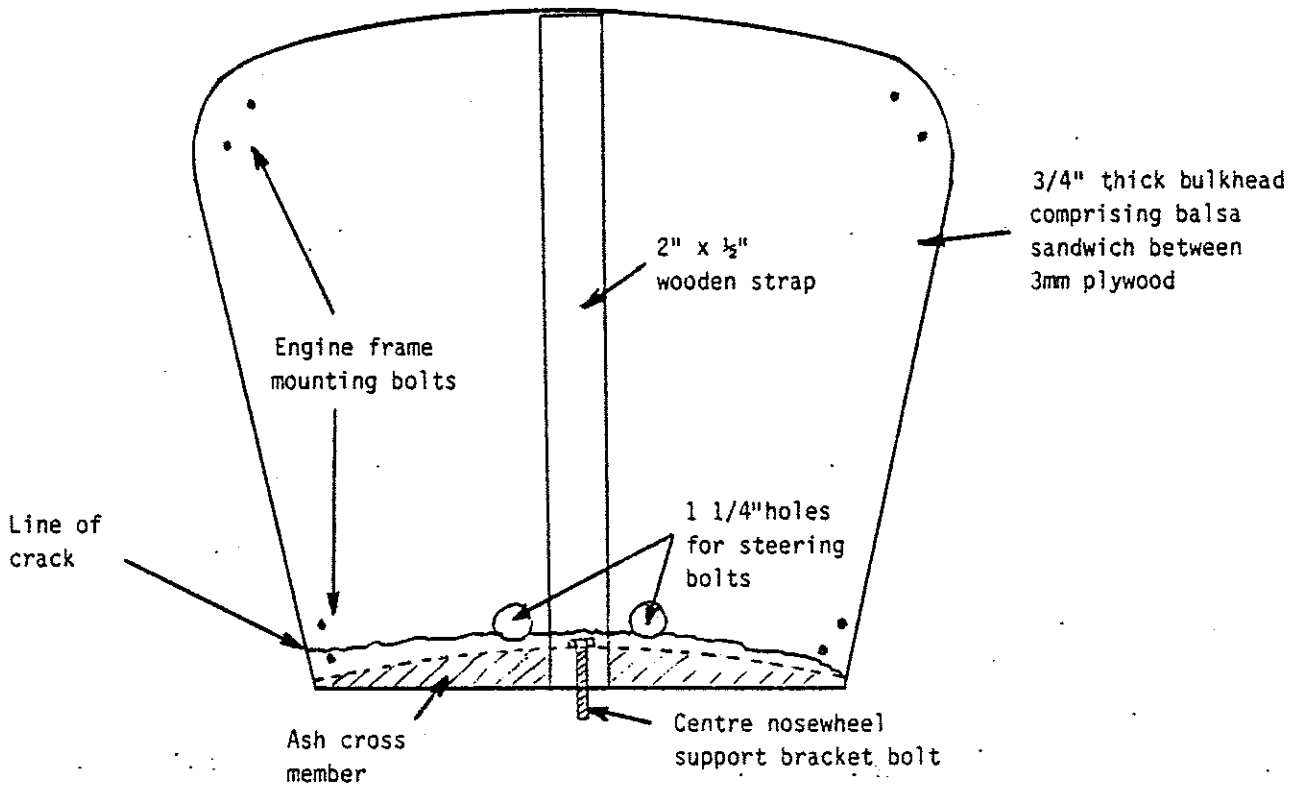
12. FRONT BULKHEAD CRACKED ACROSS WHOLE WIDTH (TURB),

During a landing in a modest crosswind from the right there was severe nosewheel shimmy which continued until the aircraft stopped. Neither the brakes nor holding the stick back or forward had any effect. The shimmy was so severe that the nosewheel spat detached. The pilot checked the nosewheel area but did not find any other problems and later flew back to base.

The maintenance organisation which normally deals with the aircraft made a careful check and found that the front bulkhead was cracked right across just above its bottom edge. The crack was only visible when the carpet was lifted and fore and aft pressure applied to the nosewheel after pushing down on the tail to remove the weight on the nosewheel. The bulkhead consists of a 3mm plywood faced balsa sandwich. The whole area had been inspected about two months previously after nosewheel shimmy occurred while taxiing across a runway edge drain channel. The maintenance organisation had experienced one previous case of identical bulkhead cracking and are aware of two other cases on Robin DR400 aircraft, possibly associated with heavy landings.

The Manufacturer states that optional modification No 30 dated 13.4.77 provides an anti-shimmy damper (not fitted to the aircraft in this occurrence). Excessive play in the connection or a faulty damper will result in shimmy. If modification No 30 is not fitted the friction on the nut on the spring washer on the landing gear pivot can be increased by increasing the torque on the nut as per the Maintenance Manual. Shimmy can also be caused by poor positioning of the locating bolt in the adjustable pin in the bottom section of the landing gear strut and by cracks in the weld securing the nosewheel steering bottom bracket to the nose leg.

While the CAA is investigating the cracked bulkhead aspects it would be prudent for all operators of DR253, DR300 series and DR400 aircraft to check for cracks in the front bulkhead, particularly if there has been a heavy landing or the aircraft is prone to nosewheel shimmy.
