B.G.A. TECHNICAL COMMITTEE

TECHNICAL NEWSHEET

TNS 11/12/83

PART 1 AIRWORTHINESS AGGRO (The 1984 issue of B.G.A. Compendium of Airworthiness Directives Mandatory Modifications and Special Inspections for U.K. and Foreign Gliders and Motor Gliders will include the following additions:-

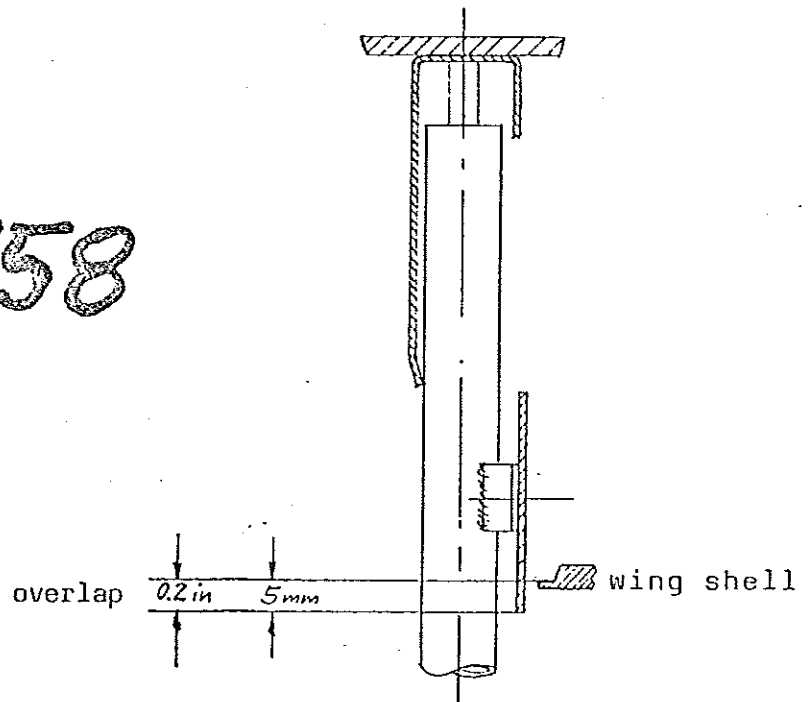
AD 83-158

Reason: Possible jamming of lower air brake blade at high speeds

- 1) Assemble sailplane
- 2) With air brakes fully extended, measure overlap between lower blade and wing shell central to levers. When overlap is below 5 mm (0.2 in) proceed according to step 3.
- 3)a. Retract air brakes until overlap is at least 5 mm (0.2 in) at both wings
- b. Check extending height at inner lever, minimum is 150 mm (5.91 in). If below minimum, contact manufacturer.
- c. Rivet stop to air brake pushrod in cockpit from approx. 45° below horizontal such, that main bulkhead reduces travel to yield required overlap

Material: Stop 4R6-15, Steel blind rivet 4x10, (drill dia.4.1 mm, DN 20)

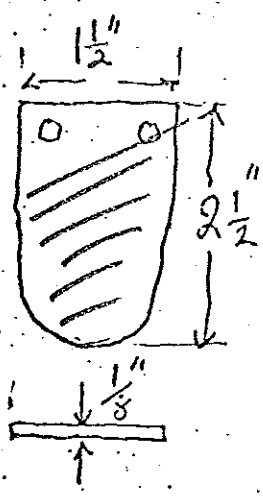
ASK 21

THESE PLATES DO NOT SECURE CANOPY TO FUSELAGE. THEY SIMPLY ALIGN & LOCATE THE CANOPY. THEY DO NOT RESTRICT THE OPENING OF CANOPY IN ANY WAY IT WILL.
