B.G.A. TECHNICAL COMMITTEE

TECHNICAL NEWSHEET

TNS 9/10/84

PART 1 AIRWORTHINESS "AGGRO" (please add to 1984 Yellow Pages)

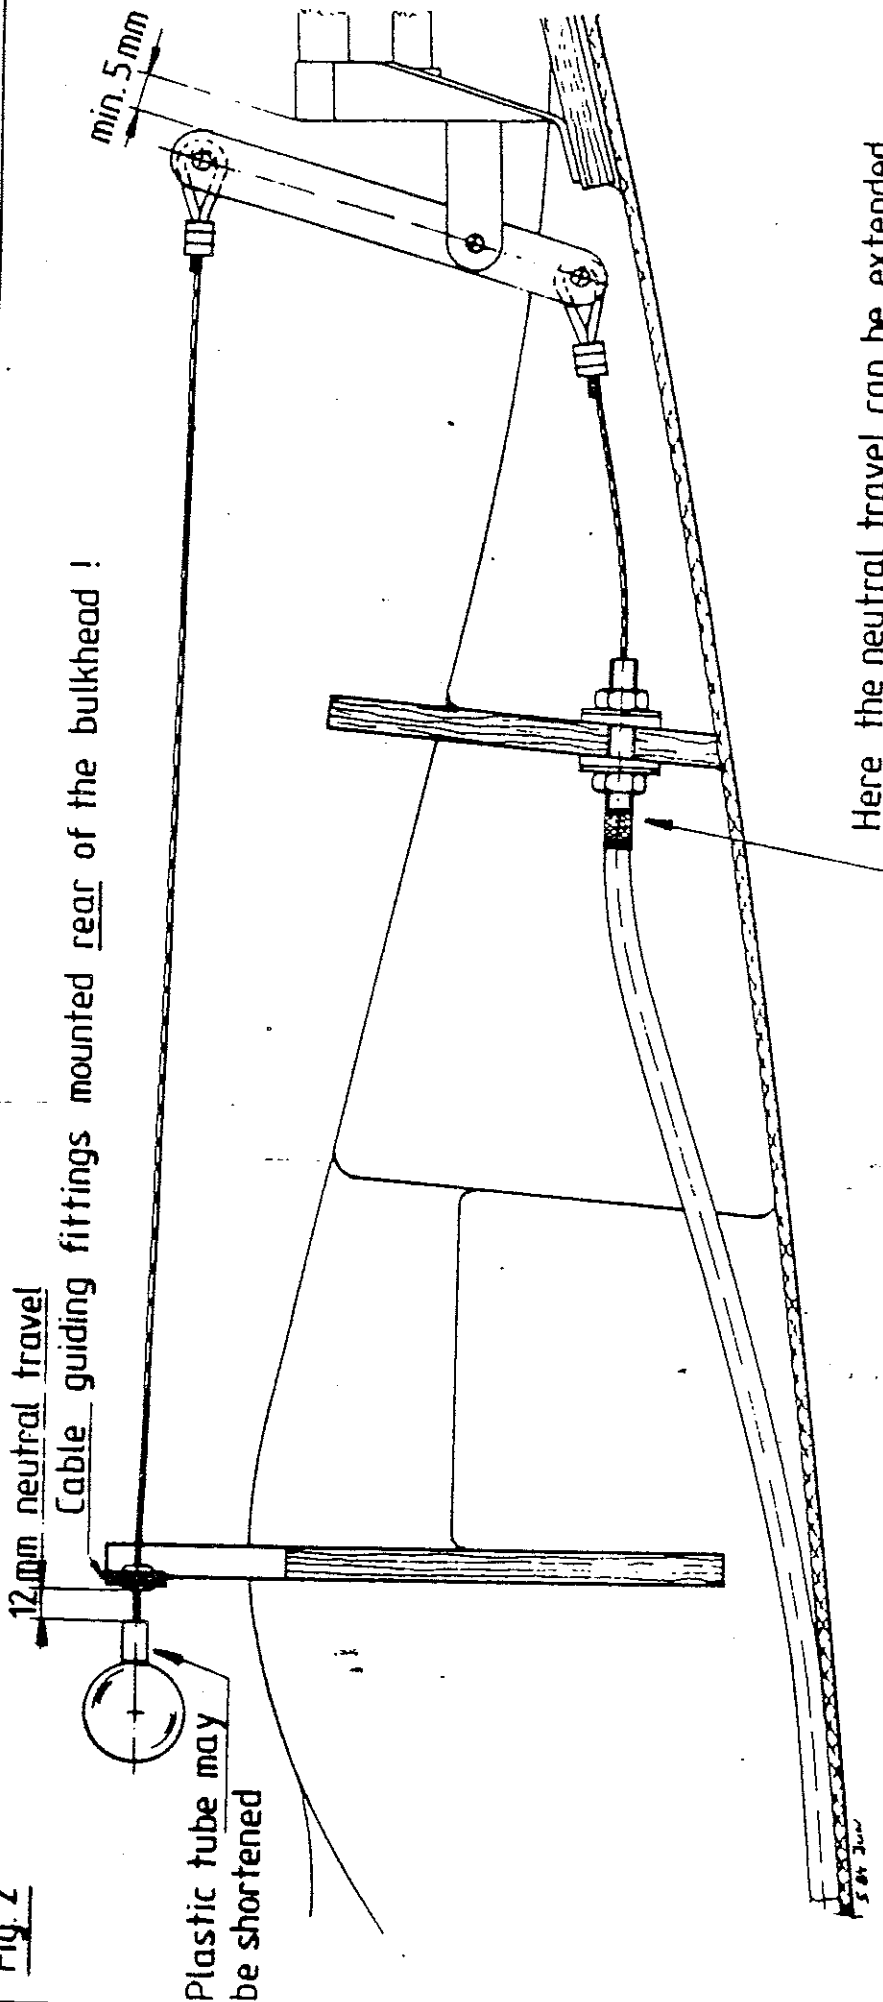
Fig. 2

Background: With older ASW 19 and ASW 19 B the cable guiding fittings were mounted in front of the control bulkhead (as shown in Fig.1), while with newer gliders the fittings were mounted as standard rear of the control bulkhead (See Fig.2).

Now the following error may arise:
If the cable guiding fittings are mounted in front of the control bulkhead with sufficient neutral travel, the neutral travel disappears in case that the fittings are mounted by mistake rear of the control bulkhead.

12mm neutral travel
Cable guiding fittings mounted rear of the bulkhead!

1. Check whether the cable guiding fittings are mounted in front of the bulkhead (Fig.1) or rear of it (Fig.2).
2. If the fittings are mounted in front of the bulkhead, they must be remounted to the rear!
3. Now you have to check whether sufficient neutral travel is left, as indicated in Fig.2. With too little neutral travel the plastic tube at the ball grip may be shortened accordingly and/or the neutral travel may be extended by turning in the turnbuckle (Fig.2).

Plastic tube may be shortened

Here the neutral travel can be extended by turning in the turnbuckle.

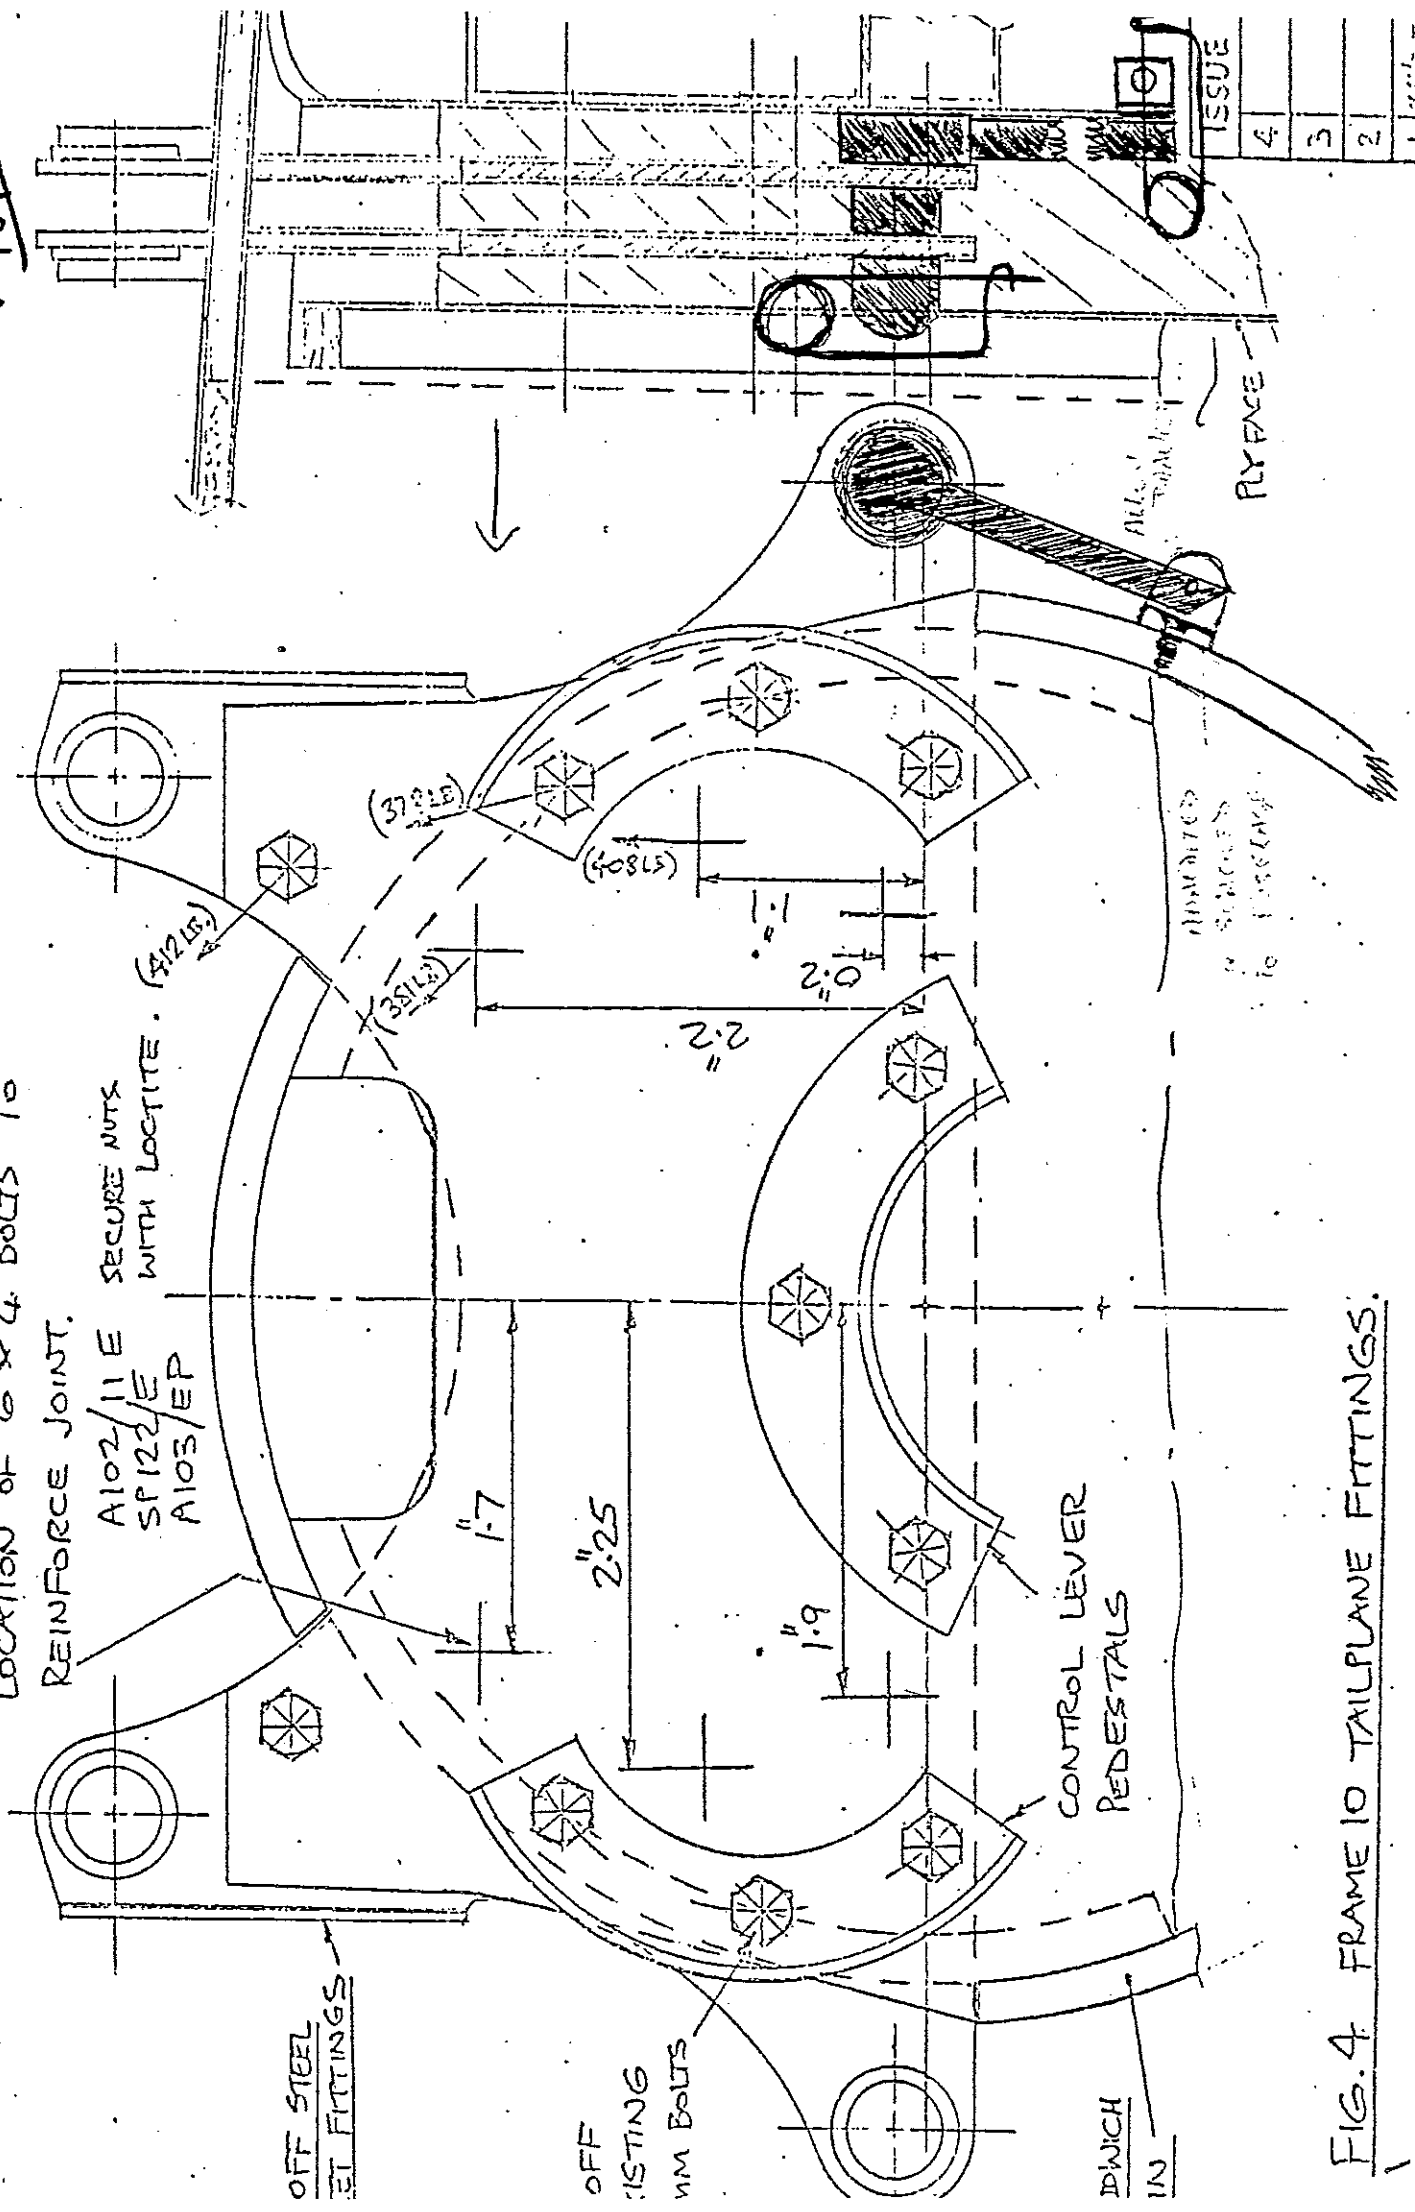
FIG. 4 FRAME 10 TAILPLANE FITTINGS.

- 1.4. "FAUVETTE" (Breguet 9055). Fatal accident caused by insecurity of tailplane rigging pin. All owners were alerted 21.8.84. Sketch of secondary locking devices attached. (By courtesy of Jeremy Menzies).

- 1.0. A fatal accident in the U.K. has been attributed to the loss of the single safety pin leading to the loss in flight, of the starboard fin/tailplane retaining pin.
- 2.0. It was discovered that some "Fauvettes" have already been fitted with a second means of securing the main pin, and it is strongly recommended that this option be incorporated in all gliders of this type. (Will anyone with details send sketch to B.G.A.)
- 3.0. Duplicate Inspections should be carried out, and recorded in the D.I. books of all gliders which have been re-rigged.

LOCATION OF 6 x 1/4" BOLTS TO REINFORCE JOINT.
 A102/11E SECURE NUTS WITH LOCTITE.
 SP122/E
 A103/EP
