B.G.A. TECHNICAL COMMITTEE

TECHNICAL NEWSHEET

TNS 5/6/84

PART 1 AIRWORTHINESS "AGGRO" (Please add to the 1984 "Yellow Pages")

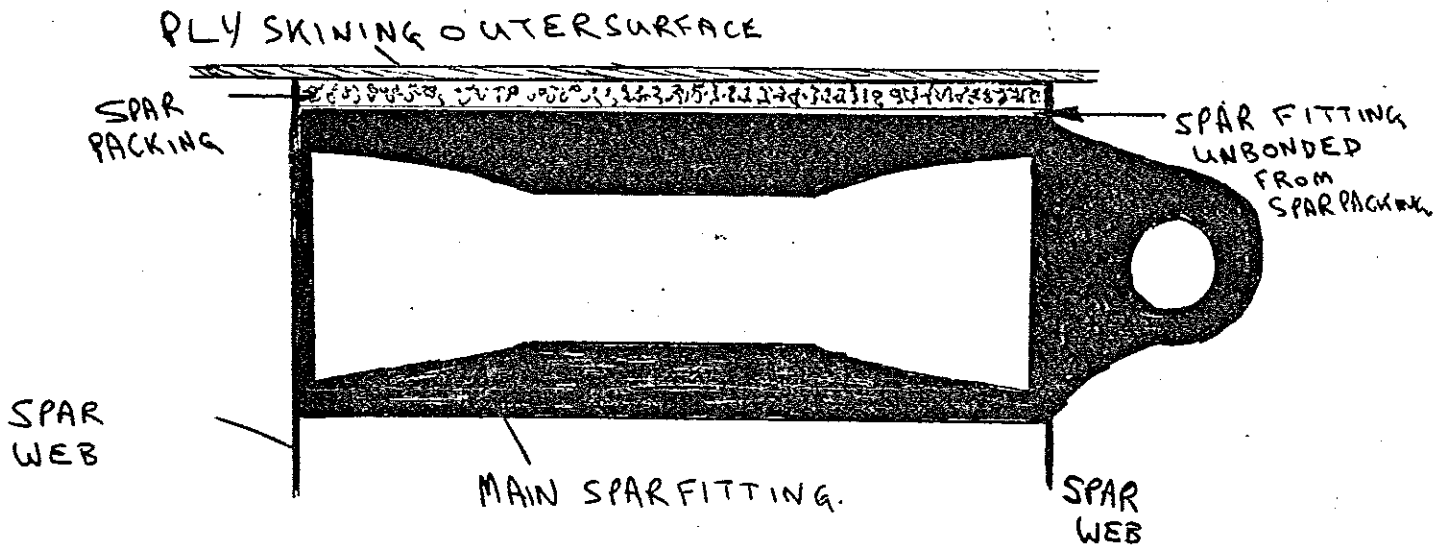
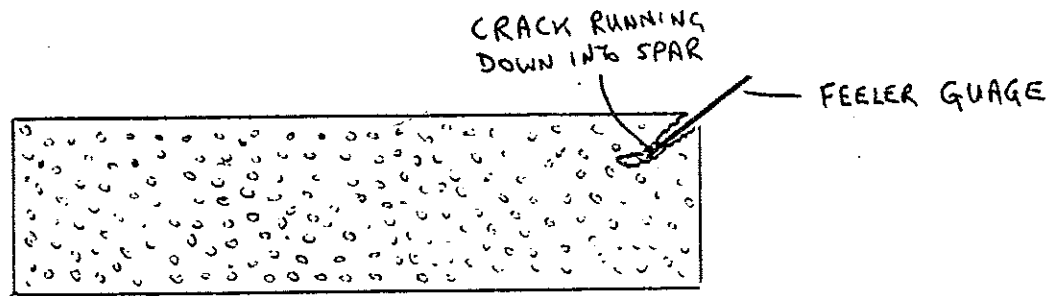
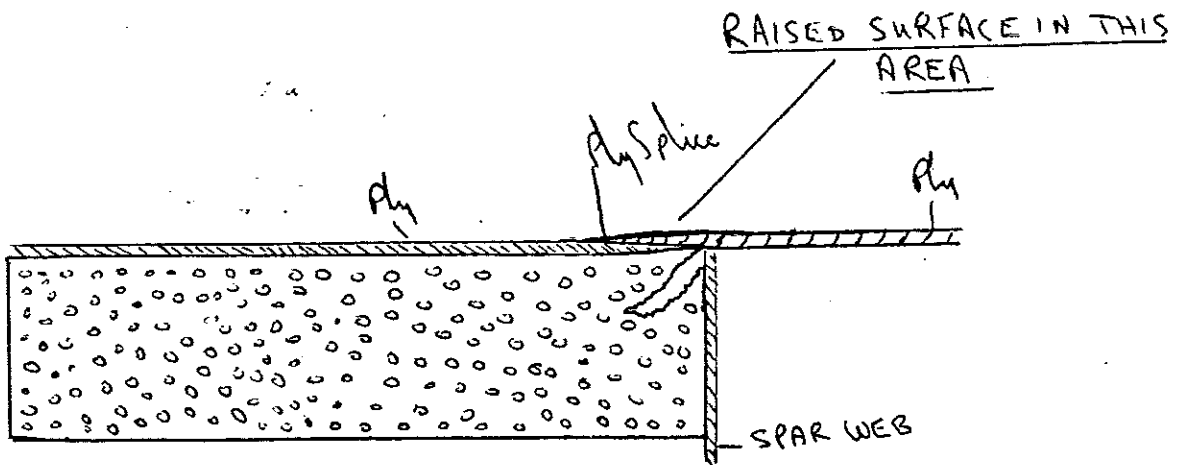
SKETCH 1.

- 1.10. BOCIAN Spar Root Inspection Further to TNS 3/4/84 (item 1.11), a more specific diagram is attached herewith, kindly supplied by Lasham Gliding Society.

VIEW OF MAIN SPAR FITTING FROM ROOT END.

X-SECTION VIEW OF SPAR

X-SECTION VIEW OF SPAR SHOWING RAISED OUTER SURFACE

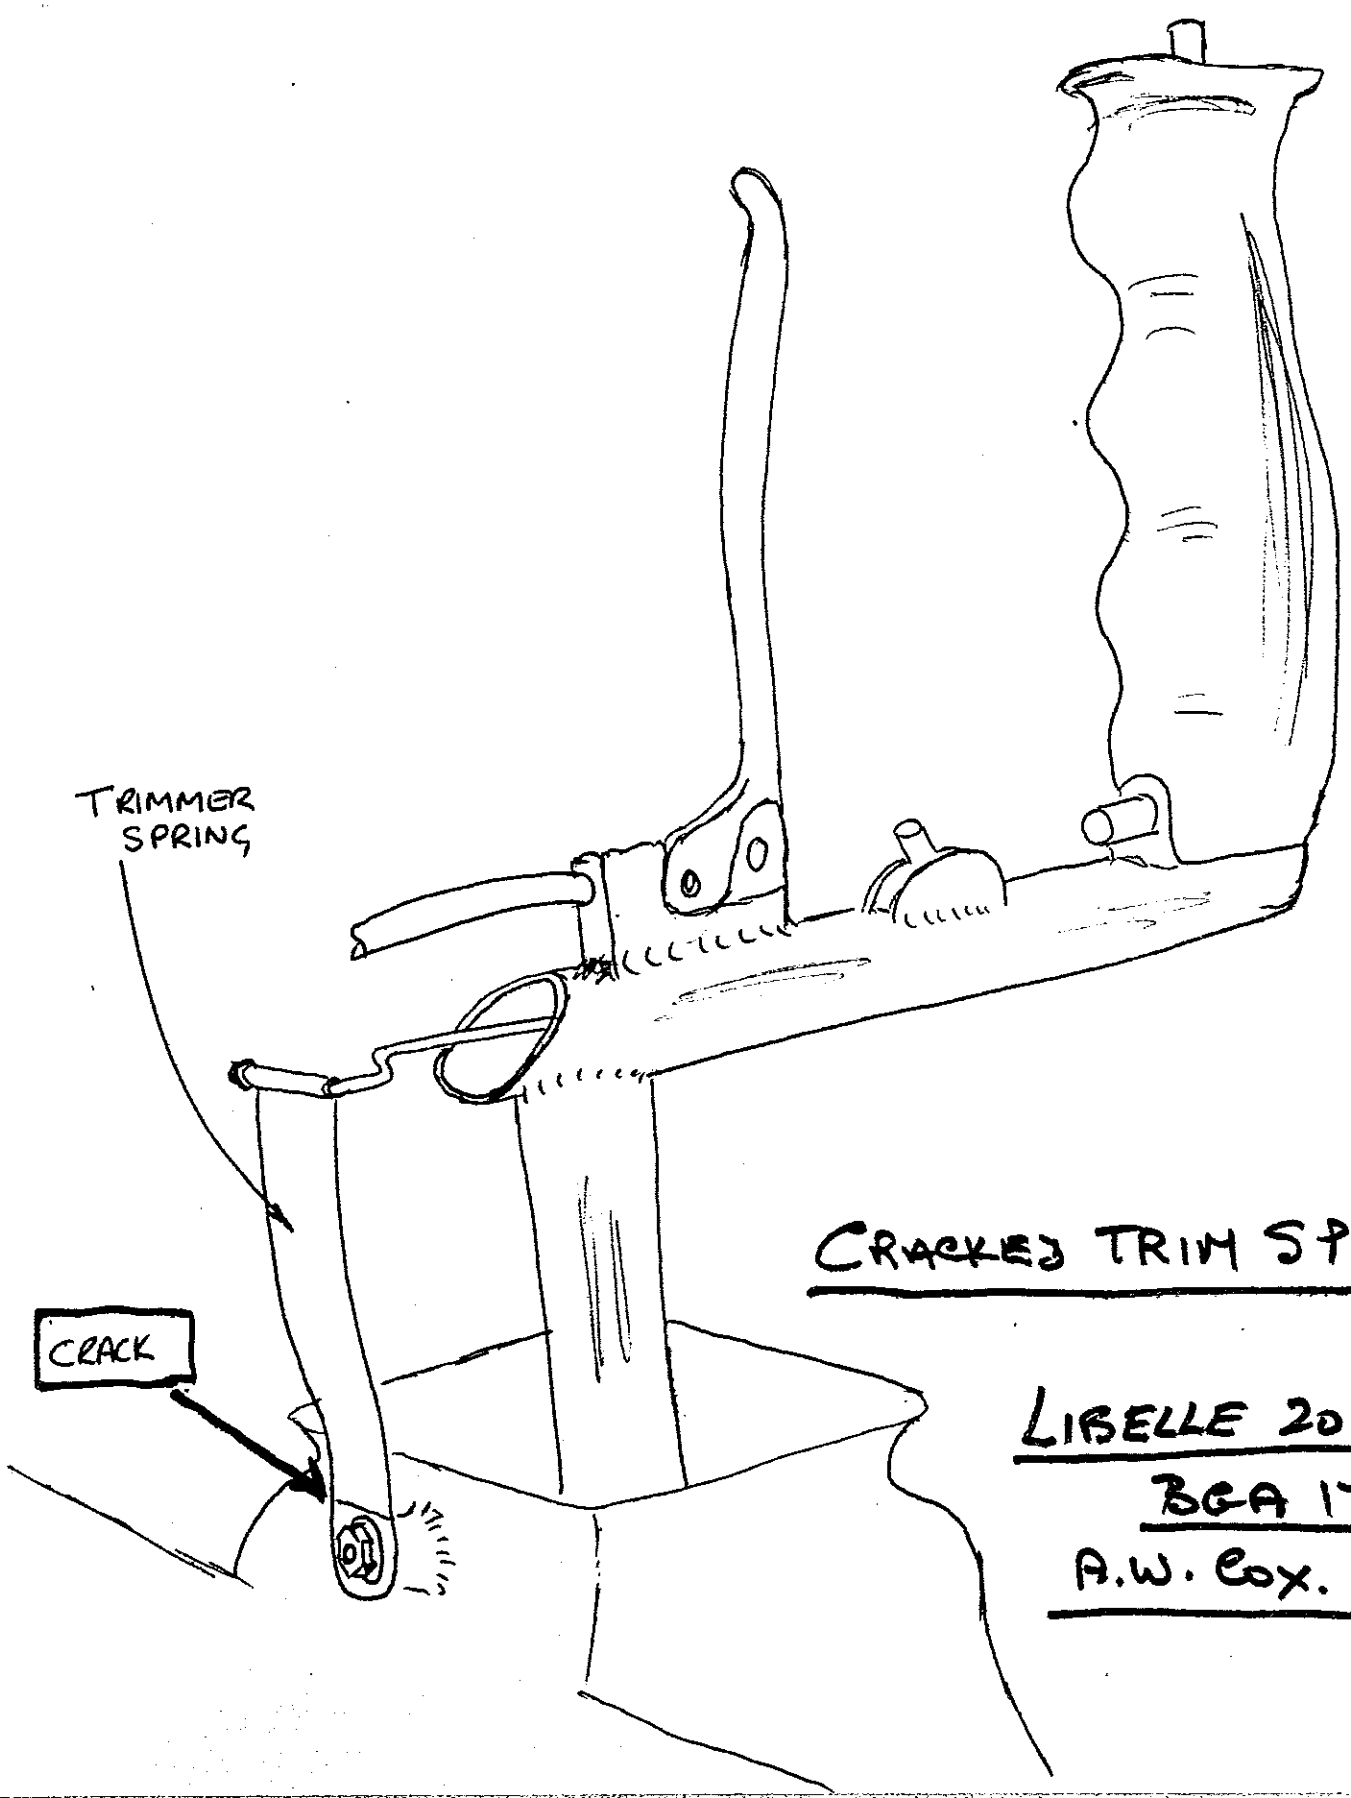
LIBELLE 2018

- 1.11. LIBELLE Trim Spring Cracked Sketch of this defect kindly supplied by A.W. Cox.
- 1.12. BLANIK Canopy Jettison found inoperative. Periodic jettison tests, and such maintenance as may be required, should be applied to all Blaniks a.s.a.p. (Reported by P. Wooller - Blackpool and Fylde G.C.).

CRACKED TRIM SPRING

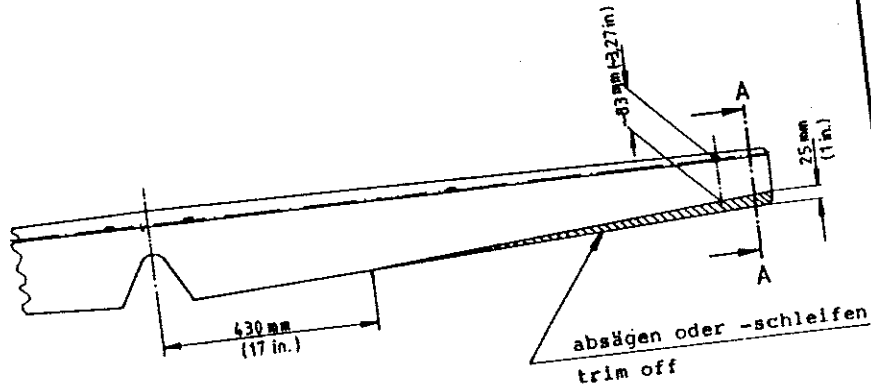
A-A

min. 7 mm (0.28 in.)
max. 12 mm (0.47 in.)

2. According to the sketch on sheet 4 of this TN, the elevator trailing edge is cut or ground off and reshaped on the lower surface.

The glue joint must be at least 7 mm wide, but no more than 12 mm.

Hinterkante verjüngen
reshape trailing edge

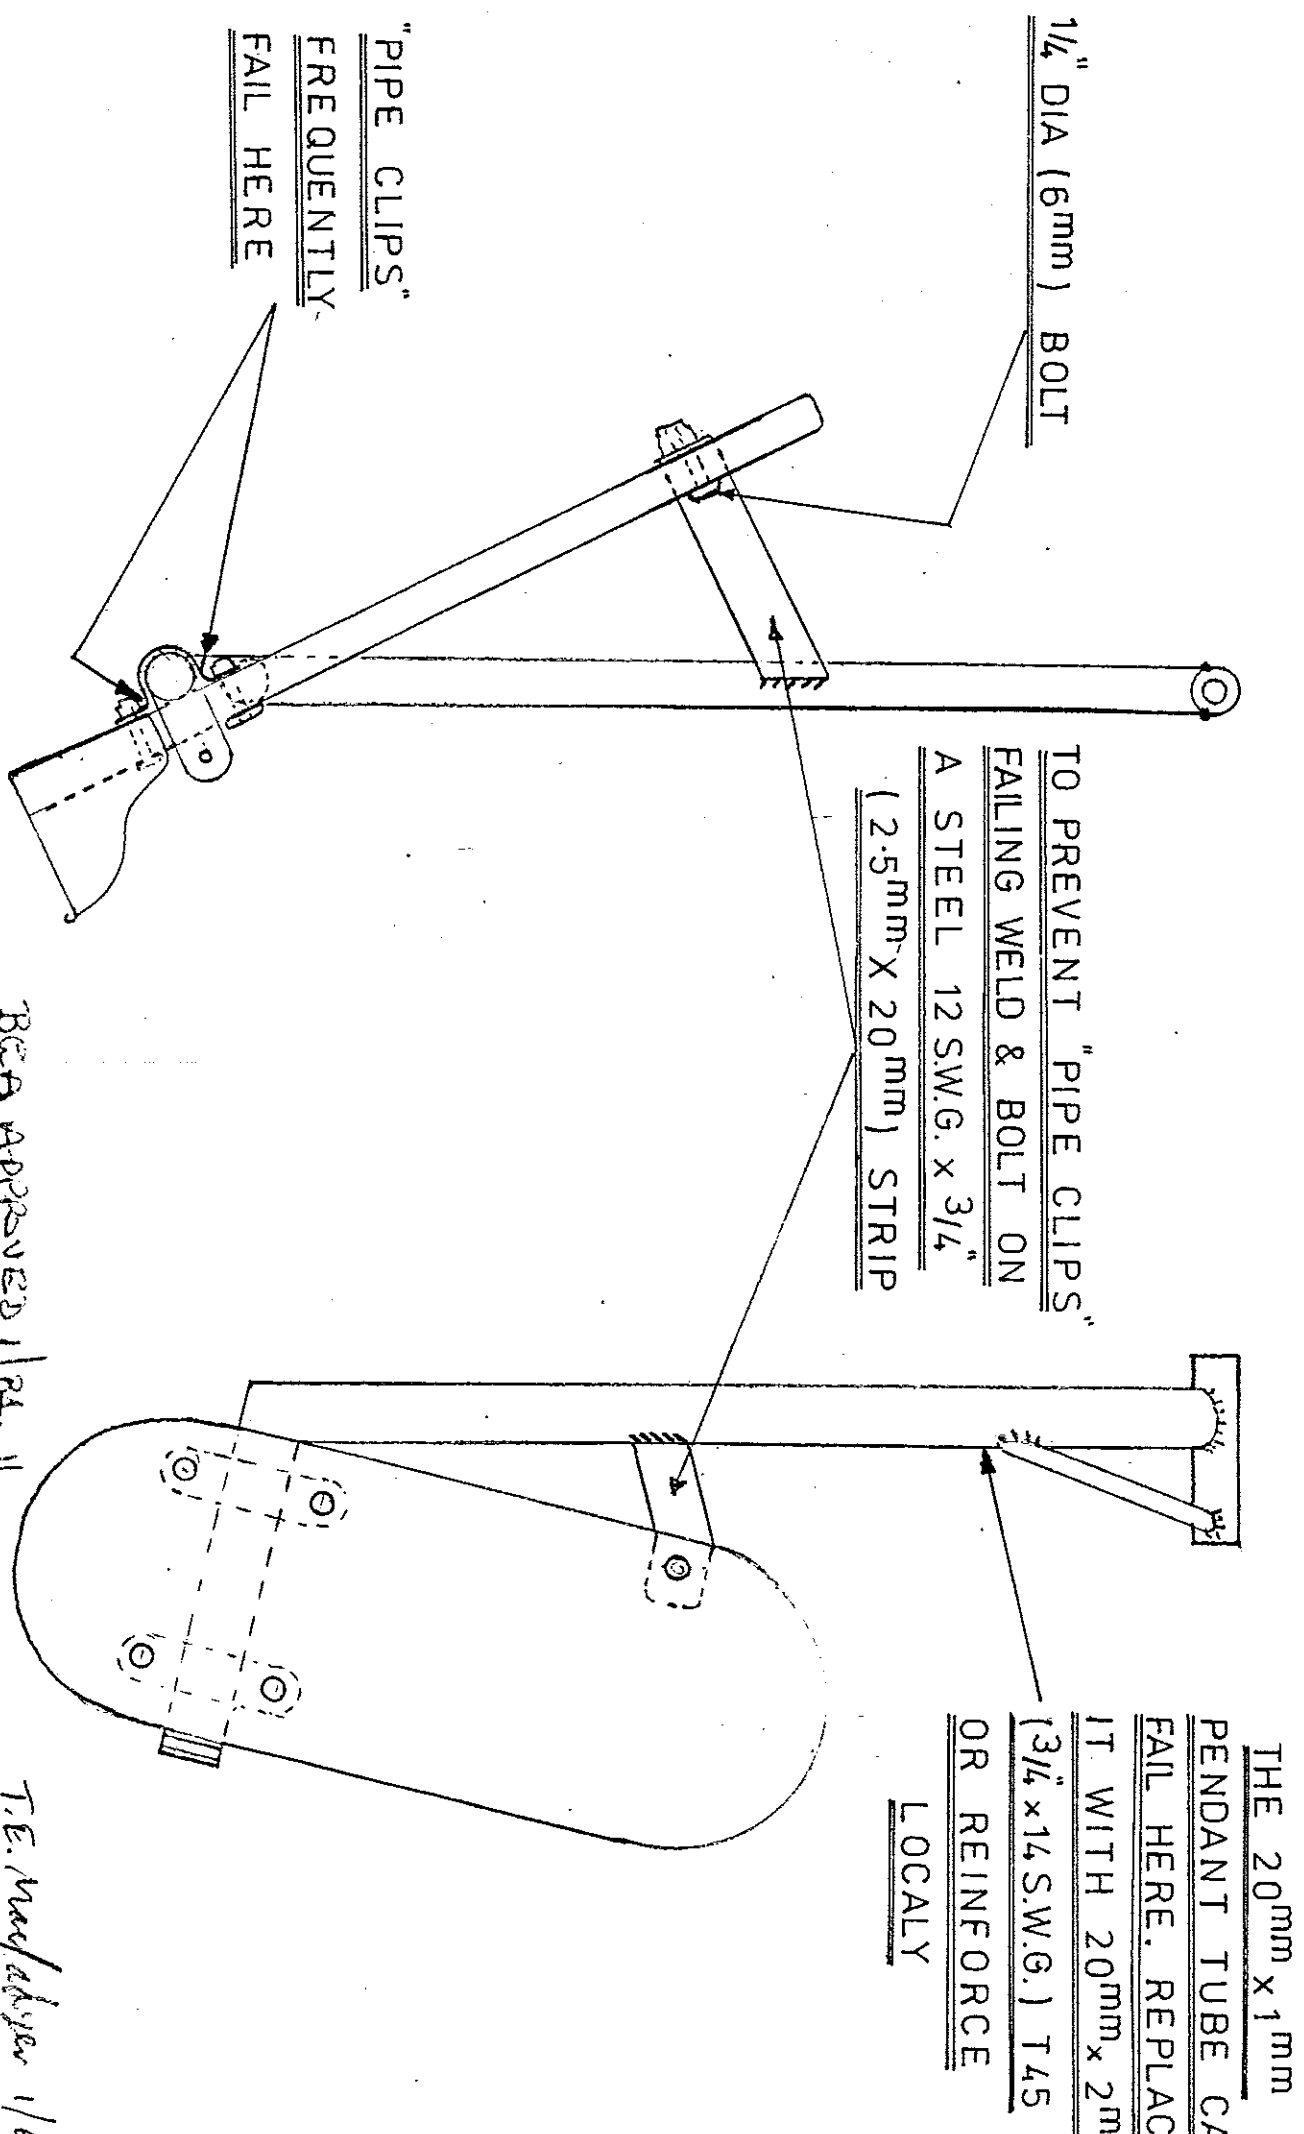
- 1.20 KA 2/KA 6/KA 7/KA 8 Cracks in Rudder Pedals (Re-enforcing modifications). Sketch attached herewith may be applied where defects are discovered by inspection (T.E. Macfadyen, Cotswold G.C.).

"PIPE CLIPS"
FREQUENTLY
FAIL HERE

TO PREVENT "PIPE CLIPS"
FAILING WELD & BOLT ON
A STEEL 12 S.W.G. x 3/4"
(2.5mm x 20mm) STRIP

THE 20mm x 1mm
PENDANT TUBE CA
FAIL HERE. REPLACE
IT WITH 20mm x 2mm
(3/4" x 14 S.W.G.) T45
OR REINFORCE
LOCALLY
