B.G.A. TECHNICAL COMMITTEE

TECHNICAL NEWSHEET

TNS 11/12/84

PART 1 AIRWORTHINESS "AGGRO"

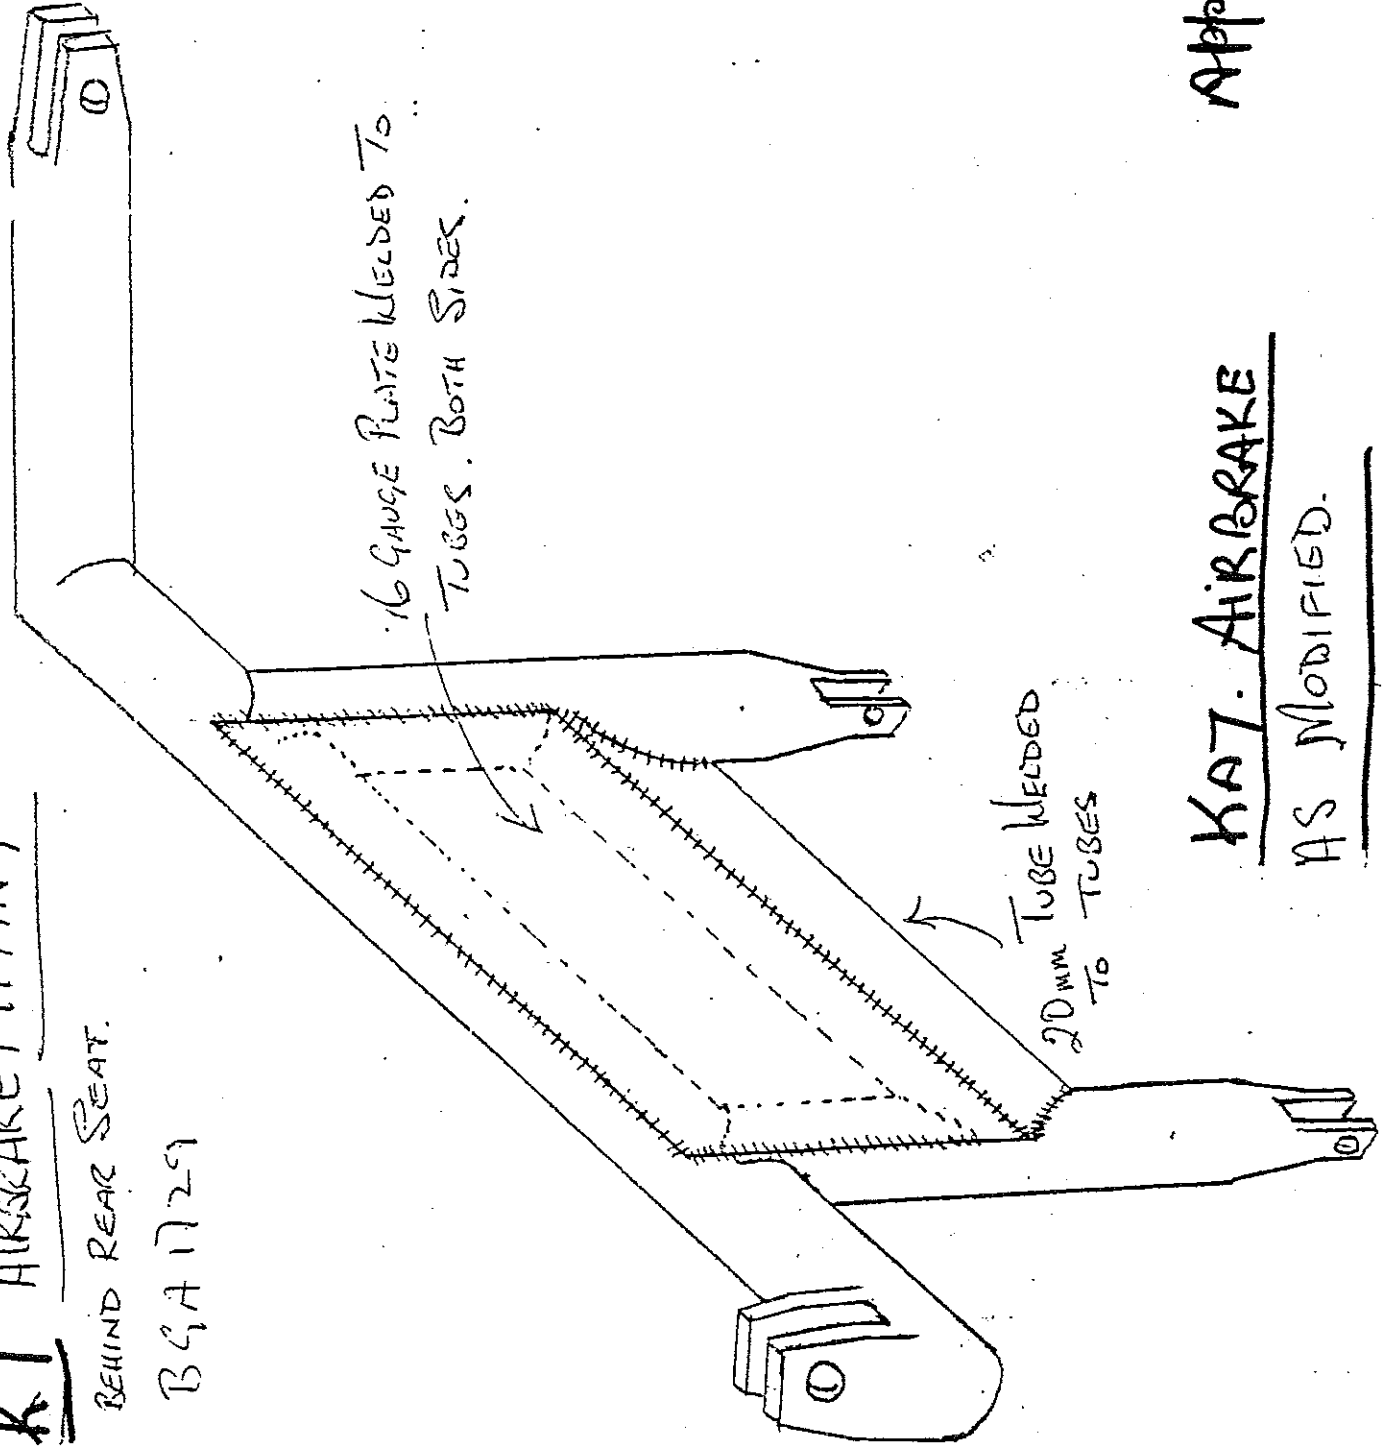
K7 AIRBRAKE FITTINGS

- 1.5. Ka7 - Air Brake Fitting (behind rear seat). Reinforcement, if required, can be incorporated as per sketch K7 1/84 proposed by B.F. Wilson (attached).

BEHIND REAR SEAT.

16 GAUGE PLATE WELDED TO TUBES. BOTH SIDES.

20mm TUBE WEEDED TO TUBES

KAT. AIRBRAKE  
AS MODIFIED.

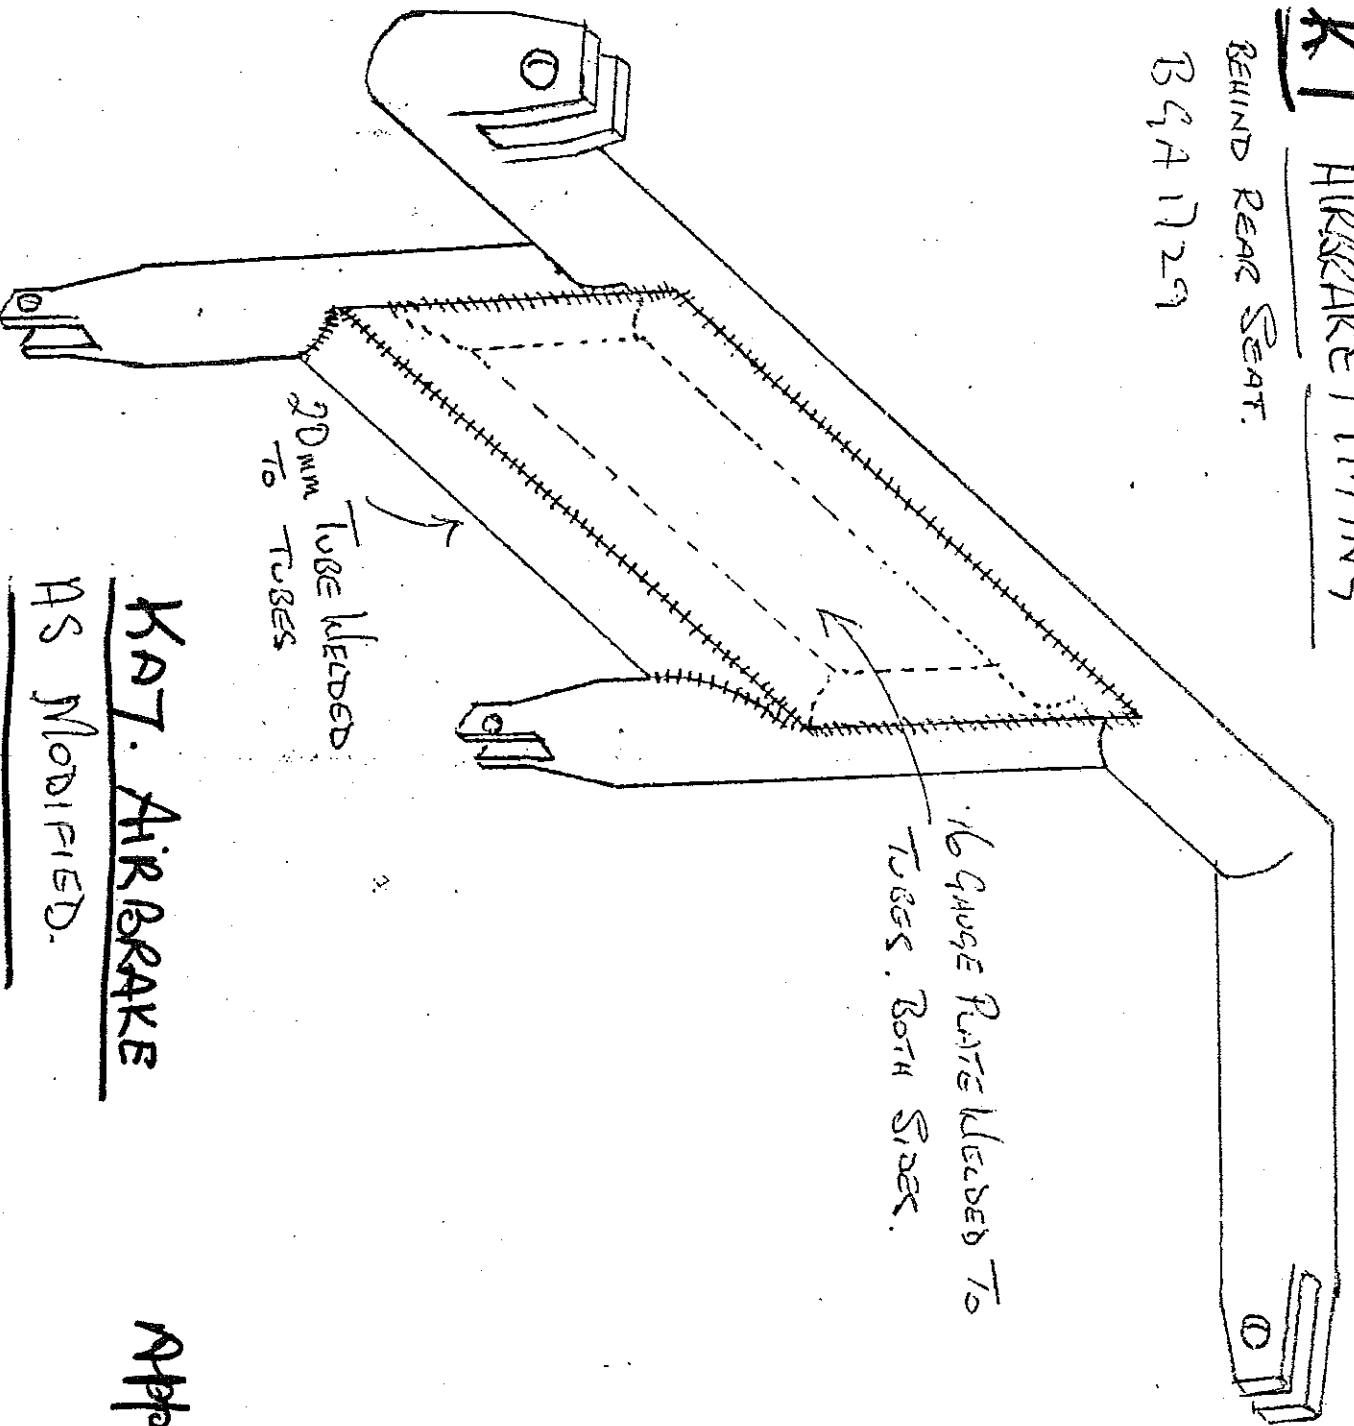
# K7 AIRBRAKE FITTINGS

BEHIND REAR SEAT.

16 GAUGE PLATE WELDED TO TUBES, BOTH SIDES.

20mm TUBE WELDED TO TUBES

## K07 AIRBRAKE

AS MODIFIED.

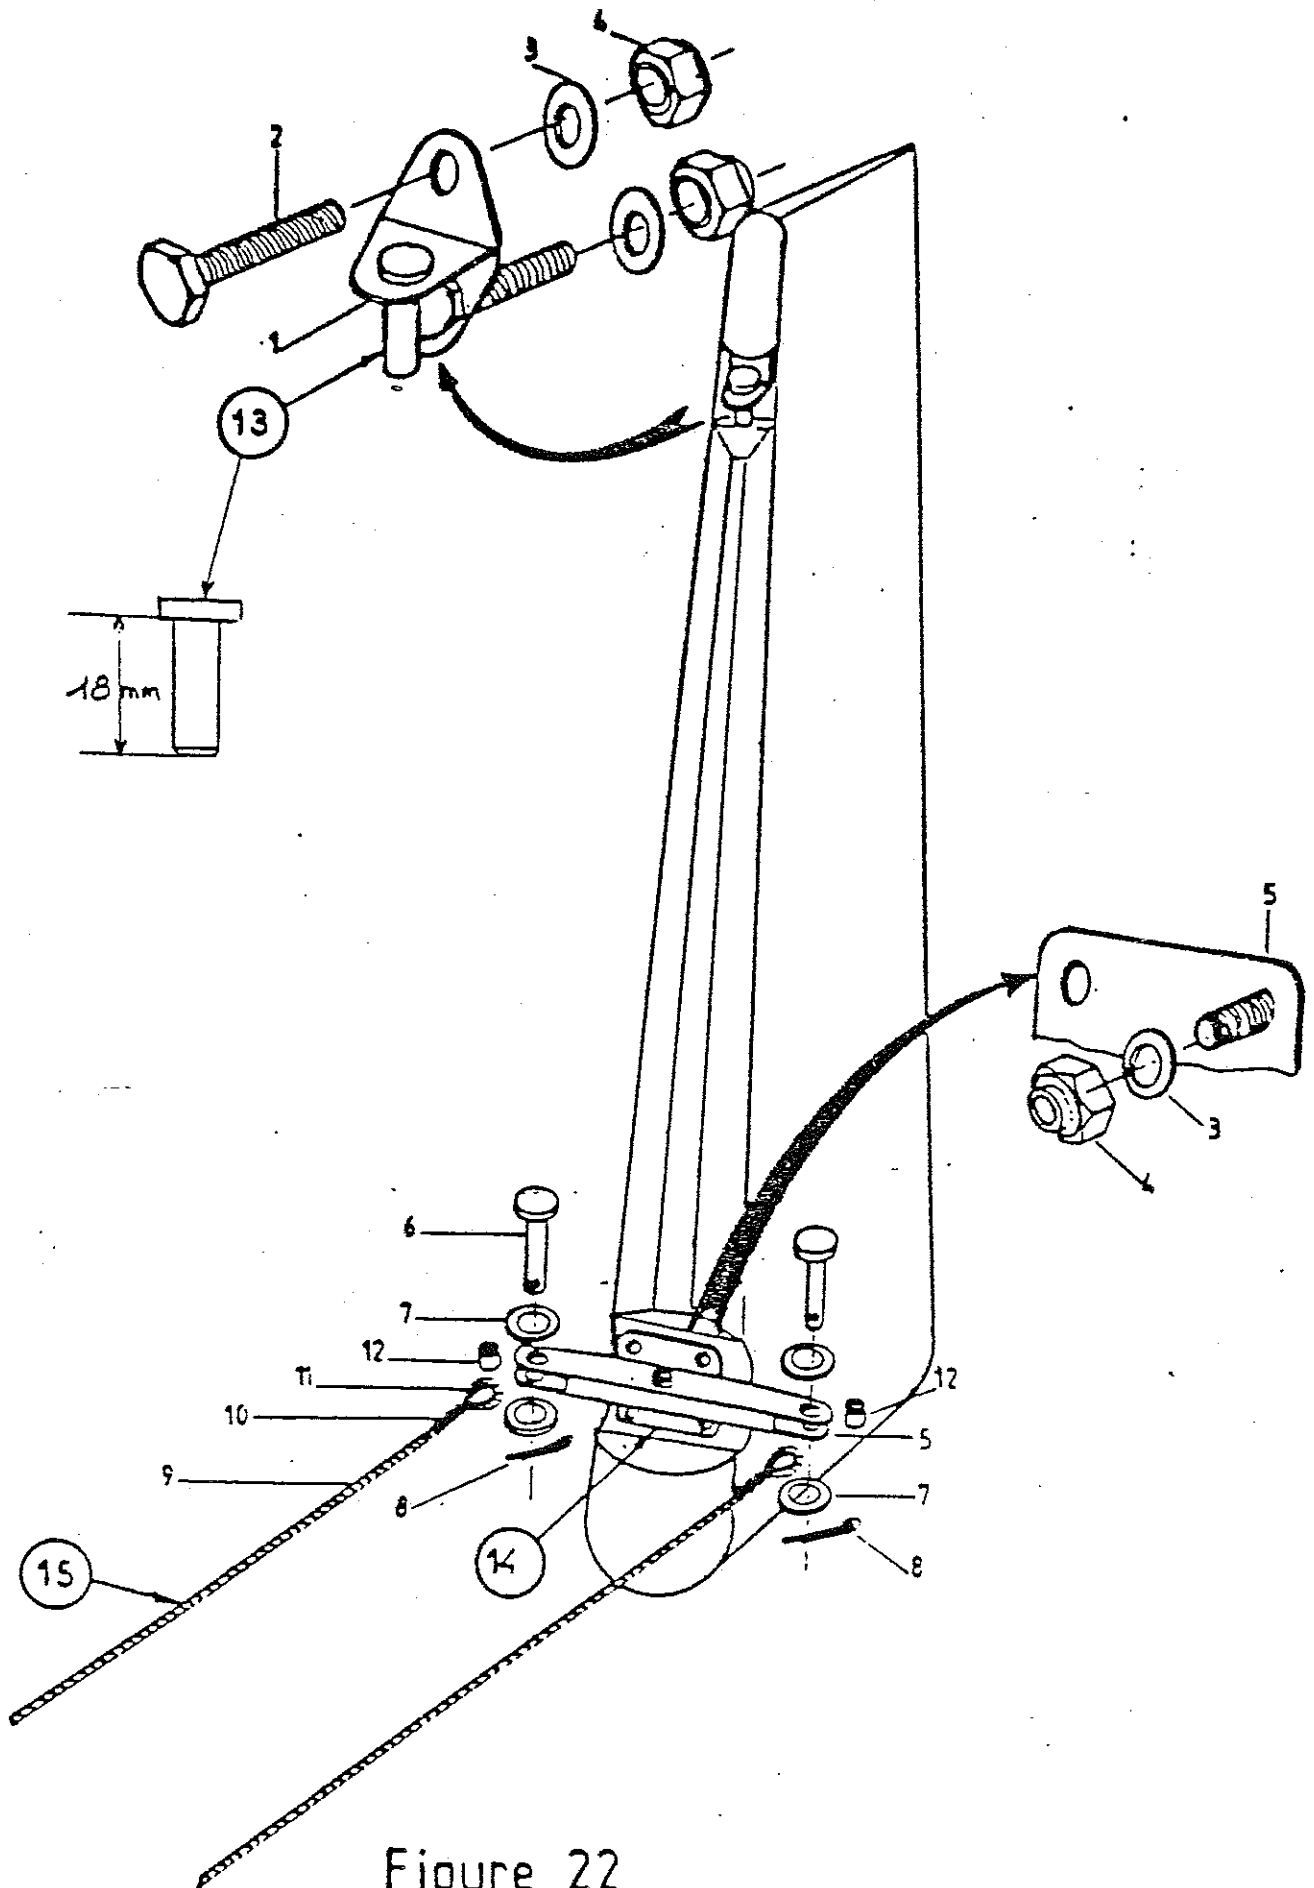
Figure 22

**Objet:** Mandatory inspection of the upper rudder hinge.

Following the discovery of two failures of the upper rudder hinge pivot, it is imperative to immediately check the upper rudder hinge pivot by disassembling the rudder :

1. Remove the rudder control cables (rep.15 fig.22)
2. Remove the bottom rudder hinge retaining bolt (rep.3 fig.33)
3. Pull the rudder back slightly (to clear the bottom rudder hinge) then lift rudder to disengage it from the vertical fin.

Proceed to visually check the upper rudder hinge pivot.

1. Check pivot weld by pushing down on the pivot
2. Check the pivot for signs of seizure

In the case of a failed pivot or seized pivot the aircraft must be grounded until repair kit number one (1) is installed. This repair kit consisting of upgraded parts must be ordered from the manufacturer CENTRAIR immediately.

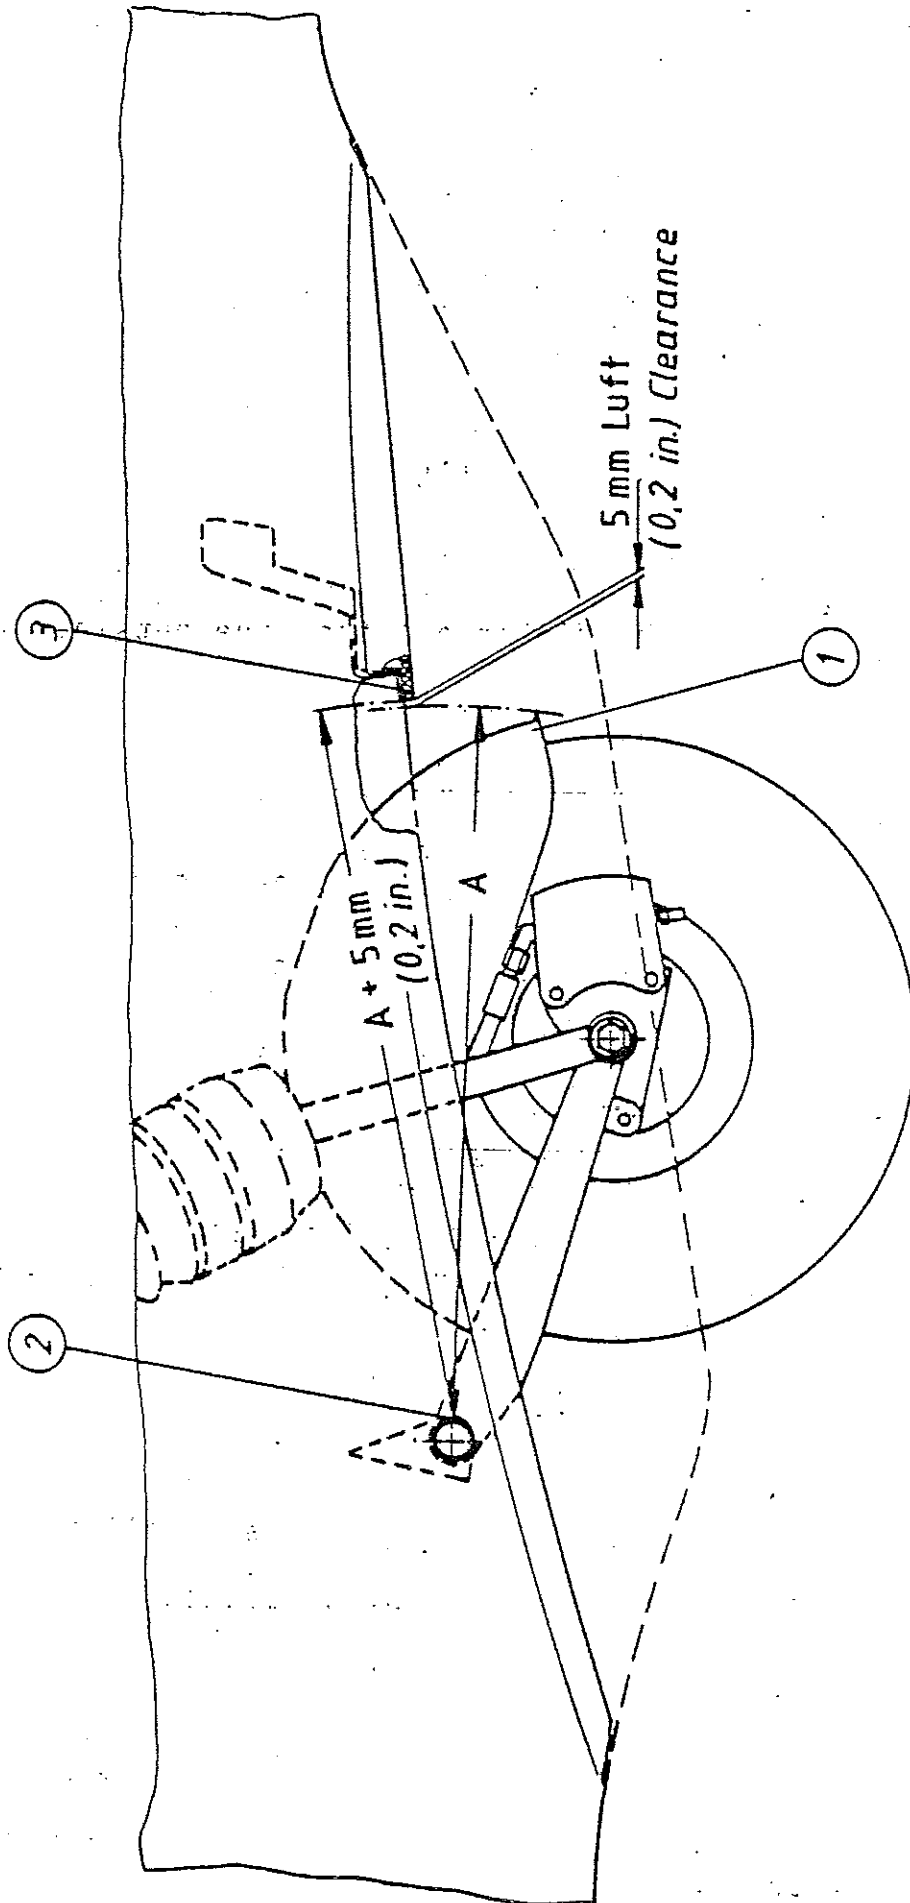
- Subject: Inspection of the wheel box cutout in the fuselage.
- Affected gliders: Serial numbers 21 194 thru 21 228 inclusive. **LBA/AD/84/180**  
**BRATNS/12/84.**

- Compliance: Prior to the next take-off.
- Reason: With the above serial numbers of the ASK 21 model, the wheel box cutout in the fuselage presumably was not cut out far enough. When retracting the main wheel, this may cause the rear edge of the wheel box to foul the edge of the wheel box cutout (see sketch).

- Action:
1. Jack up the fuselage safely and dismount the wheel fairing. As described in sketch 1 measure the distance A from the outside of the wheel box ① to the washer ② at the fulcrum of the wheel fork. Compare the above distance A with the distance to the trailing edge of the wheel box cutout in the fuselage; which must be by 5mm longer !

2. If this is not the case, then the wheel box cutout must be enlarged accordingly.
  3. Check whether the glue joint between the fuselage shell at the edge of the wheel box cutout and the anchoring strap fillet ③ is damaged.

4. If a damage is found, re-glue this glue joint (see Repair Manual). Then preserve again the repaired edge of the wheel box cutout (100 parts in weight Epikote 162, 38 parts in weight Epikure 113).
