BGA TECHNICAL NEWSHEET

TNS 3/4/85

PART 1. AIRWORTHINESS "AGGRO" - (Please add to the 1985 Green Pages)

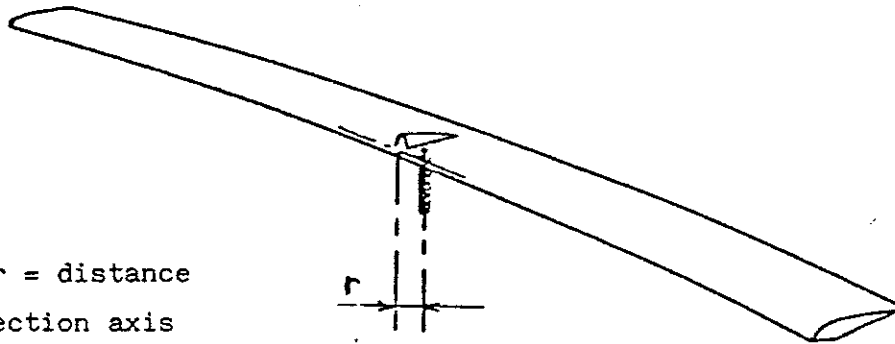
Weigh the cleaned ailerons, without their axis, with an exact balance. The weight has to be between 2,2 and 2,6 Kg. Find out the centre of gravity position of the aileron in the following way : vertical fixing of a needle. Put the aileron intrados on the needle and search for the centre of gravity position moving it until in balance. Check that the intrados is then correctly horizontal with the help of a spirit-level. Then adjust this laying point marking a small diameter circle around the needle. Often necessary to plug the front screw hole with cement because the centre of gravity can be located right there.

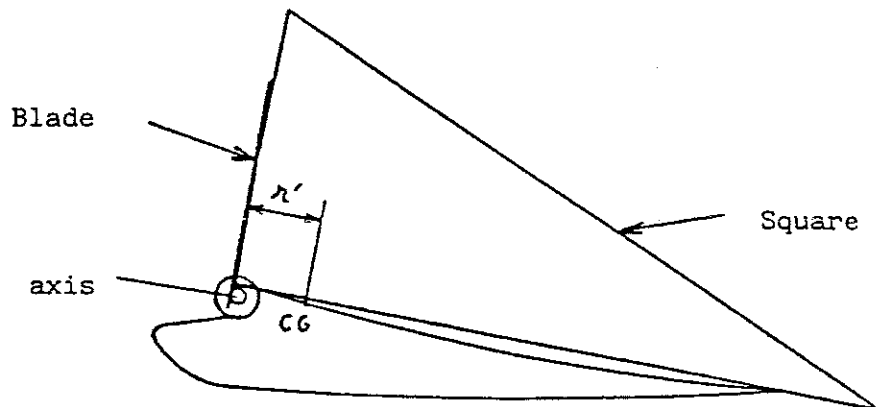
Exactly measure the distance between the aileron connection axis and its centre of gravity. For lack of a more accurate tool, put back the central hinge axis and make a blade strike on it upright to the intrados owing to a square lying on it.

Then measure the distance r' between that blade and the marked small circle centre which is the centre of gravity and subtract 3mm for the axis radius $\rightarrow r$. The maxi permissible miscalculation is 0,5mm. The product of the aileron weight (Kg) by the resulted length r (in cm) give the balance which must take place inside the definite limits as shown in Service Guide : 2,8 to 3,5 cm/Kg.

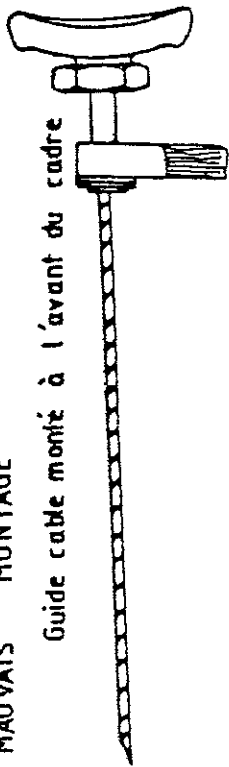
FIGURE 1

MAUVAIS MONTAGE

Guide câble monté à l'avant du cadre

- 1 - Check whether the cable guiding fittings are mounted in front of the bulkhead (fig.1) or rear of it (fig.2)
- 2 - If the fittings are mounted in front of the bulkhead, they must be remounted to the rear.
- 3 - Check whether sufficient neutral travel is left as indicated in figure 2.

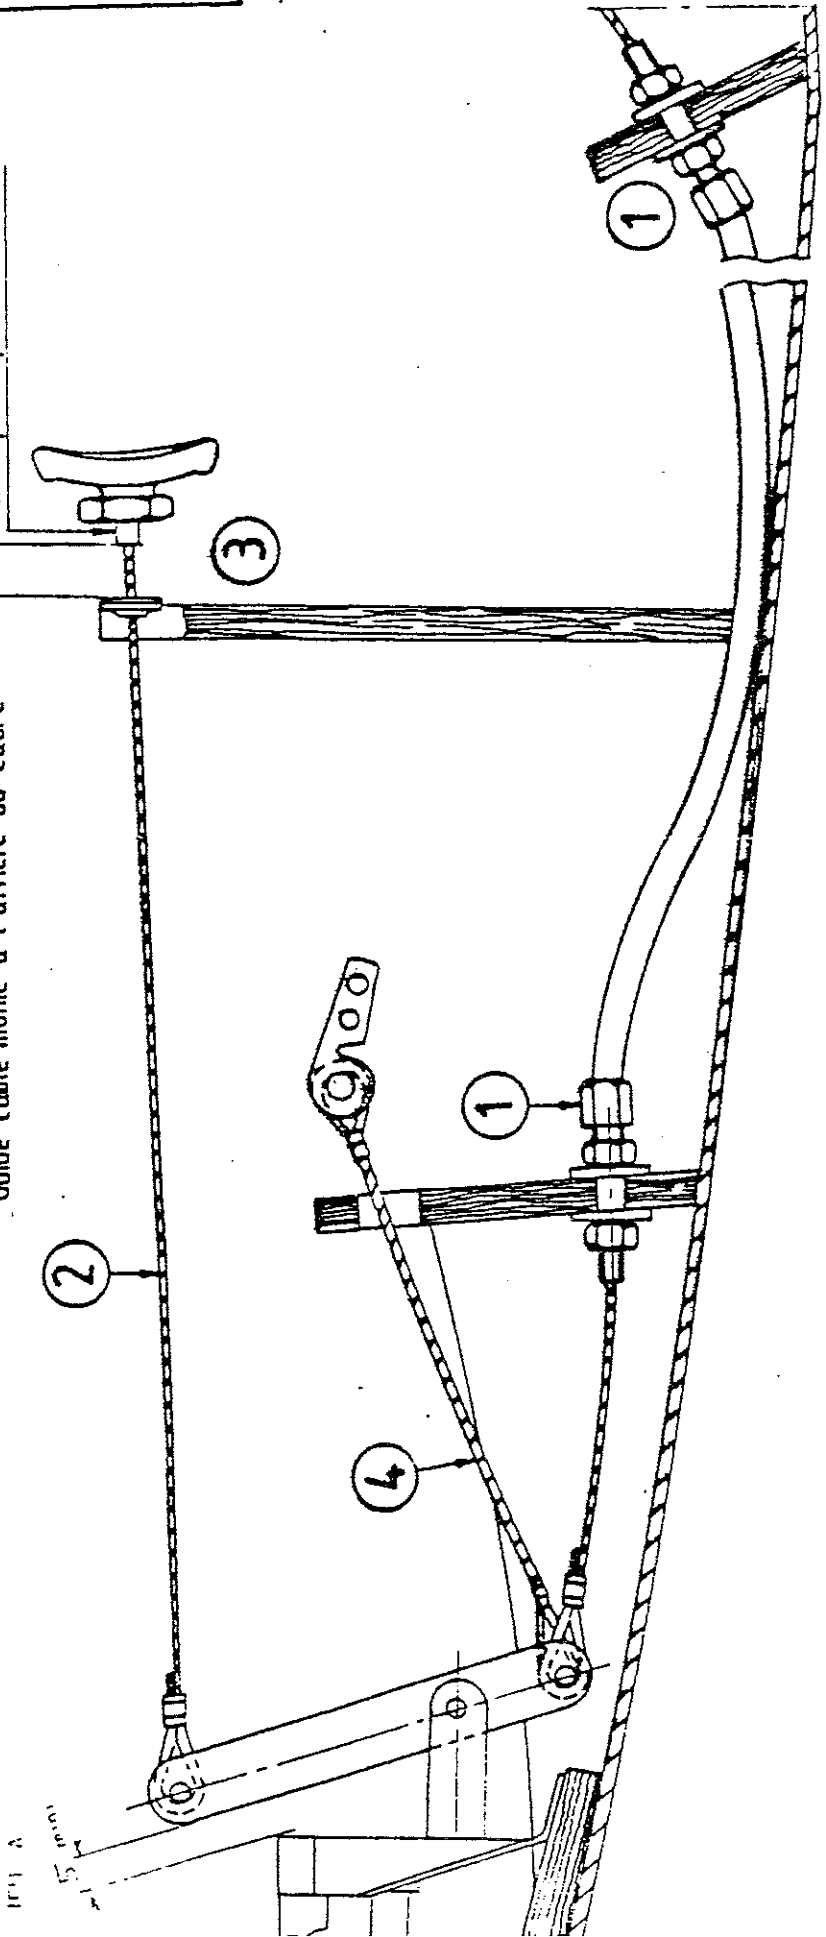
FIGURE 2

MONTAGE CORRECT

Guide câble monté à l'arrière du cadre

Gaine plastique raccourcie

3.11) On gliders with a rear hook only, screw the adjusted bits (rep. 1 fig.2)

3.12) On gliders with a front hook only, replace the cable (rep. 4 fig.2)

3.13) On gliders with front and rear hooks, replace the cable (rep.4 fig.2) if this one shortens the neutral travel and play on the adjusted bits so that the stress is identical on the 2 hooks so that they release together.

3.21) On the gliders with rear hook only and with a plastic tube between the release cable fitting and the cable guide (rep. 3 fig. 2) to ajust it, shorten the plastic tube and/or screw the adjusted bits (rep. 1 fig.2)

If no tube (rep.3 fig.2), screw the adjusted bits rep.1 fig.2 . If no back lash, replace the cable control (rep.2 fig.2)

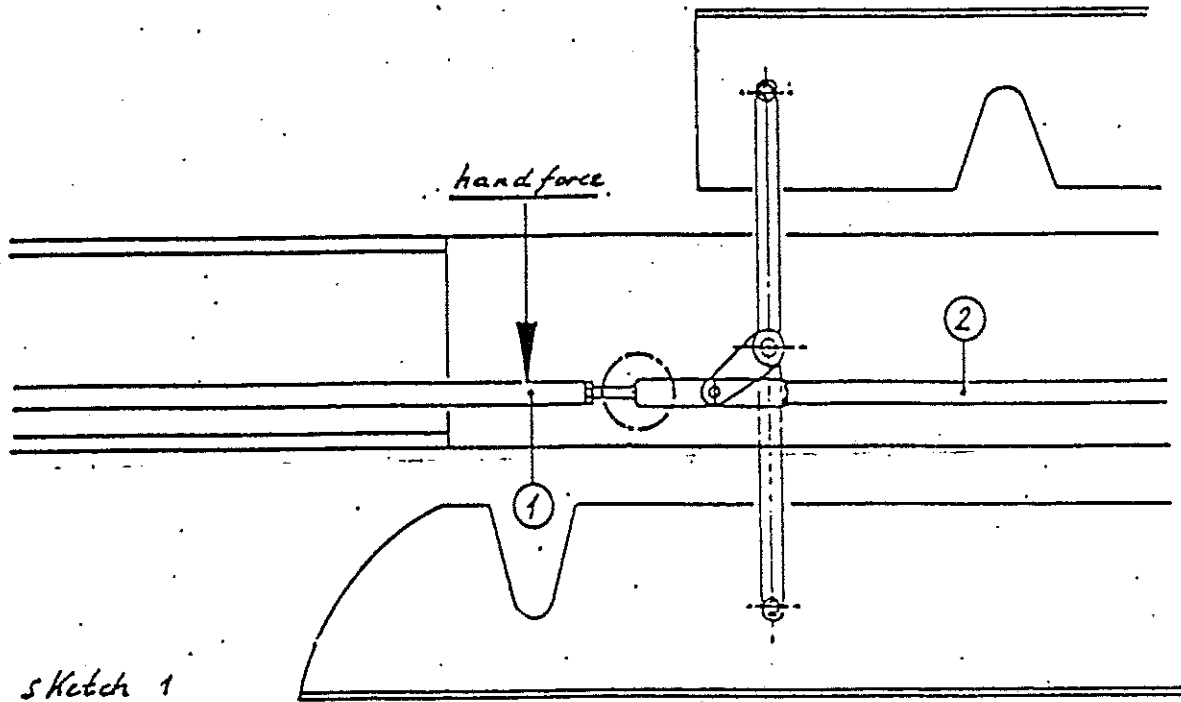
Sketch 1

(0.24 in.) threaded bolt welded to the connecting rod of the airbrake bellcranks broke off.
On all sailplanes after serial number 50 this 6 mm threaded bolt has been replaced by a 8 mm (0.31 in.) bolt.

Previously used:
 threaded bolt M6

- Urgency : Action 1: Prior to the next flight.
Action 2: Not later than April 30th, 1985.
- Actions : 1. With the airbrakes extended make a visual check of the welding seam of the 6 mm threaded bolt at the connecting rod ② by applying a mild vertical load by hand onto the push/pull rod ① as shown on sketch 1.
If cracks are found in the welding seam the following actions are to be accomplished prior to the next flight:

- Note:
These actions do not apply for sailplanes on which the 6 mm threaded bolt has already been replaced by an 8 mm bolt.
2. To remove the connecting rod ② between the airbrake bellcranks first turn out the push/pull tube ① at the root rib, then undo the split pins at the airbrake bellcranks.

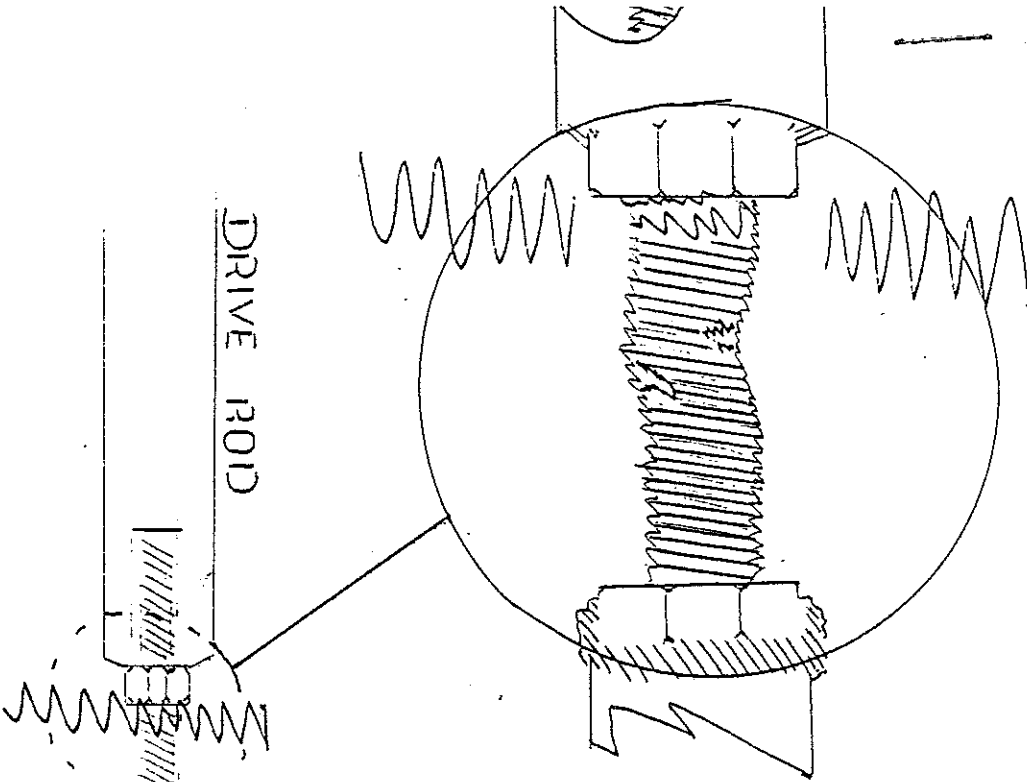
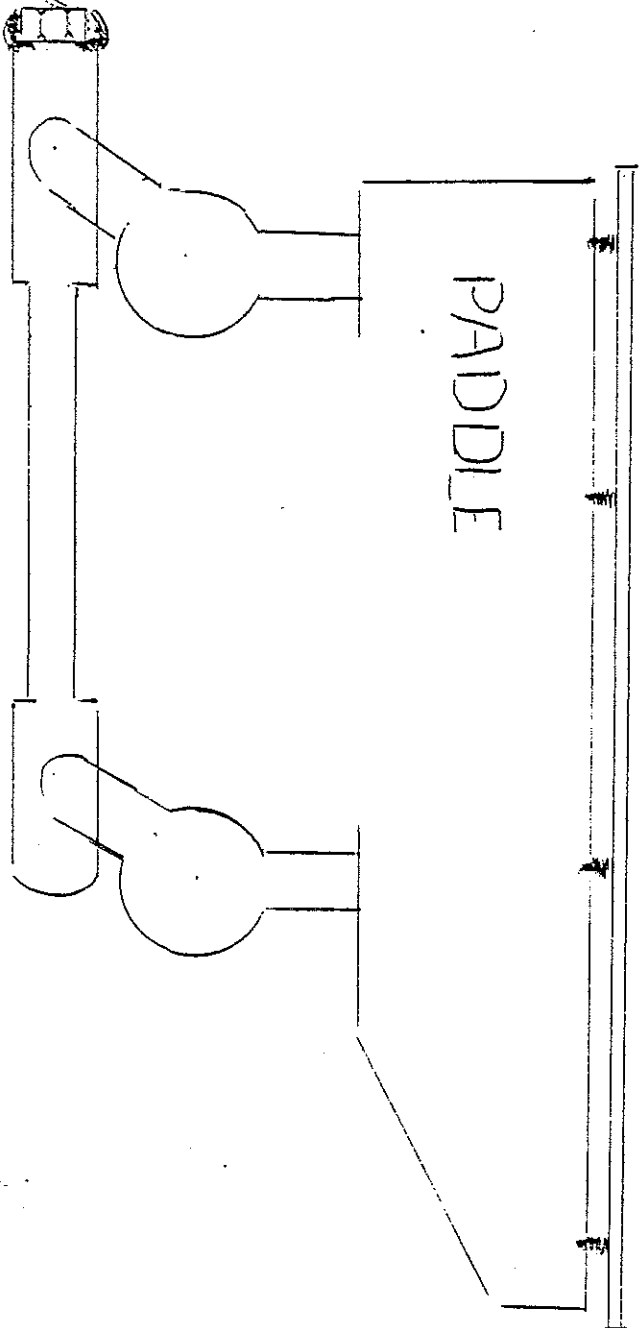
FRACTURE

OPEN CIRRRUS

BRAKE ROD END FAILURE

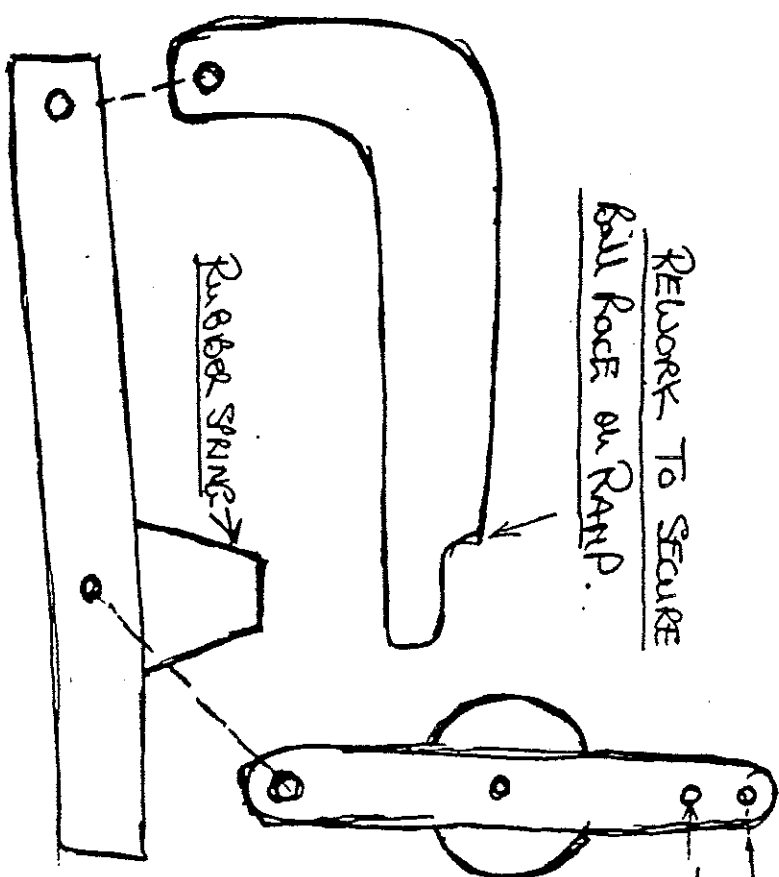
This is a rough sketch to show what it is, if you would like to have detailed drawing or photo let me know.

REWORK TO SECURE
Ball Race on RAMP.
