BGA TECHNICAL COMMITTEE

TNS 5/6/85

PART 1. AIRWORTHINESS "AGGRO" (Please add to the 1985 Green Pages)

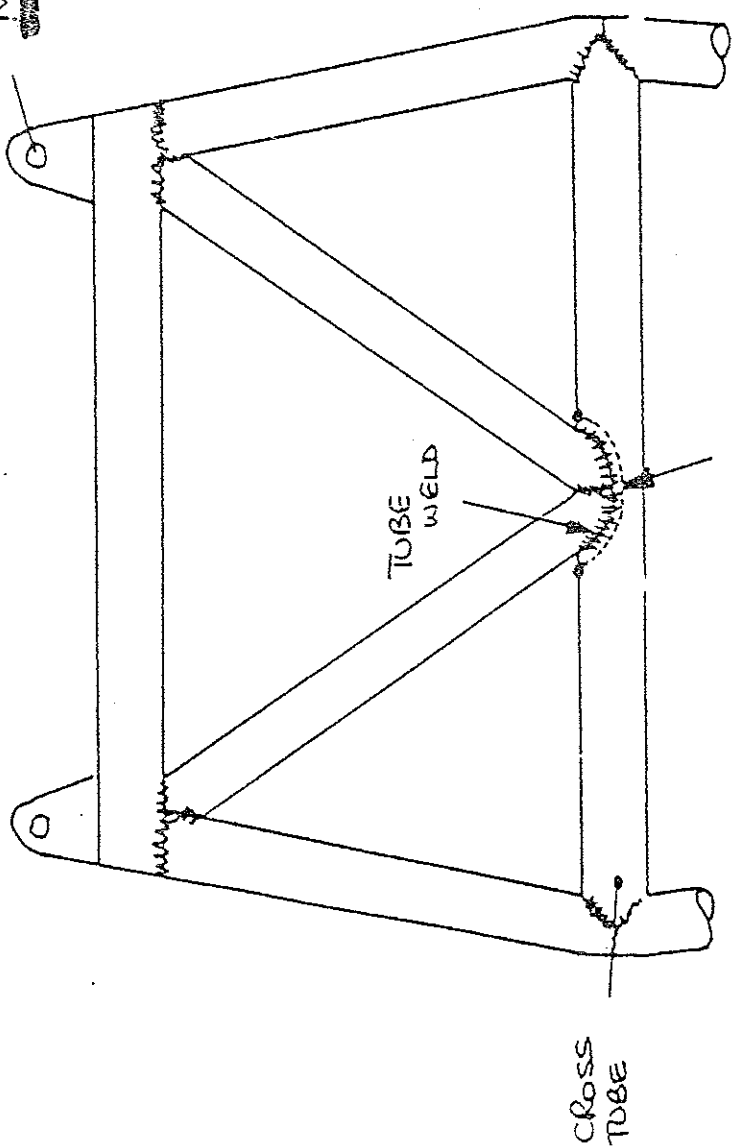
MAIN SPAR / FUSelage ATTACHMENT FITTING

- 1.9 IS28/M2/M2A Rudder Bar Axle fixing rivet, EO-13 introduces Mandatory Modification.
- 1.10 KA 7 MAIN SPAR/Fuselage attachment fitting. Cracks in welded structure. Inspect as indicated in attached sketch. (Reported by G Jones)

CRACK WAS INITIALLY VISIBLE AS A THIN RUSTY HAIRLINE CRACK IN THE PAINT FILM PAINT WAS REMOVED AND THE AREA CHECKED WITH MAGNAFLUX, CRACK DETECTING MAGNETIC INK SYSTEM.

THE EXTENT OF THE CRACK WAS THEN APPARENT I.E. IT RAN APPROX HALF WAY AROUND THE LOWER EDGE OF THE WELD.

THE CROSS TUBE WAS VERY SLIGHTLY DISHED IN THE AREA OF THE WELD SUGGESTING A LARGE DOWNLOAD AT SOME STAGE, PROBABLY AS A RESULT OF A HEAVY LANDING.

CRACK RUNNING APPROX 180° AROUND LOWER EDGE OF WELD FROM ONE SIDE TO OTHER.

THE CRACK WAS REPAIRED BY REWELDING AND THE AREA REPROTECTED.

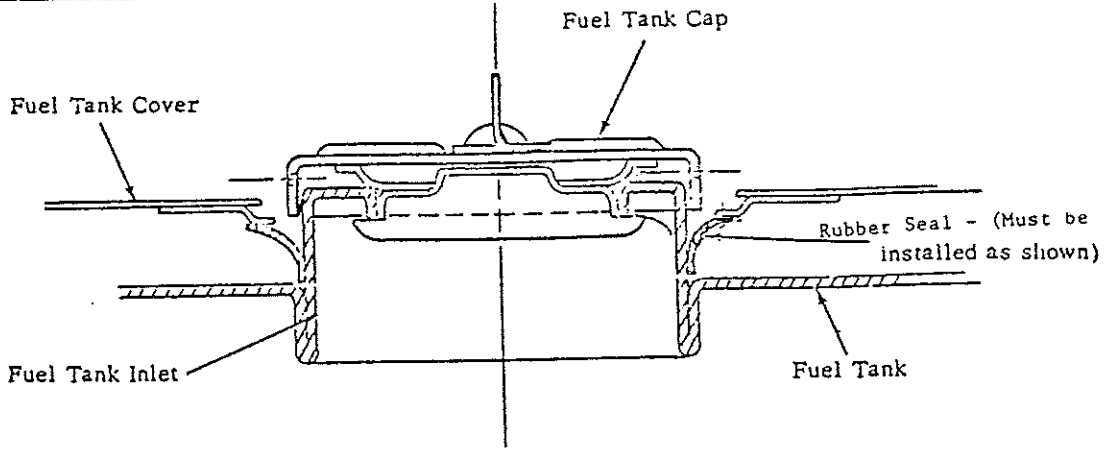
CROSS SECTION OF FUEL TANK INLET AND RUBBER SEAL
SKETCH 1
78-10-03

PIPER CUB. CORRECT FUEL CAP!!

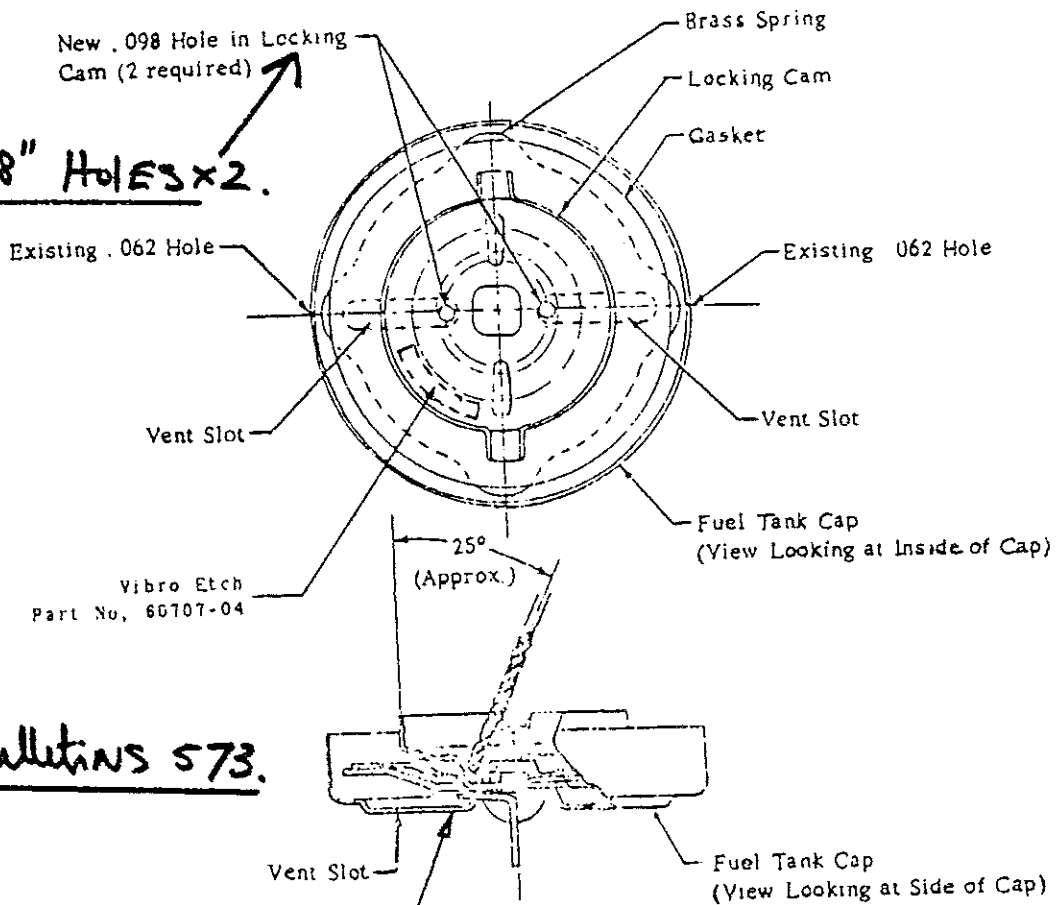
SKETCH 2
AD 78-10-03

DRILL .098" HOLES x 2.

CAUTION
DO NOT DRILL THRU
THIS SURFACE

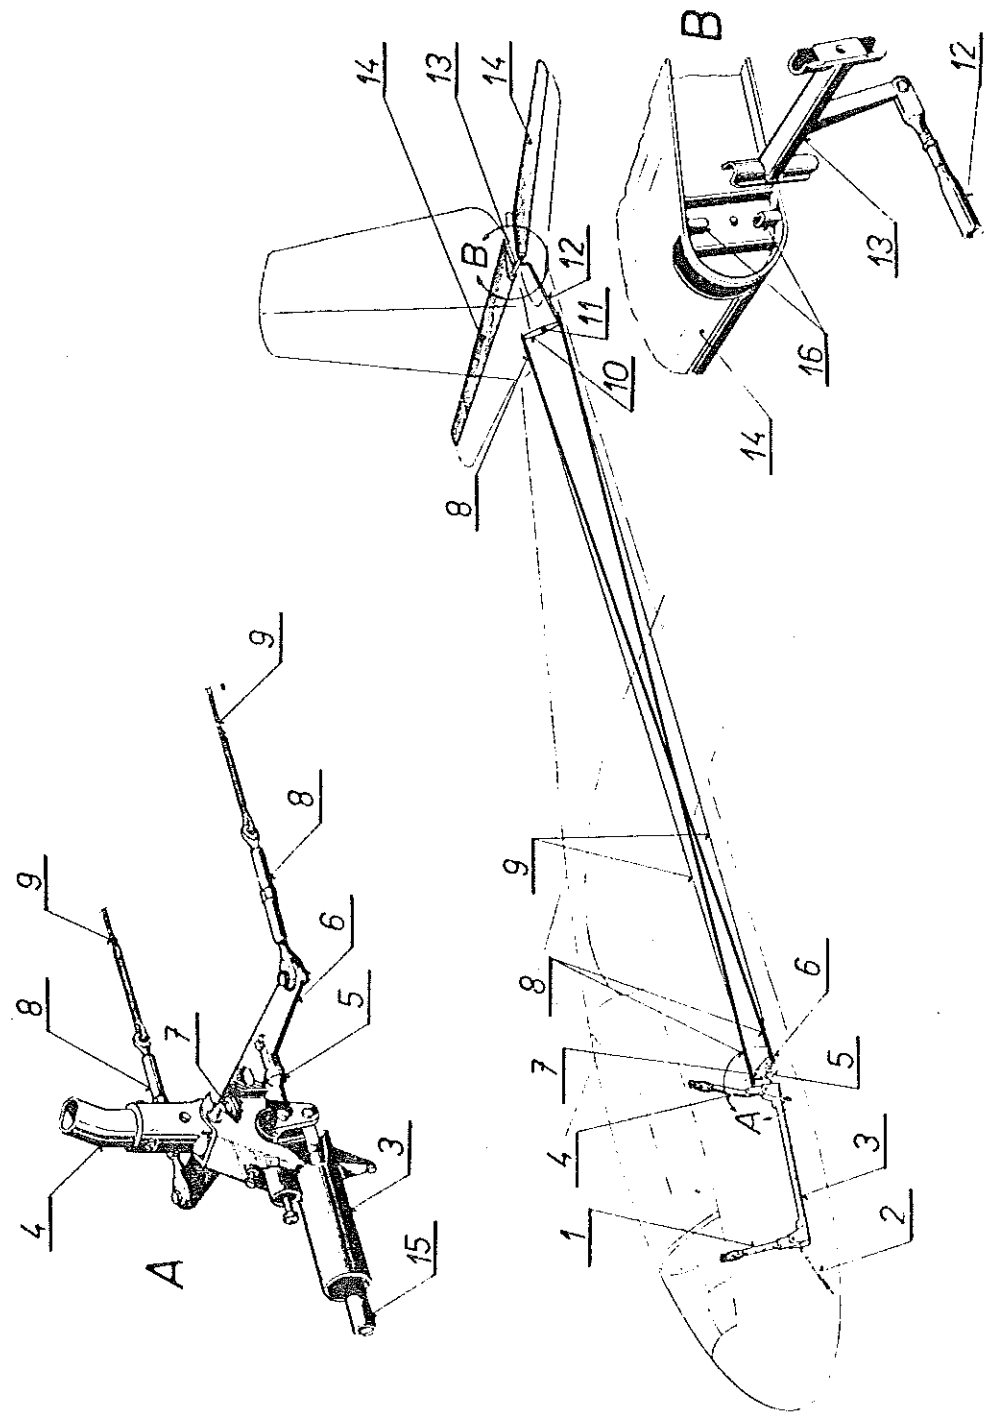
Fig. 20. Elevator control

- 1.3 GROB 109A Failure of the Elevator Drive Tube between fairleads in the rear fuselage. A fatigue failure has been confirmed by Grob. Reported to CAA/LBA. Follow up action awaited.

Blank Elevator Drive.
