BGA TECHNICAL COMMITTEE

TNS 7/8/85

PART 1 Airworthiness "Aggro" (Please add to the 1985 Green Pages)

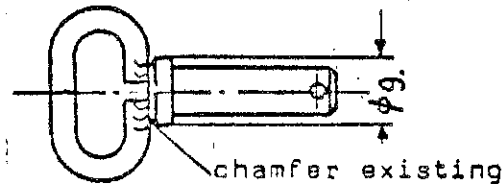
Reason: On some "Bergfalke" Sailplanes (not all), a connection bolt for elevator and airbrakes was installed, made of an eyebolt with a welded handle (made of welding rod) (see sketch)

Under bad circumstances the molecular of the eyebolt (DIN material), can change during the welding of the little handle to the bolt.

There has been a damage to a bolt for the airbrakes. For the safety, it is necessary to inspect the DIN-bolts for eventual cracks and before 31.8.1985 replace them against bolts made of "Aircraftsteel" (1.7214.4 or 1.7734.4 (see drawing Instruction 3)).

Before next flight the connection bolts must be inspected by using a magnifying glass of at least 10 x power. If cracks are found, then the bolt must be replaced immediately. If no cracks are found the sailplane may be flown until 31.8.85.

If the connection bolts are not made of "Aircraftsteel", they must be replaced against such of aircraftsteel ( see drawing), before 31.8.1985.

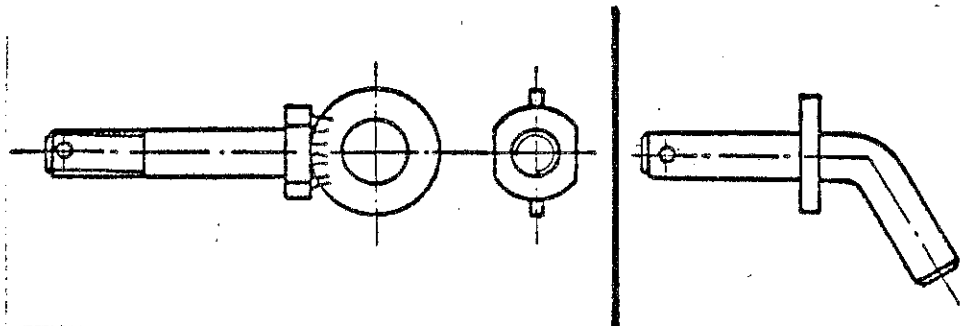
Instructions: Instruction 1  
Inspect if the connection bolts are affected. Not affected are (these bolts are already made of "Aircraft steel"):  
a) "halfautomatic" elevator connection bolts (the bolt slides in a tube which is welded to the elevator lever).  
b) elevator connection bolts in the following construction

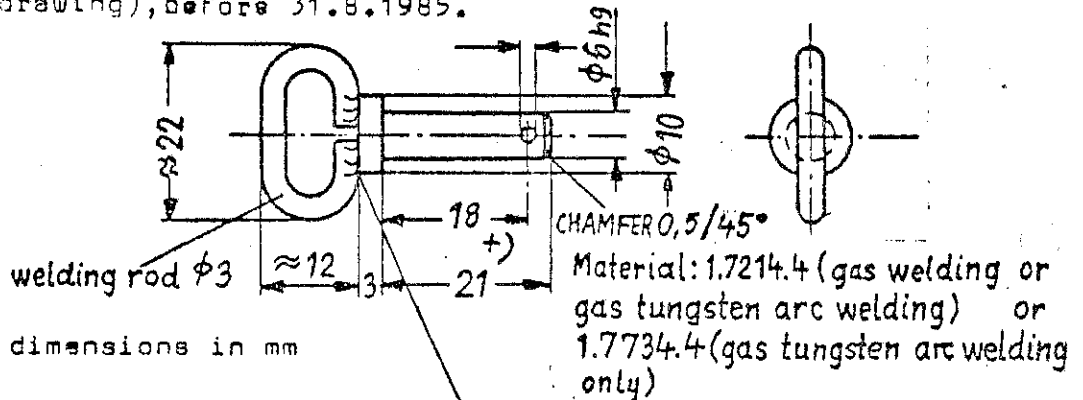
Instruction 3

here as difference to the eyebolt (From DIN material) no

+) a certain amount of Bergfalke's are "amateur-build".<sup>chamfer</sup> Therefore there may be differences in the length of the bolts, and they must be fitted to the actual Bergfalke. In any case with the new connection bolts the controls must be checked carefully on function and clearance.

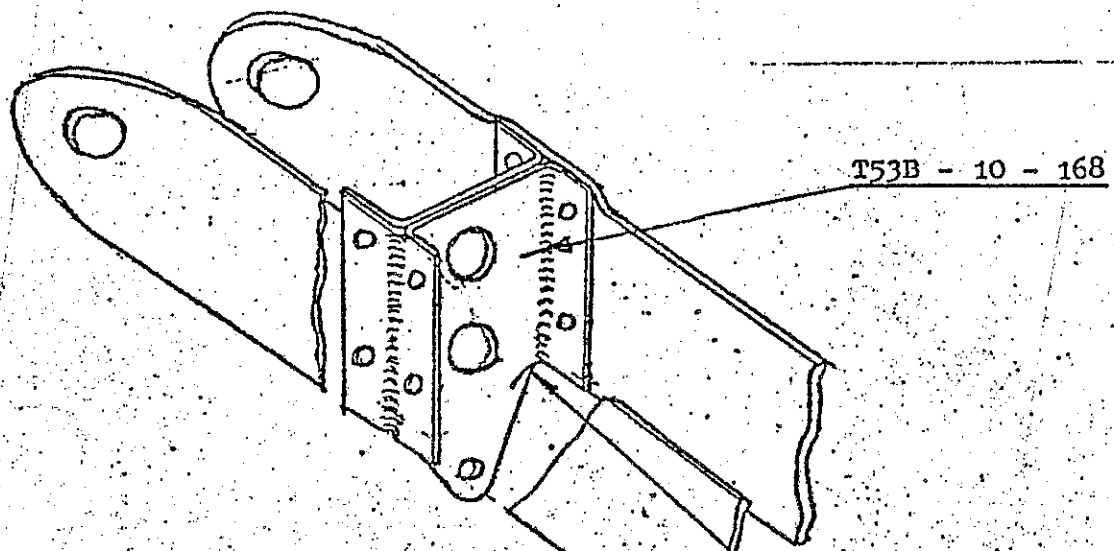
Figure 1

T53 WING CENTRE SECTION JOINTS  
TO FRAME 6

Remove glass fibre fairing No.T53B-10-1093 and wings if fitted. Using a Dye penetrant crack detection system, inspect for cracks at the corner of the fittings where the attachment flanges begin (a) the welded brackets Pt No.T53B-10-168 issue 1-4 see figure 1 page 2 which holds the rear spar member of the c/s to the fuselage frame 6 and (b) the alternative riveted bracket Pt No.T53B-10-168 issue 5. Also in a similar manner inspect the metal lugs T53B-10-115 and channel section T53-10-118 on frame 6. See Figure 2. Checking for cracks in way of rivets.	
If any cracks are found the aircraft is to be grounded. All findings to be reported to SEL marked for the attention of the undersigned. New components can be obtained from SEL if required as listed above. If there are no cracks the aircraft is cleared for flight.	
Once the inspection has been complete the TI 100/T53 action should be recorded in the aircraft log book.

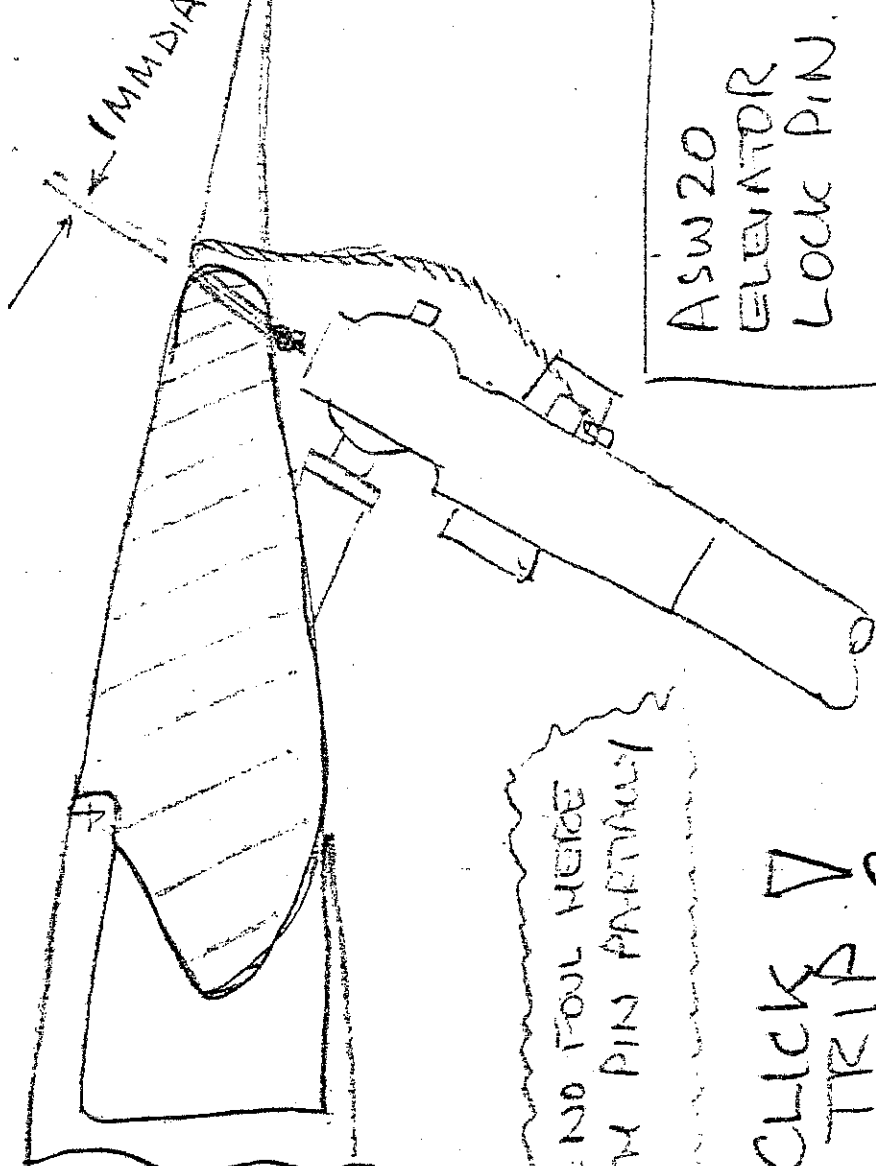
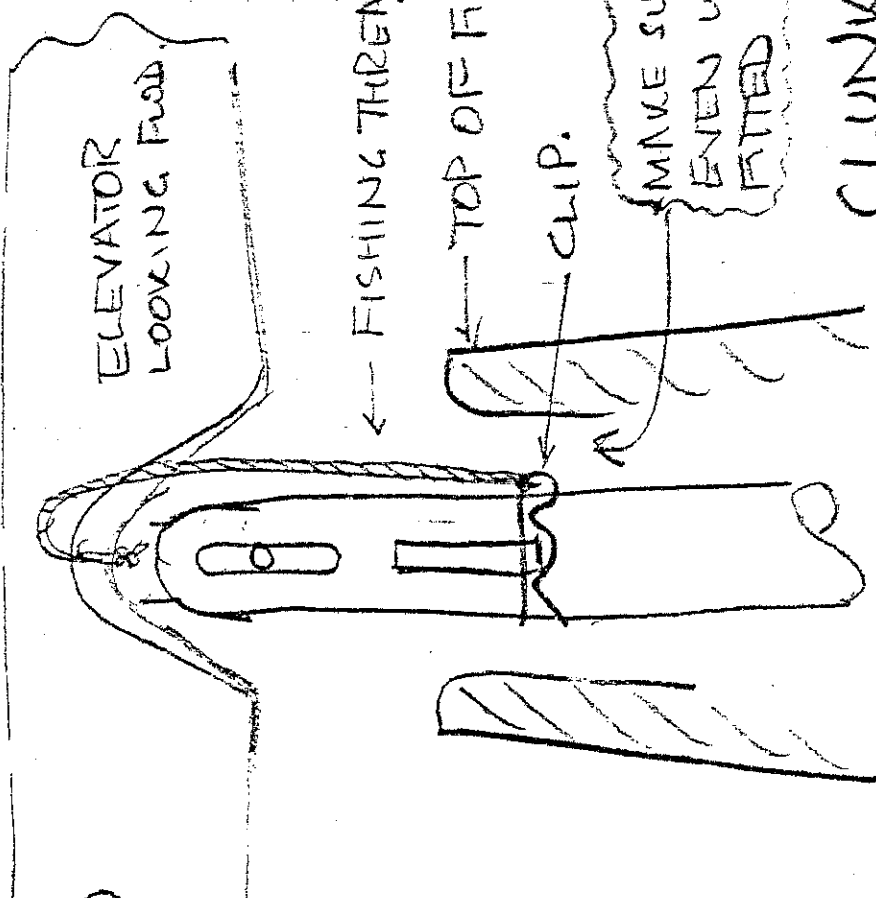
ASW 19/20 ELEVATOR 1.8:  
BGA TNS 7/8/RS

- 1.8 ASW 19/20 ELEVATOR LOCK PIN. The attached sketch by Chris Batty introduces additional safety device. ASW Tech Note 17 also illustrates this modification, which will only be effective if you remember to couple-up in the first place!

PIN MUST BE SHORT ENOUGH TO AVOID FOUL AGAINST FIN

PIN ACTUAL SIZE  
BENT FROM ZOSWOG, PIANO WIRE  
FROM LOCAL MODEL SHOP,  
KNOTTED & GLUED  
DRILL DIAGONAL HOLE IN ELEVATOR

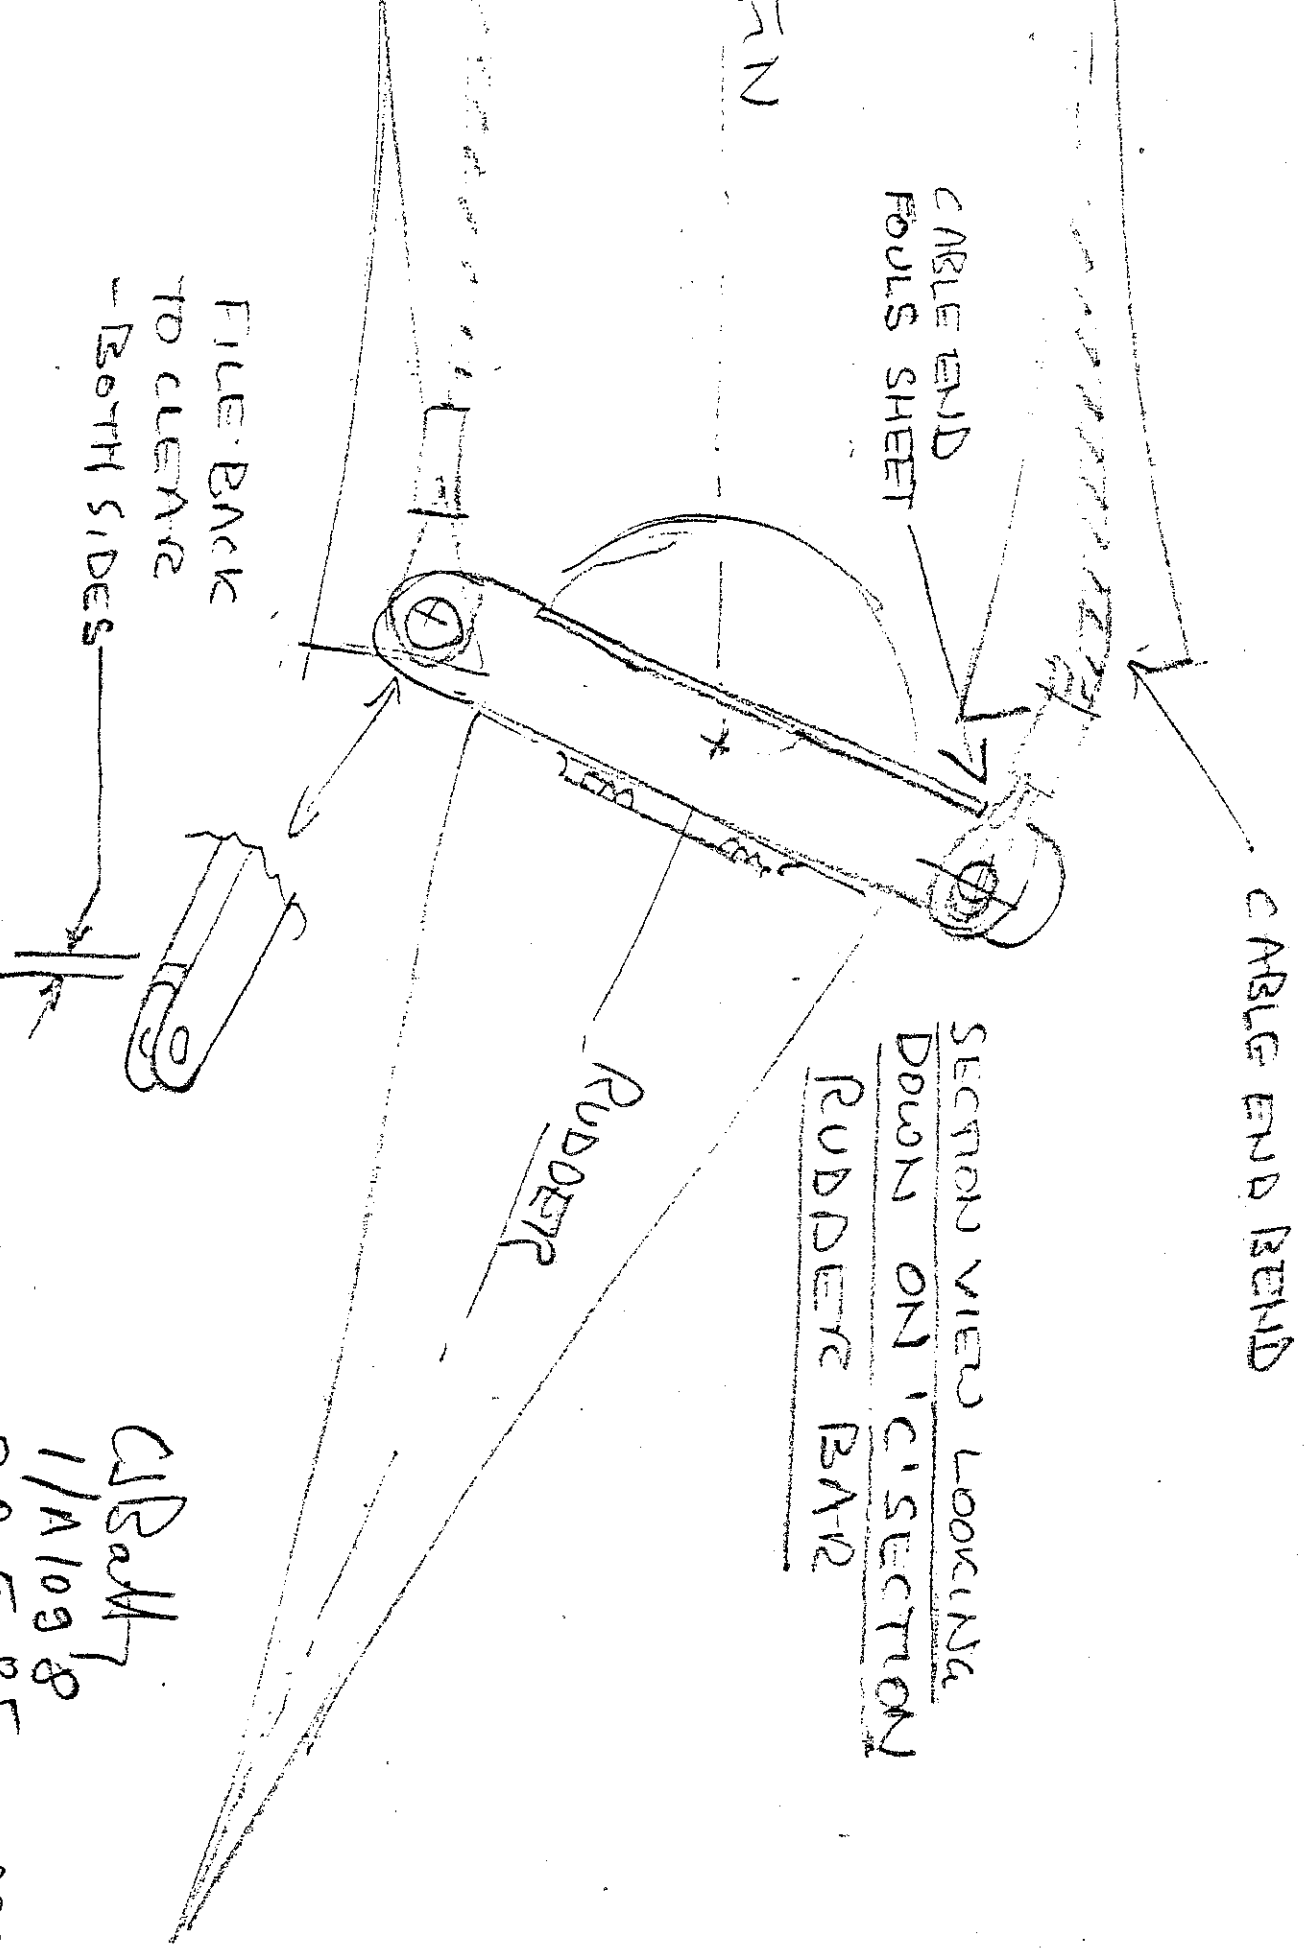
A5020 (219) RUDDER BAR CABLE END BEND

- 1.9 ASW 19/20 Rudder Cable END BEND at Rudder. Attached sketch by Chris batty illustrates potential fatigue failure.
- 1.10 LIBELLE (Standard) - Elevator Vibration. Backlash in the elevator drive must be minimal if "flutter" (which might cause damage) is to be prevented. (Reported by Kent GC)

FILE BACK  
TO CLEAR  
- BOTH SIDES

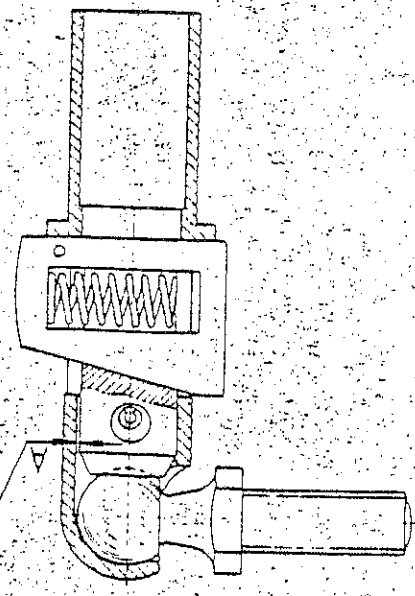
Clearance A must not exceed 0,15 mm (0,006 in); check by using a wire of 0,15 mm diameter !

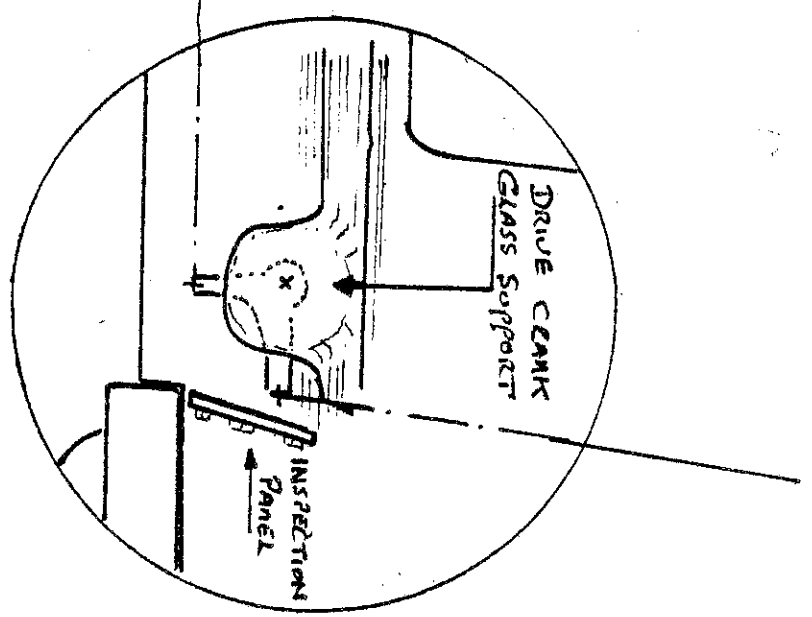
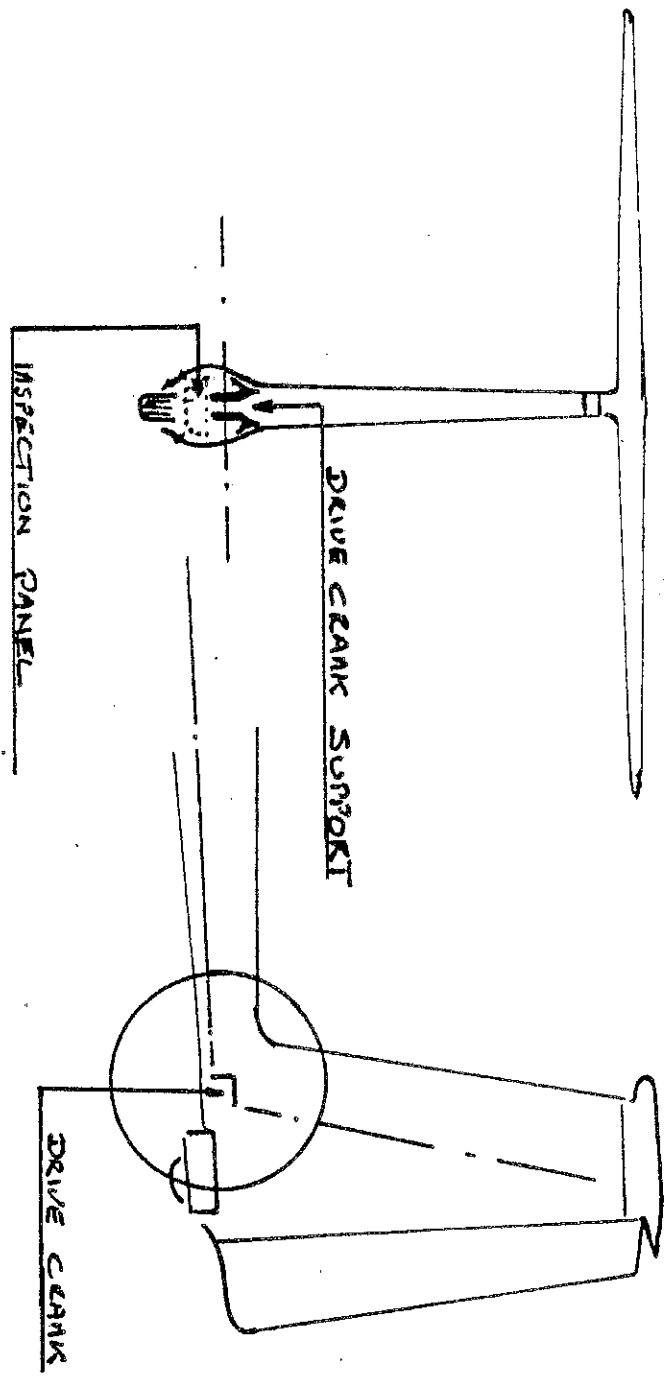
DE-LAMINATION INSPECTION.  
ELEVATOR DRIVE SUPPORT.

- 1.17. T.65 VEGA Delamination of elevator drive support at base of fin - (sketch attached - reported by J. Clarke, M.G.C.)

De-lamination & general malformed elevator drive crank support yoke  
Angle mirror must be used & inserted along side support, to inspect.

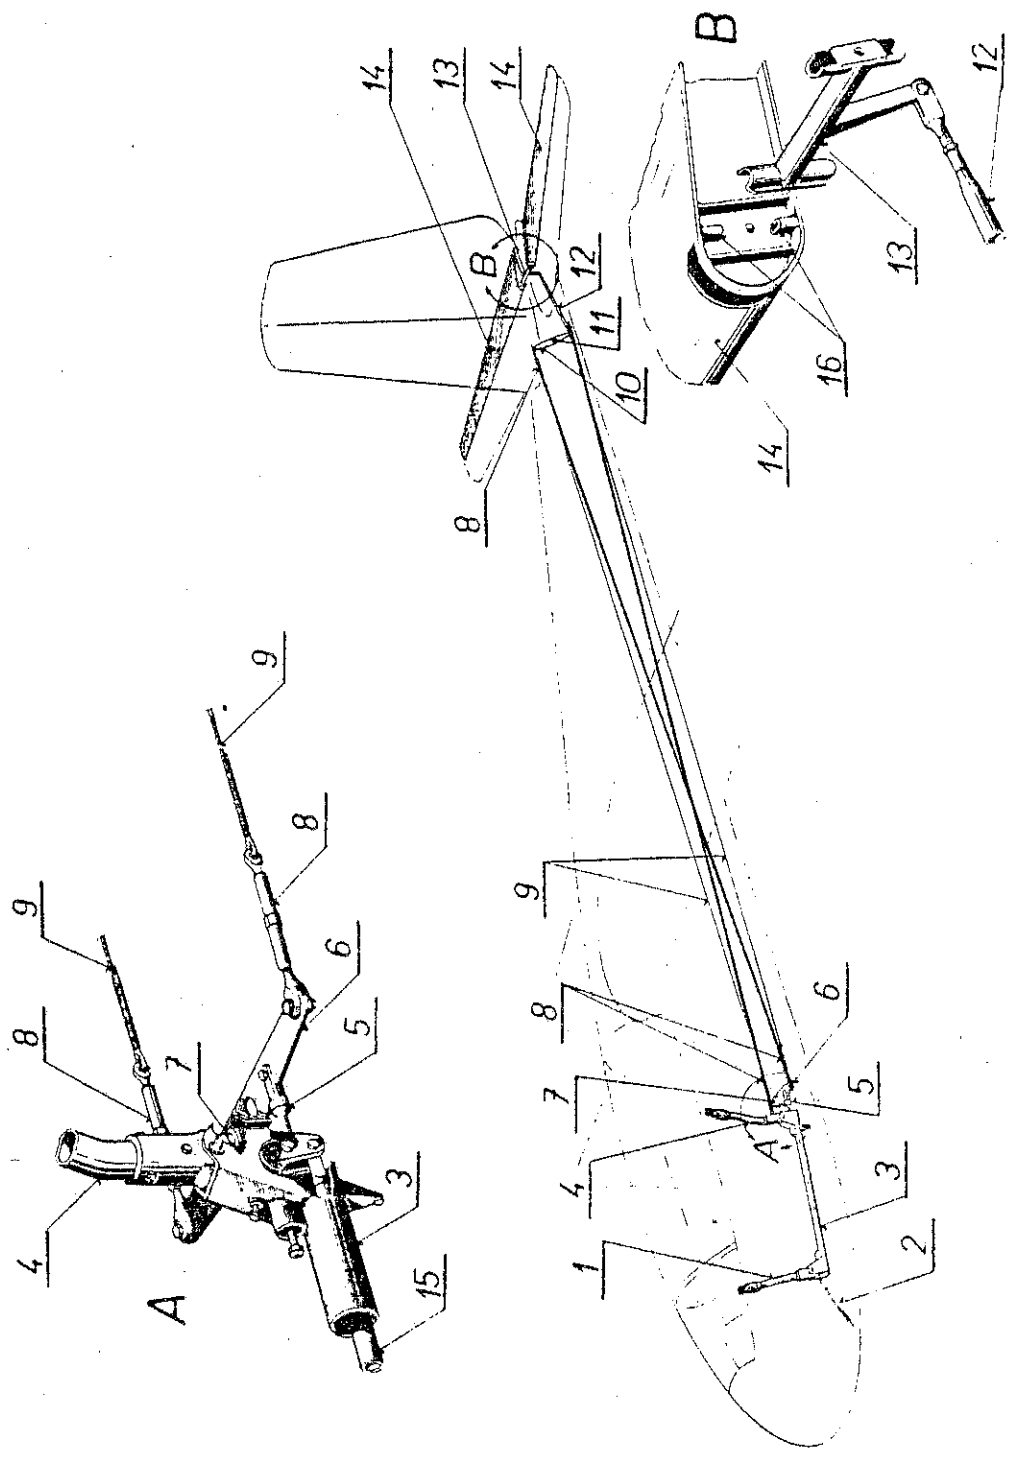
Fig. 20. Elevator control

- 1.12 Blank Elevator Drive Cables. Page 38 of the Manual illustrates incorrect routing of the cables (in parallel), whereas to achieve the correct operating sense the cables must cross over (sketch attached). Reported by Jeremy Bryson, Ulster GC.

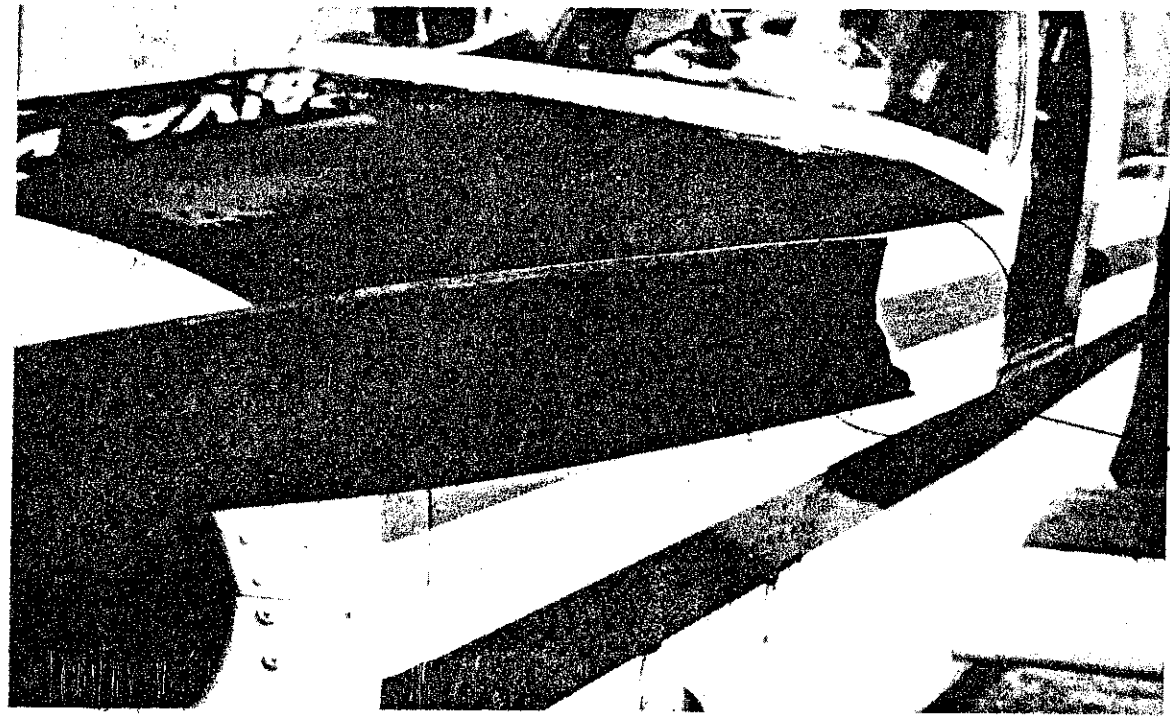
Fuji Prop Blade

- 1.14 Propeller Blade Failures. Extracts from GASIL 6/85 illustrates typical failures on Fuji, Rallye and Cessna metal propellers. Gliding Clubs operating from loose stone surfaces are very vulnerable. CAA Notice No 55 refers. DAILY inspections for blade damage should be made.

One propeller blade separated from the hub during flight because of hub cracking. Fatigue cracks had propagated from several sites in the 6th thread. One of the other blades was also cracked at this thread. Poor shot peening of the roots was noted. It was thought to be a strong possibility that the crack was visible at the outer surface of the hub at the 100 hour inspection done 30 hours previously. However, the presence of a self-adhesive decal fixed to the hub may have hindered detection. The propeller had flown 4987 hours with 1363 since overhaul. The propeller was a McCauley D3A32C-90-CM.

About 5" of one blade of the propeller tip was missing. The propeller was a Sensenich 76 EMS/0/60. The aircraft had flown 1076 hours. The propeller history is unknown.

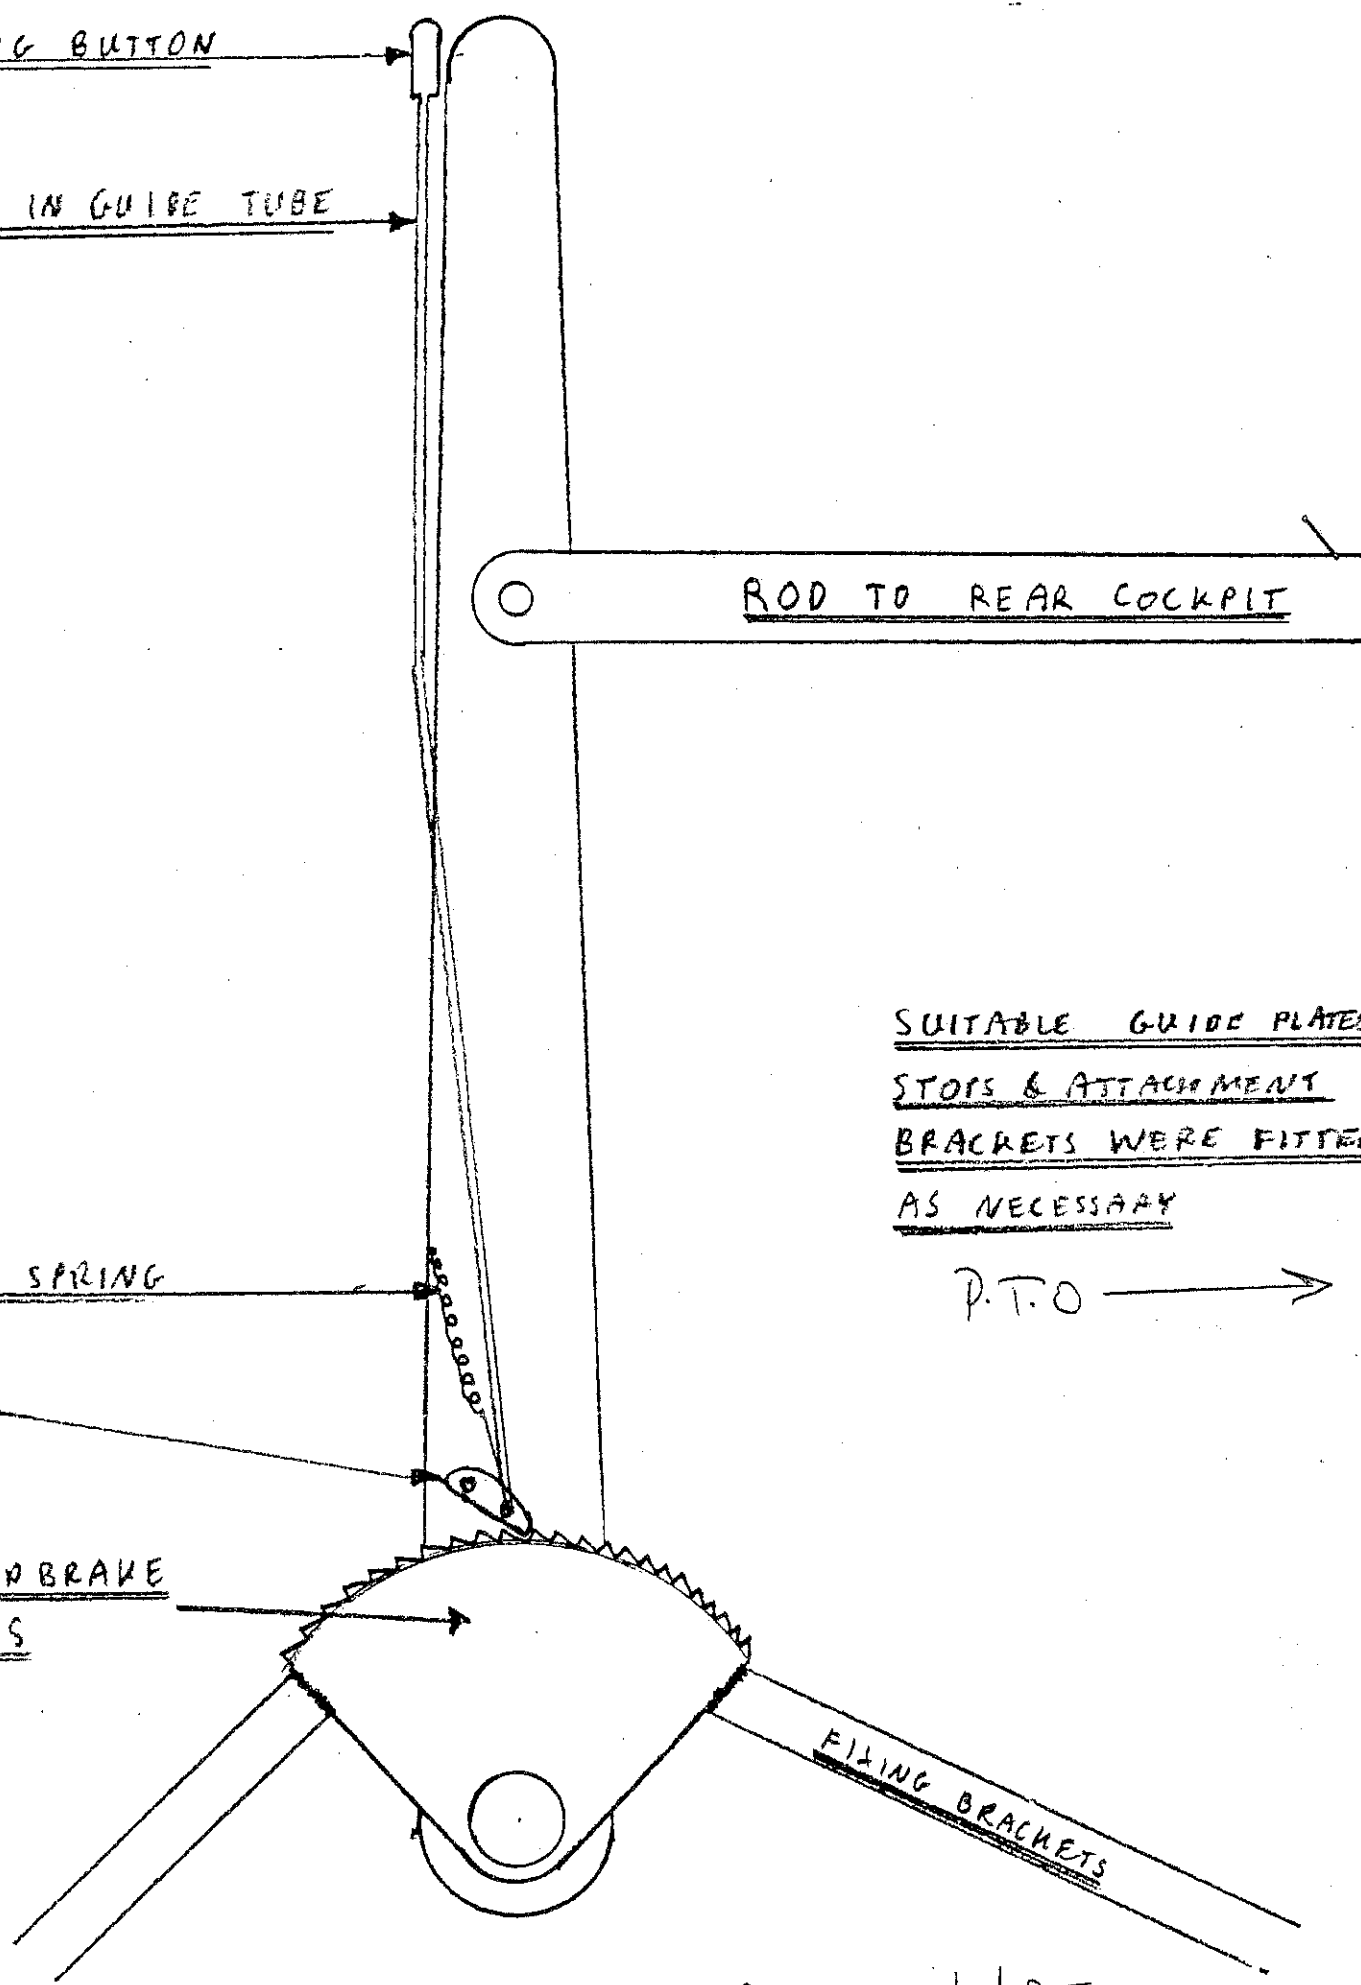
DISABLED PILOT AIRBRAKE LOCK

To enable one to lock the airbrakes in any position, so as to be able to use the hand rudder while landing, a motor car type "fly off handbrake" mechanism was fitted to the front cockpit airbrake lever.

When the button is pushed on the top of the front airbrake lever a paw engages in a ratchet and prevents the brakes opening further. The "such open" force on the airbrakes holds the paw engaged until the lever is pushed forward, by either pilot, when a spring raises the paw and the brakes revert to normal operation.
